**ACCIDENT**

<b>Aircraft Type and Registration:</b>	Dyn' Aero MCR-01 ULC, G-BZXG	
<b>No &amp; Type of Engines:</b>	1 Rotax 912ULS piston engine	
<b>Year of Manufacture:</b>	2001	
<b>Date &amp; Time (UTC):</b>	30 December 2007 at 1210 hrs	
<b>Location:</b>	Burgham Park Golf Course, near Felton, Northumberland	
<b>Type of Flight:</b>	Private	
<b>Persons on Board:</b>	Crew - 1	Passengers - 1
<b>Injuries:</b>	Crew - 1 (Serious)	Passengers - 1 (Serious)
<b>Nature of Damage:</b>	Aircraft destroyed	
<b>Commander's Licence:</b>	Private Pilot's Licence	
<b>Commander's Age:</b>	38 years	
<b>Commander's Flying Experience:</b>	2,000 hours (of which 50 were on type) Last 90 days - 20 hours Last 28 days - 5 hours (All hours are approximate)	
<b>Information Source:</b>	AAIB Field Investigation

**Synopsis**

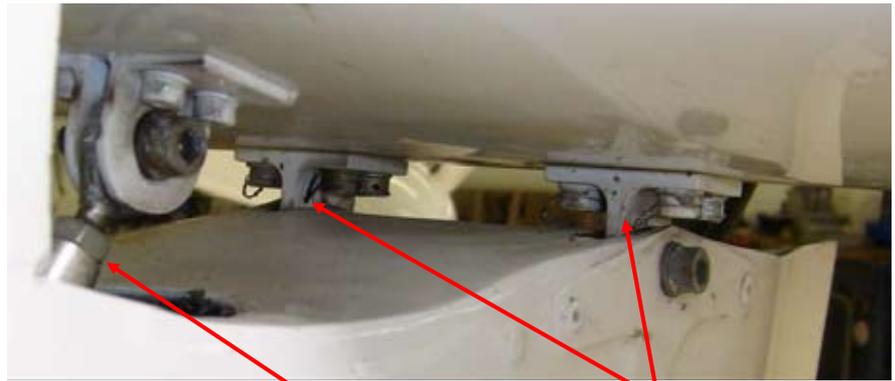
**Figure 1**

The tailplane is attached to the top of the fin via lugs which form the hinge point about which the tailplane rotates in response to pitch inputs (see Figure 1).

Tailplane attachment  
(Photograph from Dyn'Aero BS 08 B 0034)

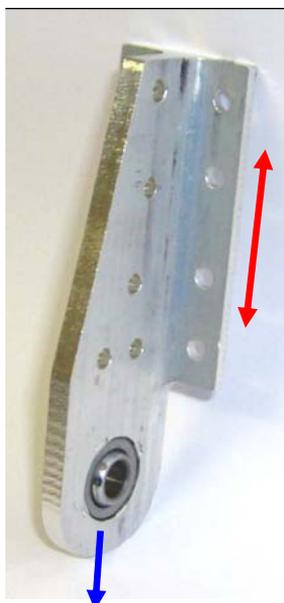
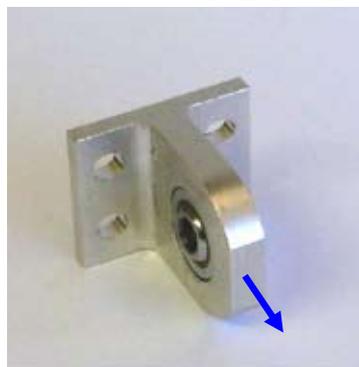
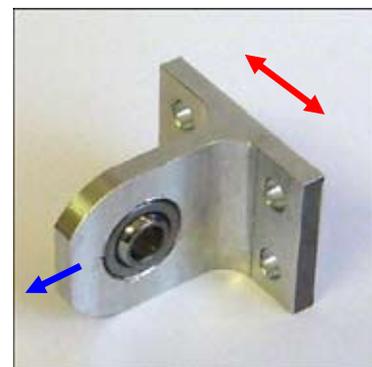
**Figure 2**

Type 1 - 4mm lug riveted and glued to tailplane spar vertical web

Type 2 - 7mm lug mounted on the tailplane with screw fixings

Type 3 - 4mm lug mounted on the tailplane with screw fixings

Different standards of tailplane fixing  
(red arrows depict material grain direction and blue arrows the direction of applied loading)  
(Photographs from Dyn'Aero BS 08 B 0034)

The lugs are machined from solid, rolled aluminium block in which the predominant grain direction of the material is parallel to the direction of rolling of the block. Figure 2 shows the material grain direction specified for the Type 1 lug and the grain direction for the Type 3 lugs examined by the AAIB. Material properties can be markedly different when applying load parallel, or perpendicular, to the direction of the material grain boundaries. The Type 1 lug is manufactured with the grain direction oriented longitudinally, such that the applied loads act along the direction of the grain, which is the ideal condition. The grain direction for the Type 2 and 3 lugs is not specified and thus, in theory, can be in any orientation. However, all the Type 3 lugs examined by the AAIB, including those from G-BZXG and new lugs provided by the manufacturer for testing, had a transverse grain direction. For such lugs, the applied loads act perpendicularly to the grain direction, which is the least preferable condition as the material is weakest in this direction. The aluminium alloy used for all three types of lug is a French specification AU4GN, which is similar to 2017 T4 or T451 alloys.

There were a number of factors which could have contributed to the stress corrosion mechanism which precipitated the failure of the left hand lug. A key factor was that the applied loads were perpendicular to the orientation of the material grain in the failed lug. This situation had arisen because whilst the material grain direction was specified for the Type 1 lug, there was no such requirement for the Type 2 and 3 lugs. All the Type 3 lugs examined by the AAIB had a transverse grain direction. The material is weakest in the direction transverse to the grain orientation and loading in this direction is most likely to result in stress corrosion.

The Service Bulletin (SB) required the identification of the type of fitting installed on each aircraft. If found to be the 4 mm Type 3 lug as described above, the lug must be removed and returned to the manufacturer for a replacement. The replacement is of similar dimensions, but manufactured from stainless steel with 'loose-fit' bearings which are glued in position, rather than the 'press-fit' bearings and staking previously used, which can introduce stress concentrations.

It is recommended that the Direction Generale de l'Aviation Civile (DGAC) considers mandating the replacement of Type 2 tailplane attachment lugs on all variants of MCR models with a stainless steel replacement as described in Dyn'Aero Procedure M EH NO 01, dated 13 March 2008.

It is recommended that the aircraft manufacturer, Dyn'Aero, should consider informing owners of all variants of MCR models with the Type 2 tailplane attachment lug fitted, as identified from Dyn'Aero Service Bulletin (BS 08 B0034 issued on 13 February 2008), of the availability of a stainless steel replacement, as described in Dyn'Aero Procedure M EH NO 01, dated 13 March 2008.

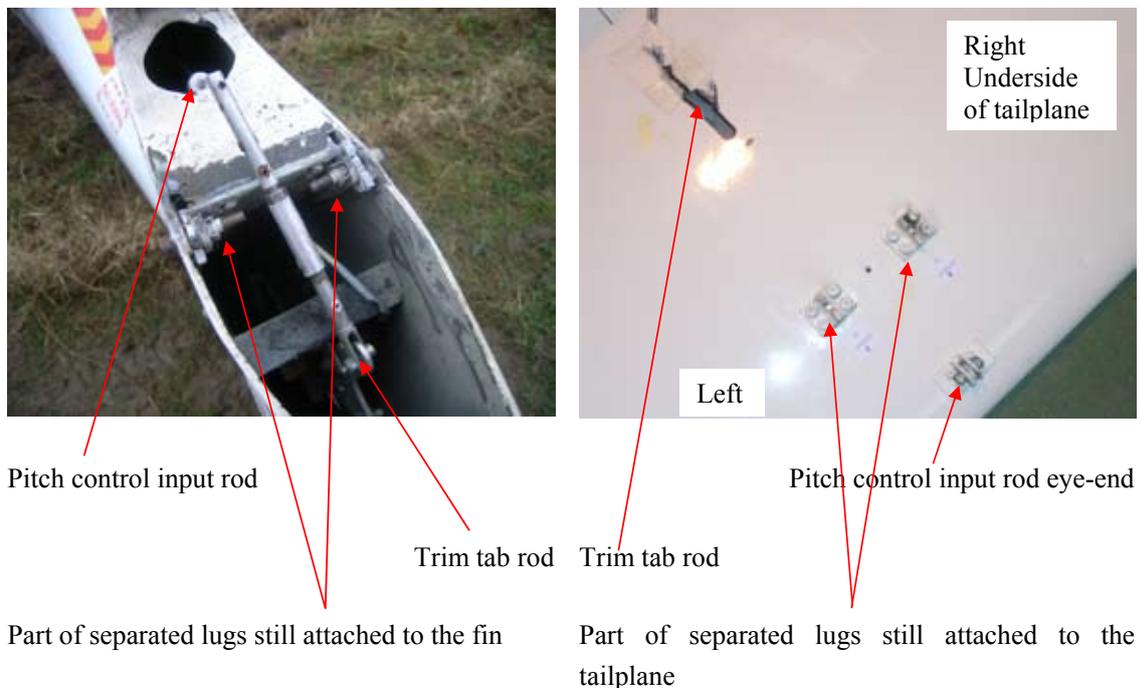
**Figure 3**

The separation of the tailplane had resulted from the failure of the two lugs attaching it to the fin. The subsequent failures of the pitch control rod eye end and the trim tab control rod, which was probably the last connection to fail as it sawed through the underside of the composite tailplane skin (Figure 3), allowed the tailplane to finally detach.

Top of fin (left) and underside of tailplane (right)

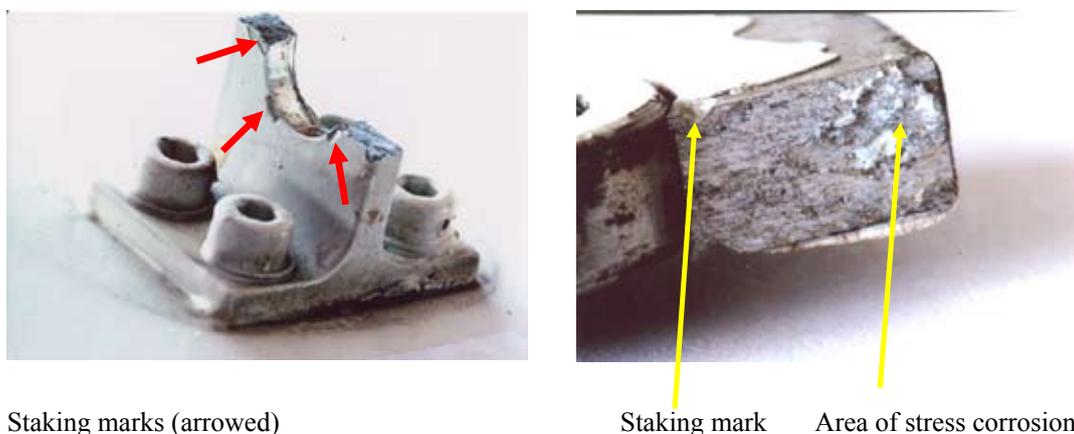
**Figure 4**

The tailplane and its attachment lugs were subjected to specialist metallurgical examination. The separations in both tailplane lugs had occurred due to tensile overload, with the fracture surfaces aligned parallel to the grain direction. However, the left lug contained evidence of a stress corrosion mechanism, which was present prior to the accident and had weakened the lug.

The hinge bearings were of a spherical self-aligning type. The bearing in the left lug had been an interference fit, with hinge material having been pushed into the bore of the lug during assembly. The bearing was also rotationally tight and showed evidence of corrosion. The bearings were retained by means of staking. Significantly, the separations had all initiated at positions coincident with staking marks (Figure 4). (Staking is a method in which a tool, usually a punch, is used to locally deform the material at various locations around the bearing, thereby ‘retaining’ the bearing in place.) In this case the staking marks appeared deep and could therefore have given rise to areas of increased stress concentration with local distortion of the material.

Left hand tailplane lug

Other possible contributory factors may have been the deep bearing staking marks, which could have caused increased stress concentration in those areas around the lug, and the poor corrosion protection of the lug. It was also noted that the left bearing was rotationally tight and showed evidence of corrosion. This could have introduced additional stresses in the lug from elevator control inputs.
