ACCIDENT

Aircraft Type and Registration:	Enstrom 280FX Shark, G-OJMF	
No & Type of Engines:	1 Lycoming HIO-360-F1AD piston engine	
Year of Manufacture:	1999 (Serial no: 2086)	
Date & Time (UTC):	8 February 2012 at 1425 hrs	
Location:	Manchester Barton Airport	
Type of Flight:	Training	
Persons on Board:	Crew - 2	Passengers - None
Injuries:	Crew - None	Passengers - N/A
Nature of Damage:	Tail rotor; rear fuselage and left landing gear skid	
Commander's Licence:	Private Pilot's Licence	
Commander's Age:	38 years	
Commander's Flying Experience:	3,905 hours (of which 3,890 were on type) Last 90 days - 33 hours Last 28 days - 23 hours	
Information Source:	Aircraft Accident Report Form submitted by the pilot and AAIB examination of tail rotor bearing

Summary

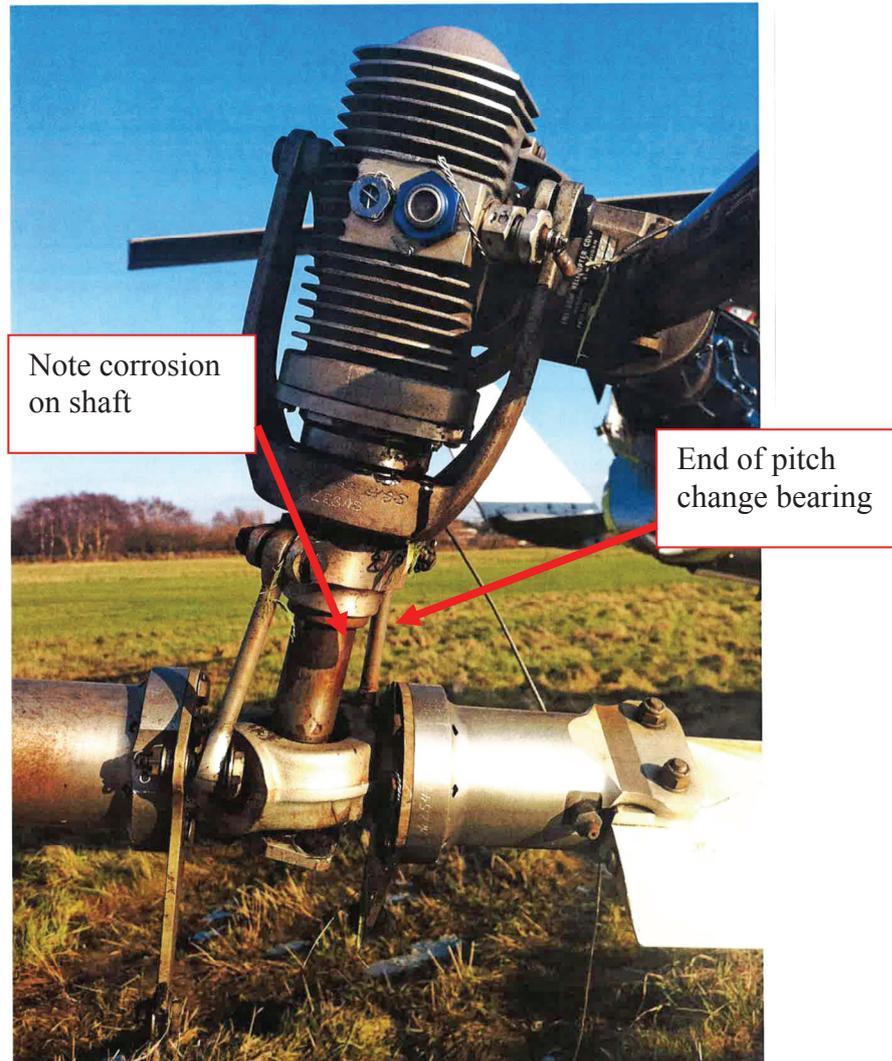
Figure 1

and transmitted a PAN call on arrival. He decided to conduct a run-on landing on grass Runway 14. Although the initial touchdown was straight, the helicopter veered to the right and encountered rough, frozen ground at the side of the runway. This caused the helicopter to bounce on its skids such that the tail rotor struck the ground prior to coming to a halt. As a result the tail rotor assembly, together with the rear of the tail boom, were damaged (see Figure 1). The pilot was uninjured.

Tail rotor assembly after the accident

According to the helicopter's maintenance organisation, G-OJMF had achieved 570 operating hours since new (in 1999) and was parked outside at its operating base. No significant corrosion problems were reported, although an area of corrosion had developed on the tail rotor drive shaft, as can be seen in Figure 1.

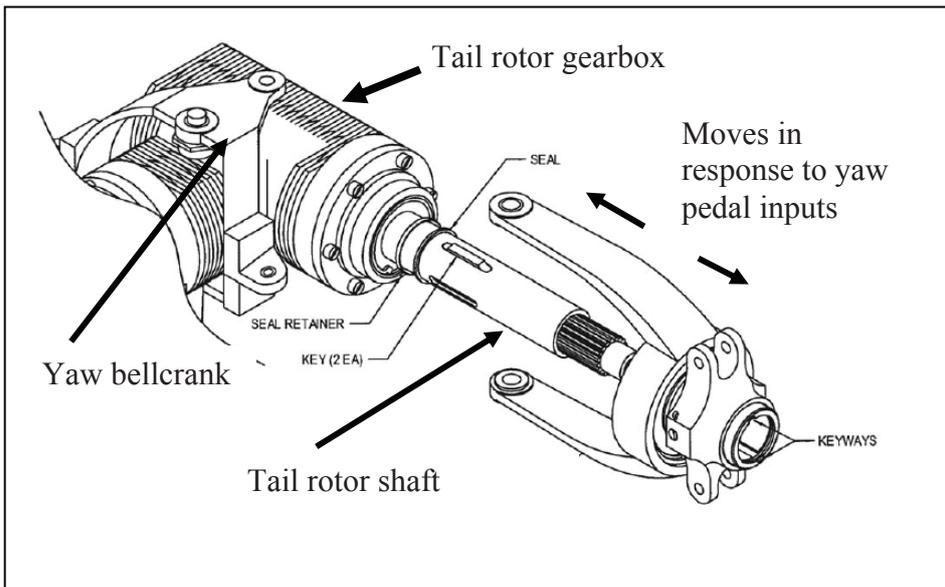
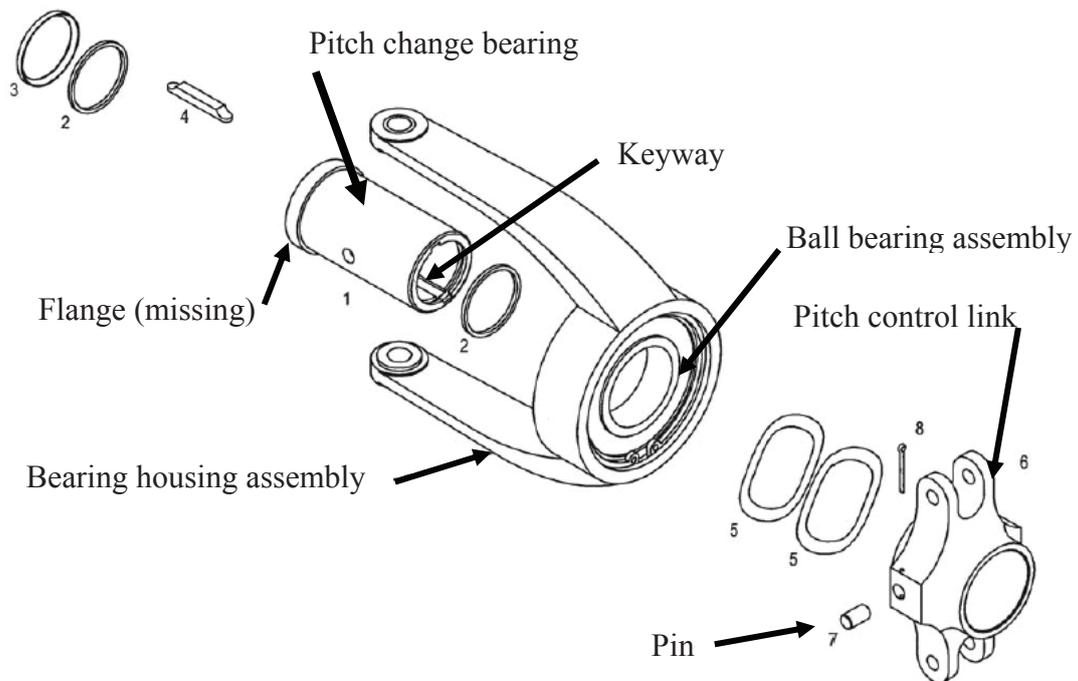
After disassembly of the tail rotor it was observed that that the flange on the inboard end of the bronze pitch change bearing had broken off and was missing. Figure 2 shows the salient details of the tail rotor drive and pitch control components.

Tail rotor pitch control details (adapted from illustrated parts catalogue)

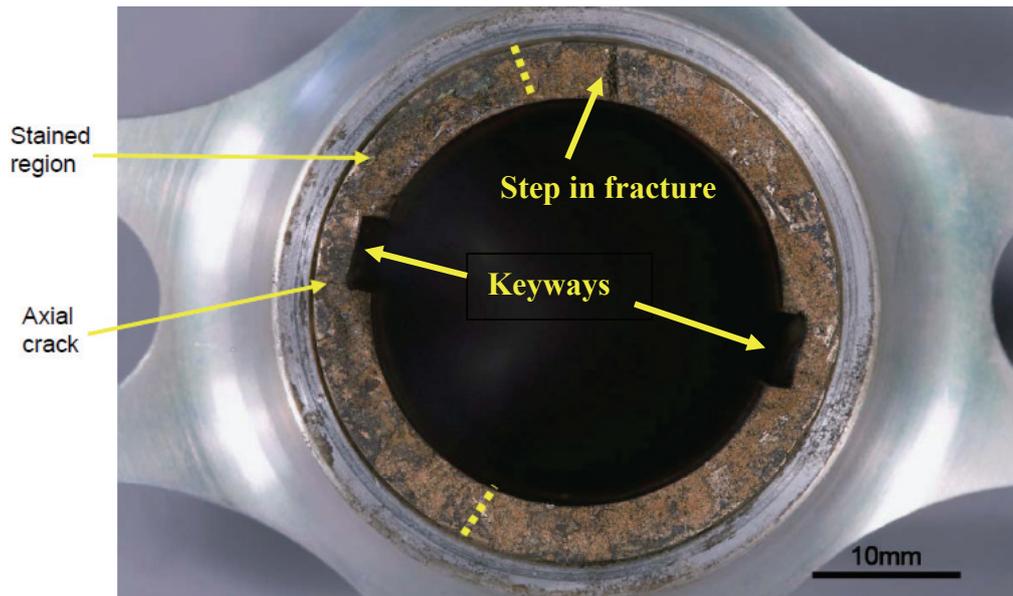
Figure 3

View of bearing fracture face

approximately one-third of the circumference; this was still evident after being cleaned. A detailed visual inspection revealed the presence of a crack in a corner of one of the keyways within the stained region of the fracture. This had propagated through the wall thickness

of the bearing and extended axially for approximately 5 mm. The crack is just visible in Figure 3, with a further view of it on the outer wall of the bearing in Figure 4. There was also a step in the fracture, close to one end of the clean region, as shown in Figure 3.

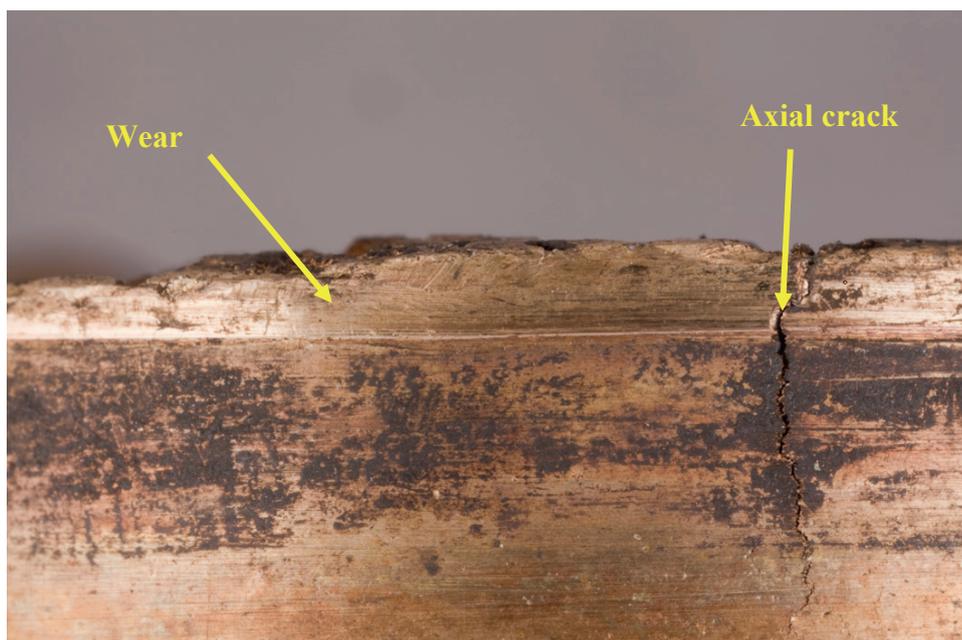
Figure 4

View of bearing outer surface, showing crack and wear mark

The crack progression ran from top to bottom (Figure 4), so the crack origin was likely to be in the missing flange portion of the bearing. The wear band extended around approximately one third of the bearing circumference and was coincident with the stained region on the fracture surface. (Note: The outer surface of the bearing is in contact with the inner surface of the bearing housing, within which it rotates, during operation.)

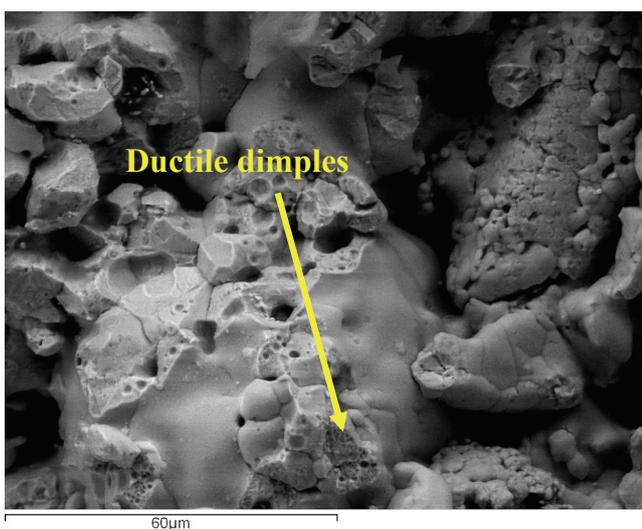
Figure 5a

The SEM examination revealed different features between the fracture surfaces of the stained and clean regions. Whilst the fracture was intergranular (ie following the surface of the powder particles) in both cases, ductile dimples, consistent with overload failure, were visible in patches in the clean areas, where adjacent particles had bonded. In contrast, the fracture surface within the stained region was masked by corrosion products, with an absence of ductile dimpling. There was insufficient evidence in this area to determine the mode of crack growth. Photographs of the fracture surfaces of the two regions are shown in Figures 5a and 5b.

Fracture surface in clean area

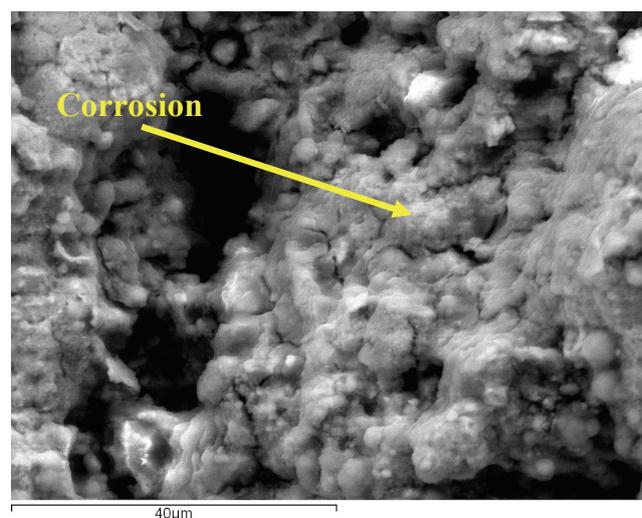
Figure 5b

Energy dispersive X-ray (EDX) analysis was carried out within the stained region of the fracture to determine the elemental composition of the corrosion deposit. This revealed the presence of chlorine, which is corrosive to bronze. A comparative analysis conducted on the clean area revealed that the main elements present were copper, tin and iron, which is consistent with AMS 4805. It was concluded that the chlorine was likely to have come from atmospheric moisture.

Fracture surface in stained area
