*Accident
on 25 July 2000
at La Patte d'Oie
in Gonesse (95)
to the Concorde
registered F-BTSC
operated by Air France*

REPORT translation
f-sc000725a

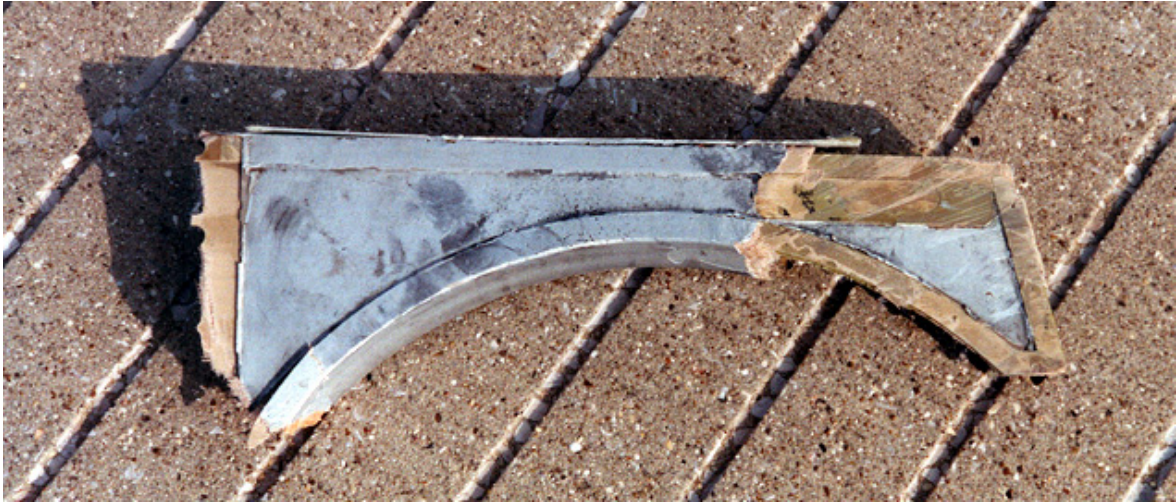
Figure 19: Part located at line 157 - right part of deflector

Parts of the water deflector of the left main landing gear were found between Slabs 139 and 166, that is 1,642 to 1,845 m from the beginning of runway 26 right, more precisely at 139, 149, 151, 157 and 166. The parts found did not include metallic parts.

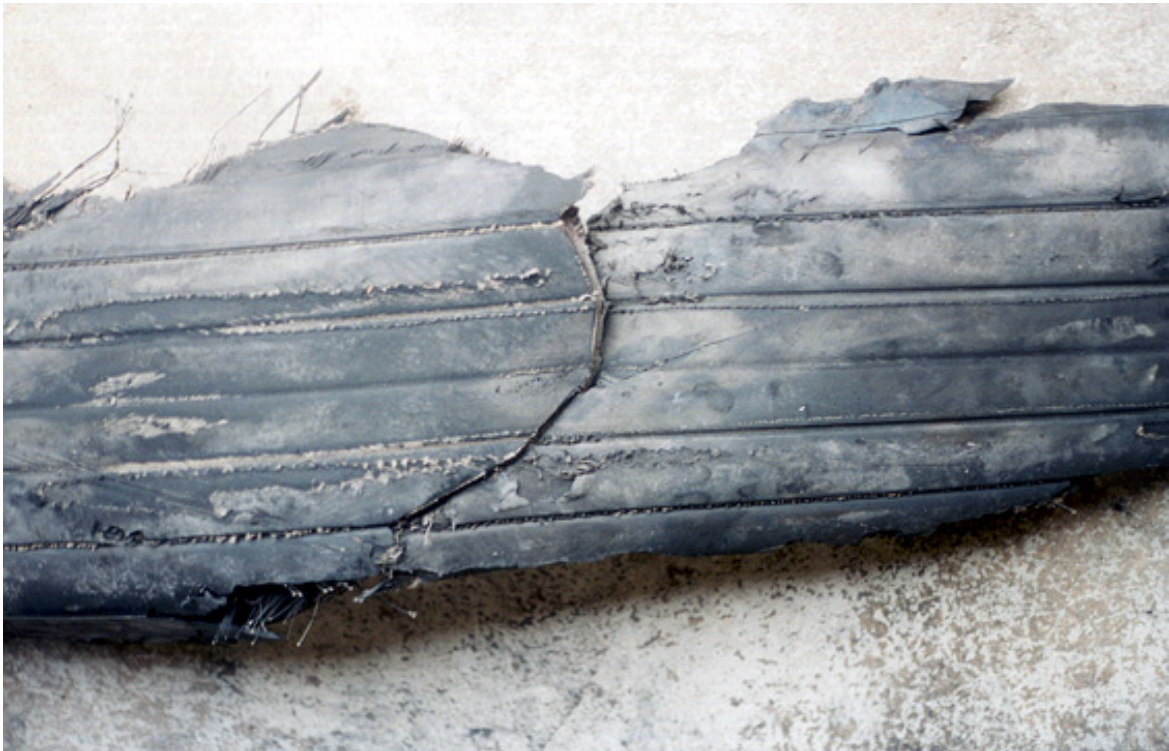
Figure 20: Piece of tyre at line 180 - piece of tyre at line 152

Pieces of tyre from the Concorde were found at slab levels 146, 152, 166, 180, 186 and 187. The parts found at Slab 152 level (a piece measuring 100 x 33 cm and weighing about 4.5 kg) and that found at Slab 180 level fitted together. Visual inspection revealed a transverse cut about 32 centimetres long.

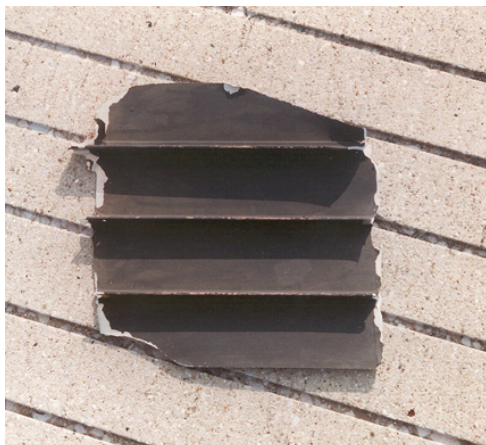
A ribbed structural part measuring about 32 x 32 cm was found at Slab 160 level. It was white on the external side and dark on the ribbed side. It came from the aircraft's No 5 fuel tank. It showed no signs of impact damage.

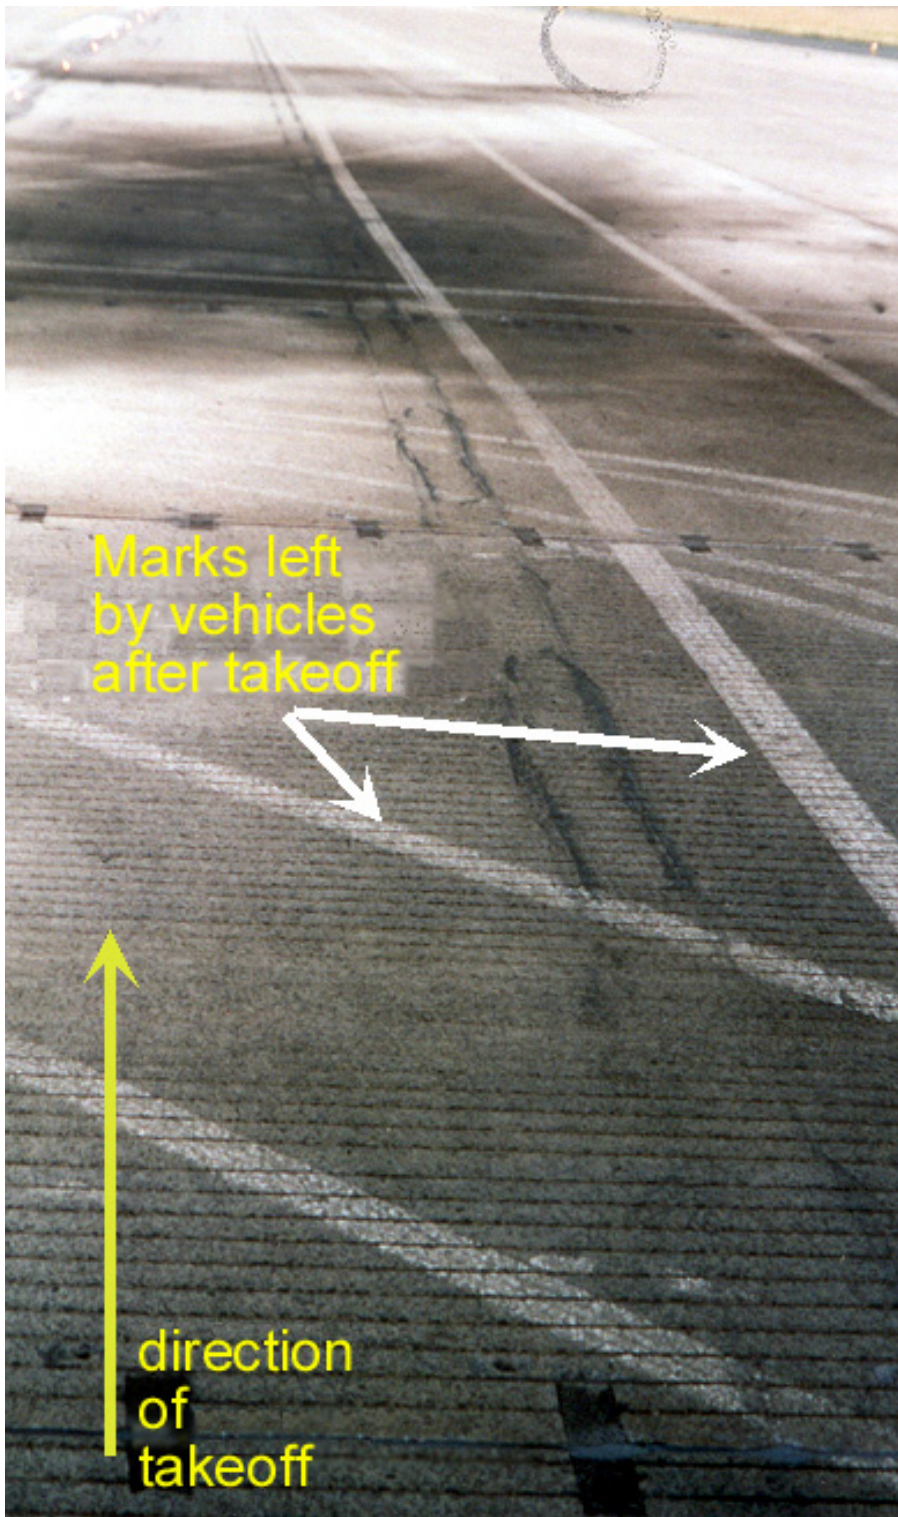
Figure 24: Marks of Wheel No 2 and soot on the runway

When this mark disappeared at about 2,340 m, its displacement from the centreline was about 8 m. This corresponded to the right front tyre of the aircraft's left landing gear.

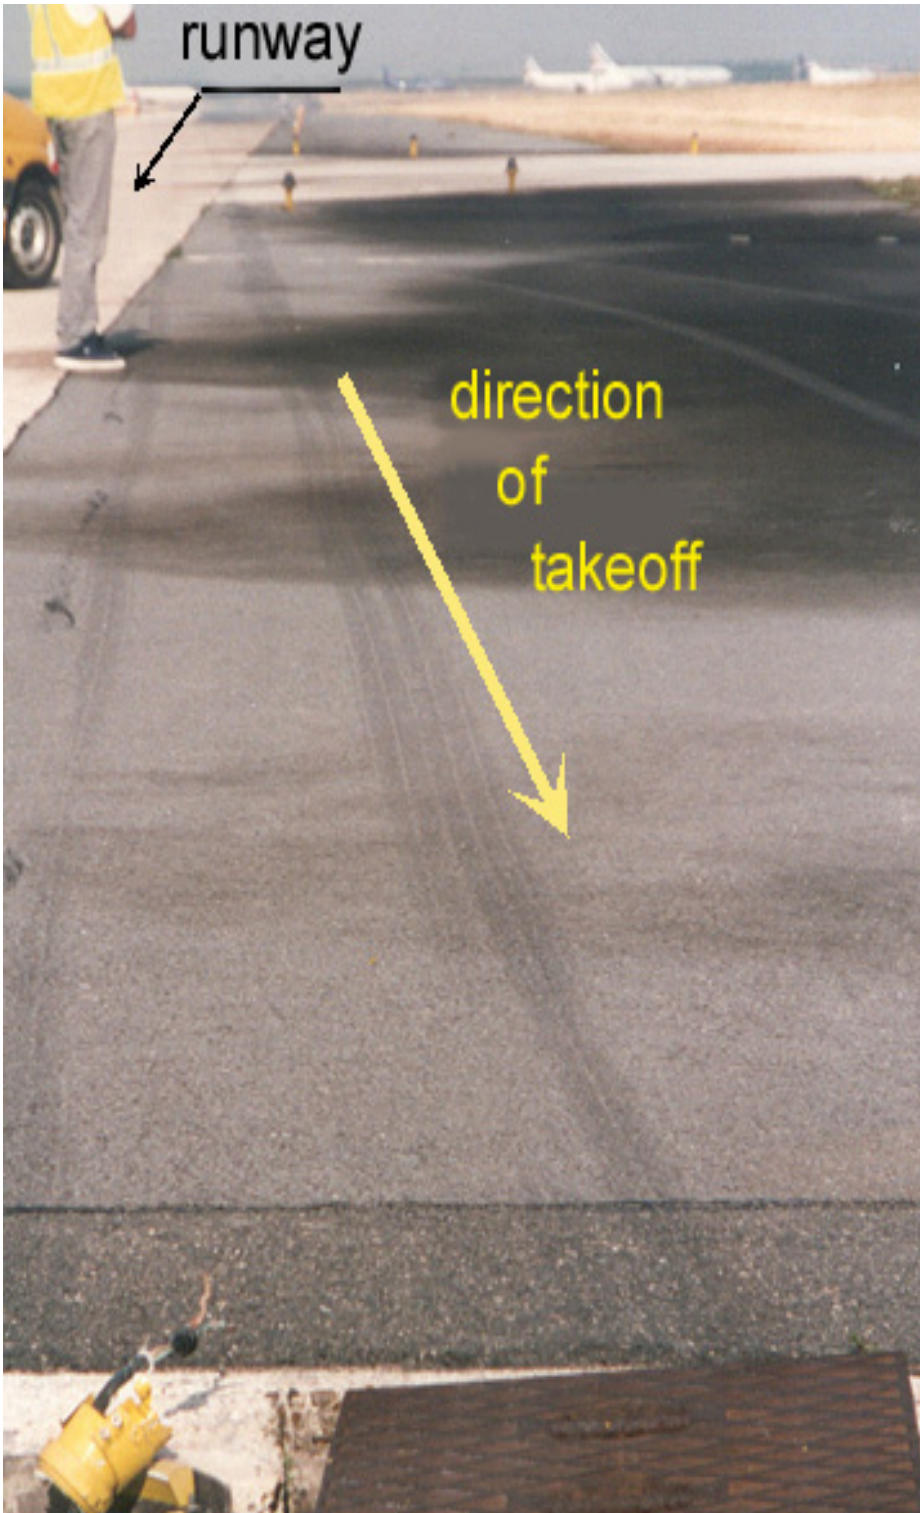
Figure 25: Marks of left bogie tyres and edge light

After that point, the tracks become intermittent then disappear at about 2,830 metres from the runway threshold

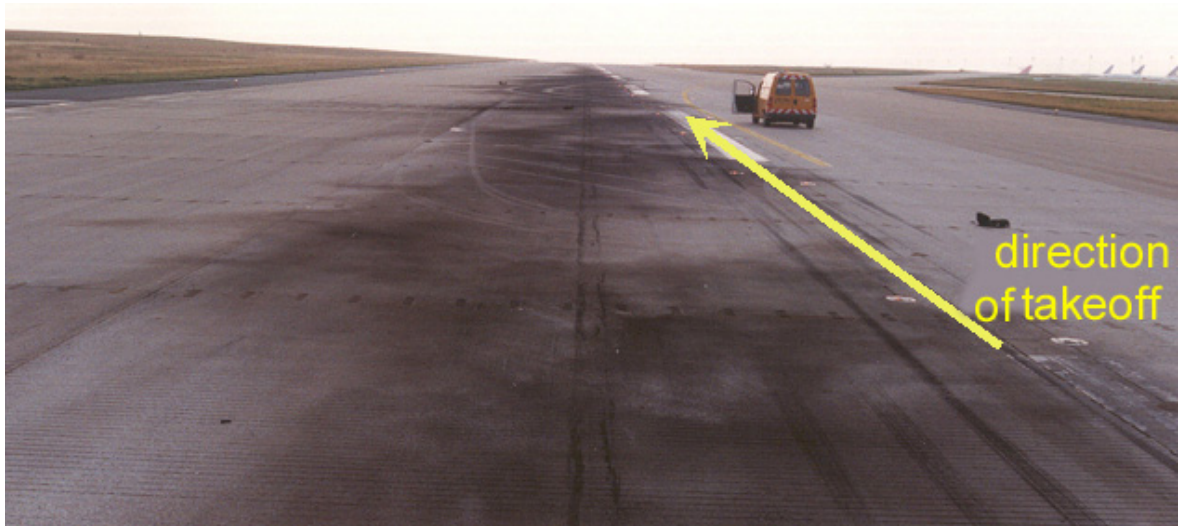
Figure 26: Soot marks on the runway

combustion of kerosene, were apparent on the runway 1,860 m onward from the origin (Slab 168). These were large and dense up to 2,300 m and then became less dense and rich in carbon up to taxiway S4, at 2,770 metres. The traces, which were on average 7 m wide, were initially centred on the damaged wheel ground mark and progressed towards the left.

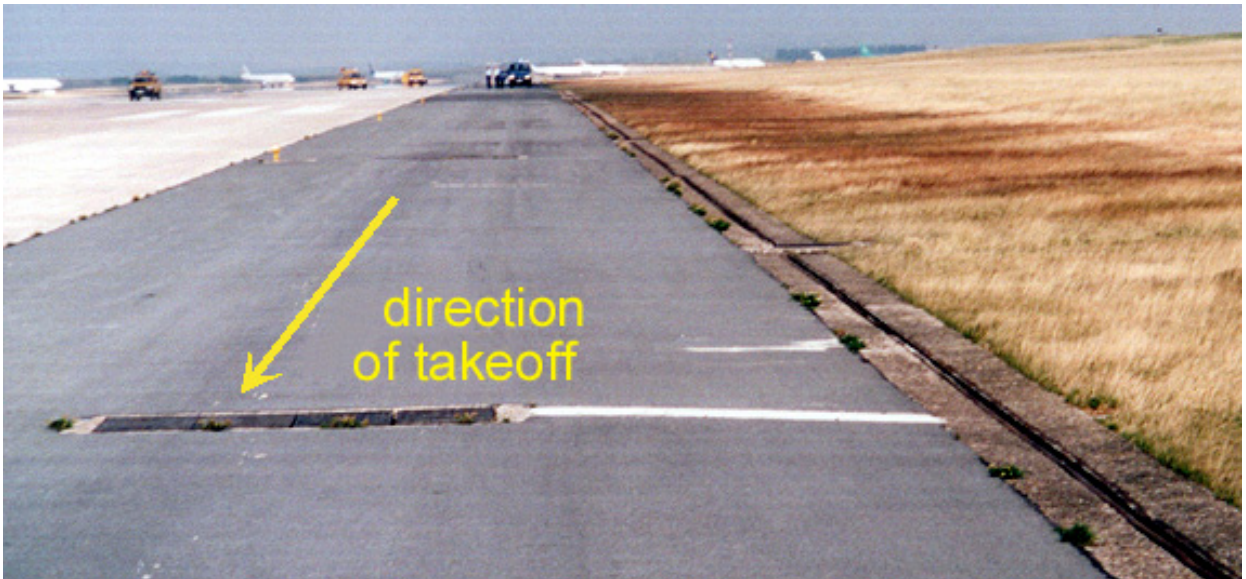
Figure 28: Burnt grass on the edge on the runway

The grass was burnt adjacent to the runway edge, between 2,902 and 3,165 metres. This area, also featuring soot deposits, indicated that there was an extensive flame after the aircraft became airborne.

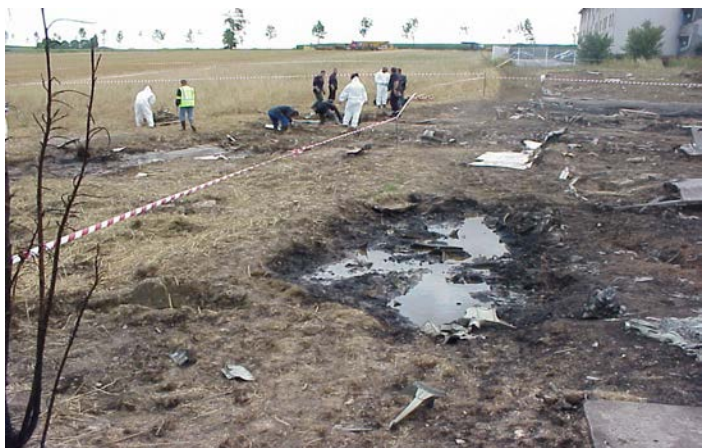
Figure 32: Impact marks

Signs of ground impact were found to the north of the site at the intersection of areas A and B. There was a row of trees about three metres high, oriented east to west, then a crater at the bottom of which was rear tank 11. Pieces of engine air intake were found half-buried at A3 and signs of ground impact were apparent at A3 and CB2-North. Wheel No 6 was embedded in the ground.

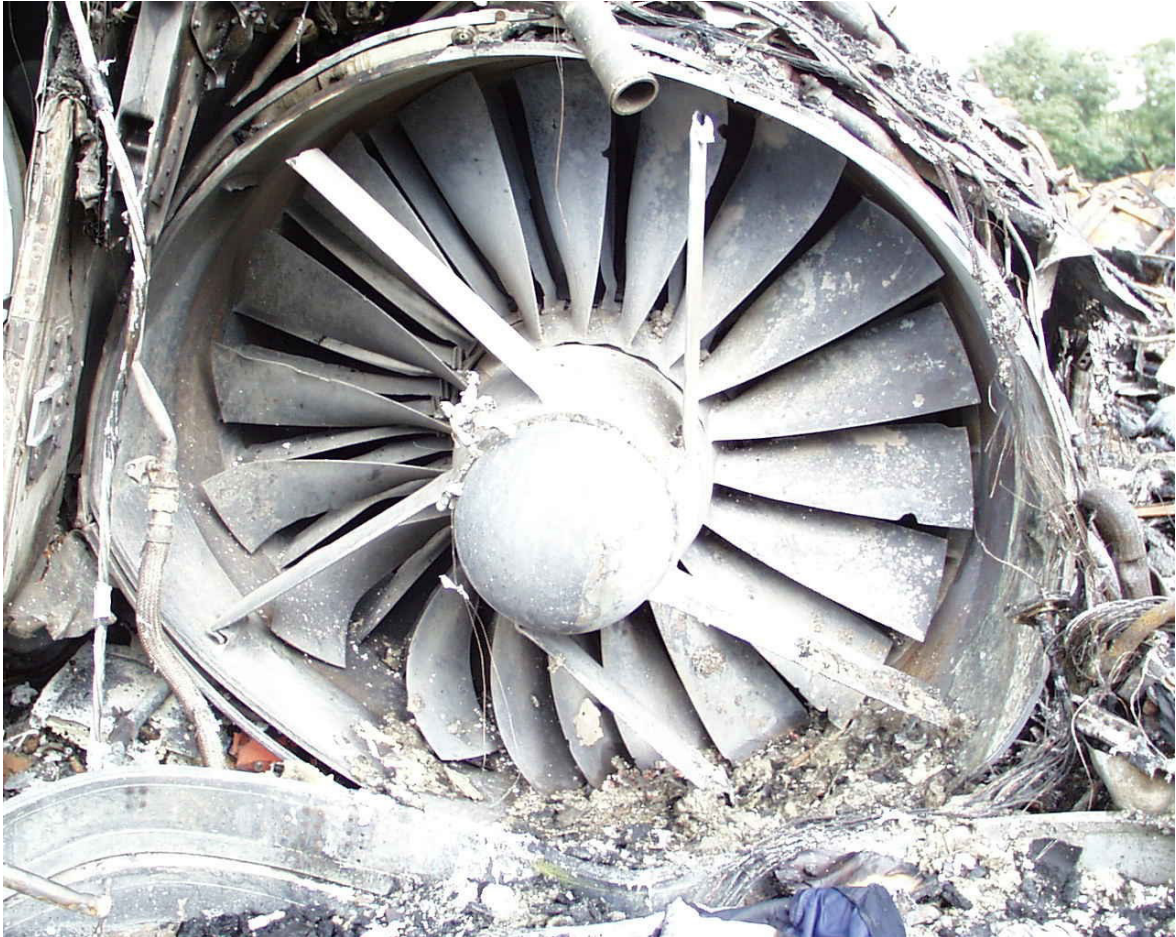
Figure 37: Engine 1 LP compressor

Examination of engine 2 appears to indicate a negligible N1 before impact. The rotor of the LP compressor of engine 1 apparently made less than a quarter of a revolution after the impact before being stopped by the casing being crushed.

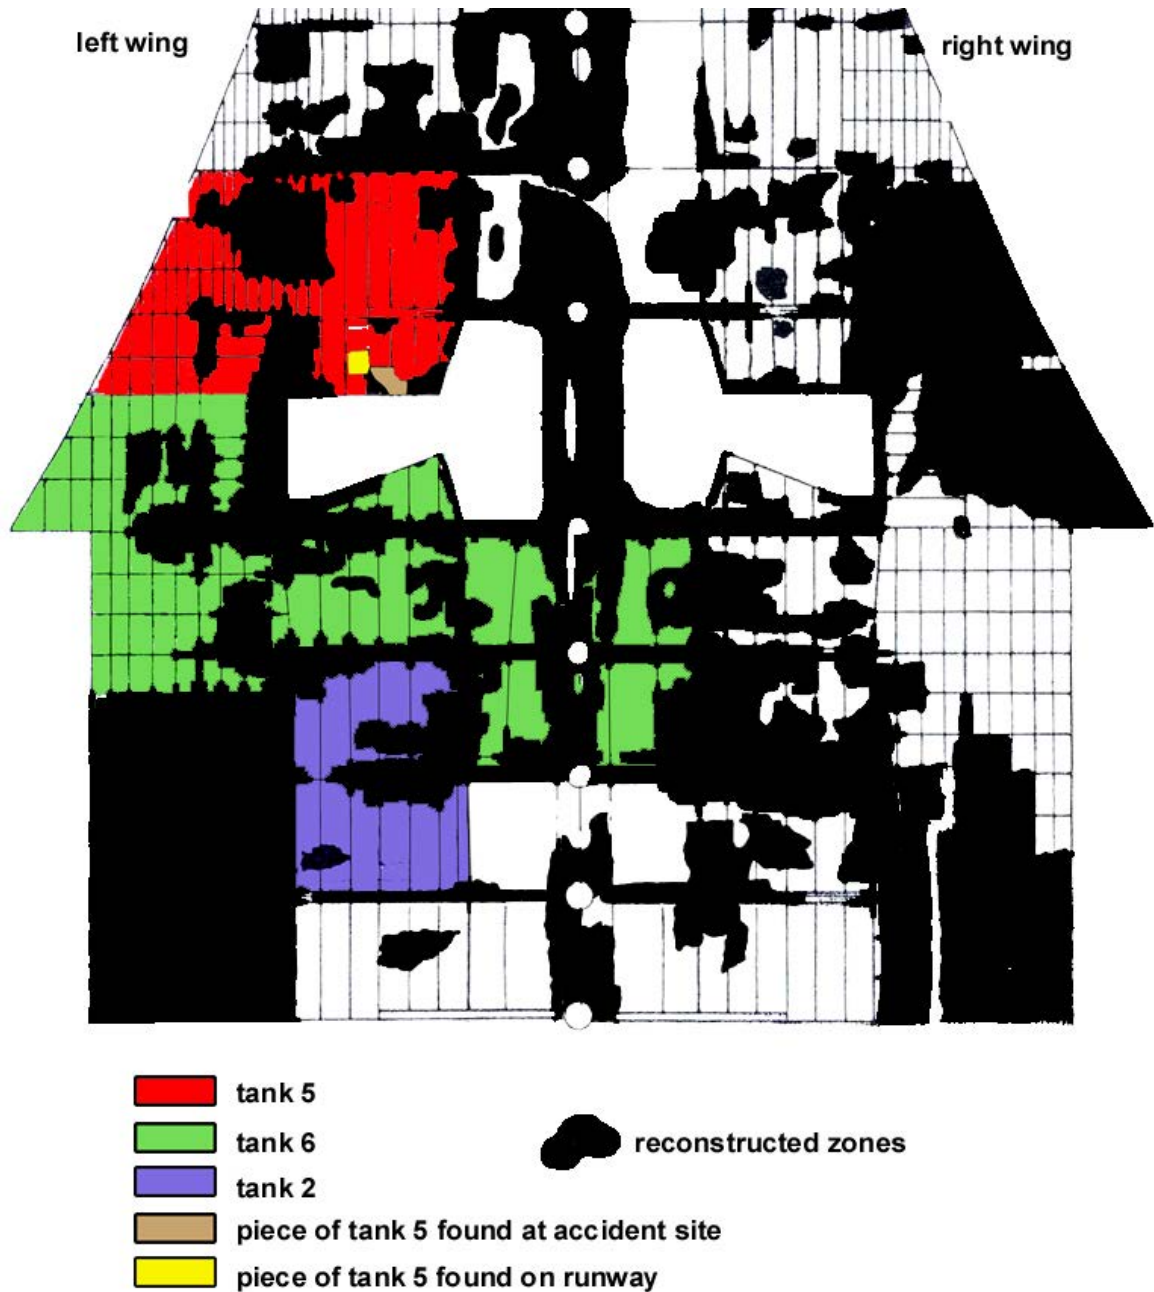
Figure 40: Computer reconstruction of lower wing

Almost nothing from tank 5 was recovered. Only one part of the edge of the landing gear well and two probe locations were still visible near the location of the piece found on the runway. These parts showed no puncture or impact marks, except on one of them.
