ACCIDENT

Aircraft Type and Registration:	Cessna U206F Stationair, G-BGED
No & Type of Engines:	1 Continental Motors Corp IO-520-F piston engine
Category:	1.3
Year of Manufacture:	1974
Date & Time (UTC):	27 June 2004 at 1800 hrs
Location:	Beacon Village, near Honiton, Devon
Type of Flight:	Aerial Work
Persons on Board:	Crew - 1 Passengers-5
Injuries:	Crew - 1 (Fatal) Passengers - 3 (Fatal), 2 (Serious)
Nature of Damage:	Aircraft destroyed
Commander's Licence:	Private Pilot's Licence
Commander's Age:	52 years
Commander's Flying Experience:	628 hours (of which in excess of 172 were on type) Last 90 days - 6 hours 42 minutes Last 28 days - 4 hours
Information Source:	AAIB Field Investigation
	All times in this report are local (UTC+1)

Synopsis

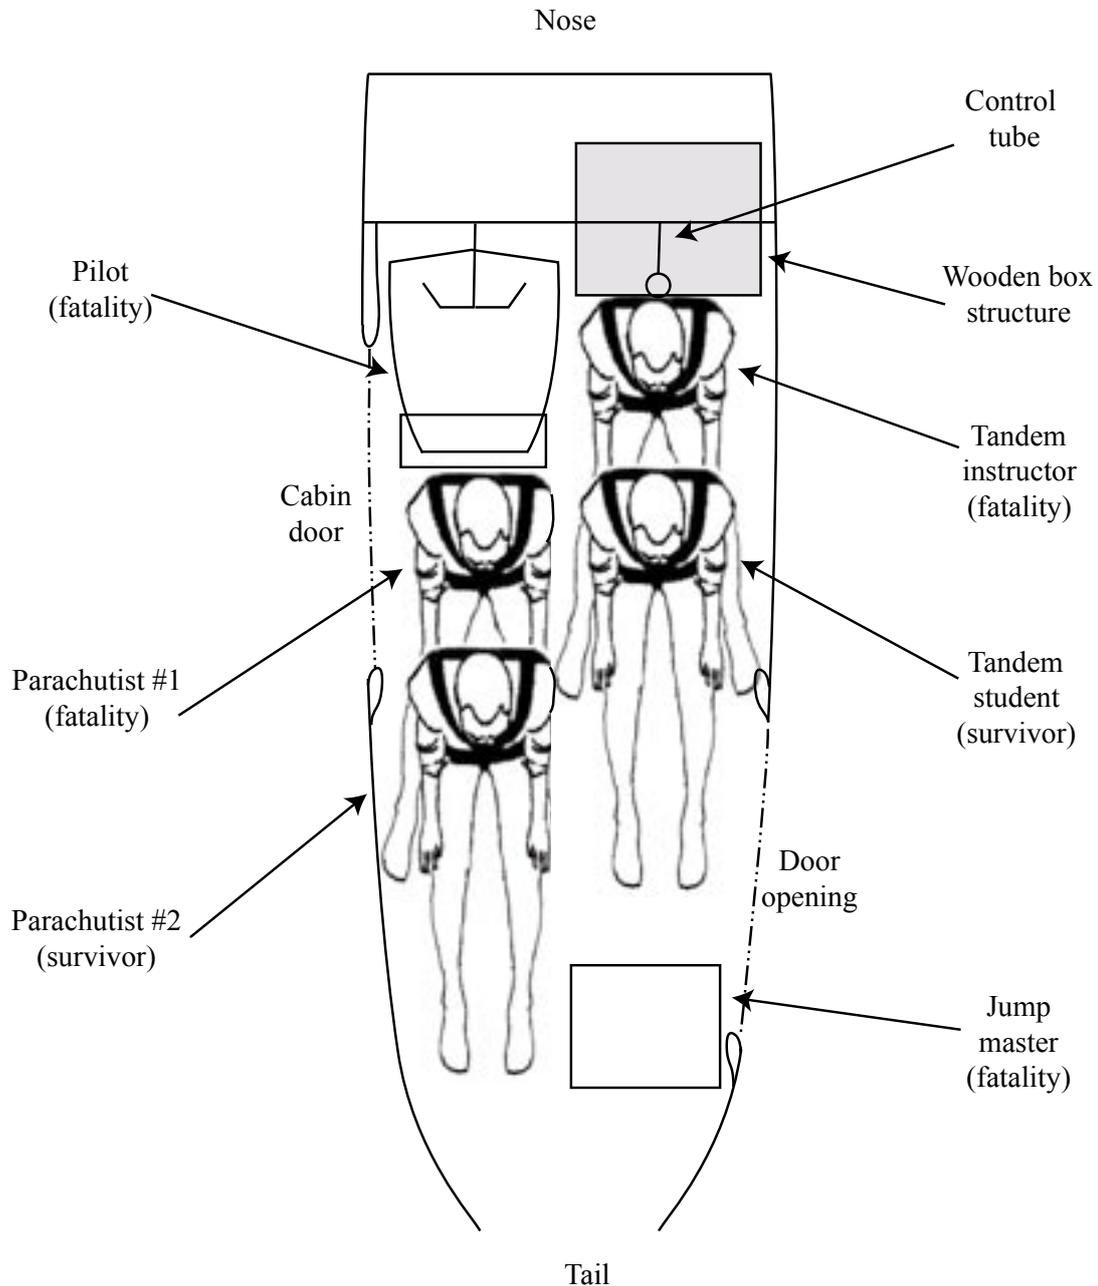
Figure 1
Seating layout for G-BGED

Figure 1 illustrates the probable locations of those parachutists aboard G-BGED at the time of the impact, all of whom were seated on the floor and unrestrained. The 'tandem' instructor and student were seated beside the pilot leaning against the wooden box and facing

rearwards. The two single parachutists, identified as Parachutist No 1 and 2, were facing rearwards, with No 1 leaning against the back of the pilot's seat. Parachutist No 1 was fatally injured and had sustained a fracture of the pelvis and been struck in the face. Parachutist No 2, seated against Parachutist No 1, survived and, although he had sustained spinal injuries, his pelvis was intact. He was able to exit the aircraft after the impact and subsequently was treated by the emergency services. The tandem parachutists both sustained pelvic fractures. The fatally injured instructor had a deep laceration to the back of his head, indicative of striking his head on the right side control wheel tube. There was evidence to suggest that the harness of the surviving tandem student attaching him to his instructor, had been cut, although it was not established whether this occurred pre- or post impact or by whom. The injuries to these four parachutists were consistent with high longitudinal and vertical forces resulting from the aircraft's impact with the ground.

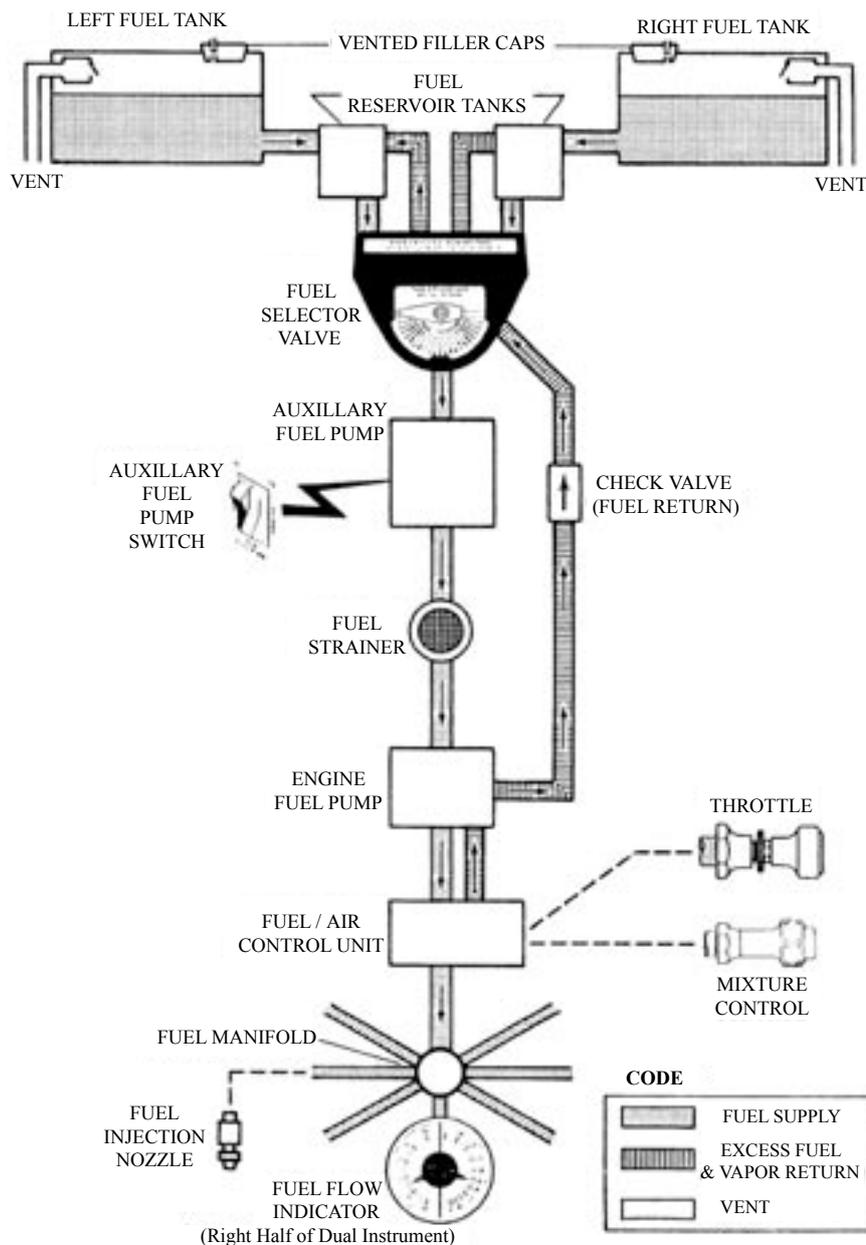
Figure 2
C206 Fuel system

The engine-driven fuel pump provides sufficient fuel flow/pressure for normal engine operation with the electric auxiliary fuel pump acting as a back-up in the event of an engine-driven pump failure. The electric auxiliary pump is manually selected by means of a yellow and red split rocker switch on the lower left side of the instrument panel. The yellow right half of the switch is labeled START, and its upper ON position is used for normal starting and minor vapour purging during taxi. The red left half of the switch is labeled EMERG and its upper HI position is used in the event of an engine driven pump failure during takeoff or high power operation. The HI position may also be used for extreme vapour purging. With the right half of the switch in the ON position, the pump operates at one of two flow rates dependant on throttle setting. Maximum fuel flow is produced when the left half of the switch is held in the spring loaded HI position. When this is selected, an interlock automatically trips the right half of the switch to the ON position. The auxiliary pump is also required to assist in restarting the engine should fuel exhaustion from the selected tank occur. However, if the engine-driven pump is functioning normally, with a good supply of fuel, and the auxiliary pump 'START' switch is placed in the ON position, an excessively rich fuel/air ratio can result and lead to a loss of power and/or a 'rich cut'.

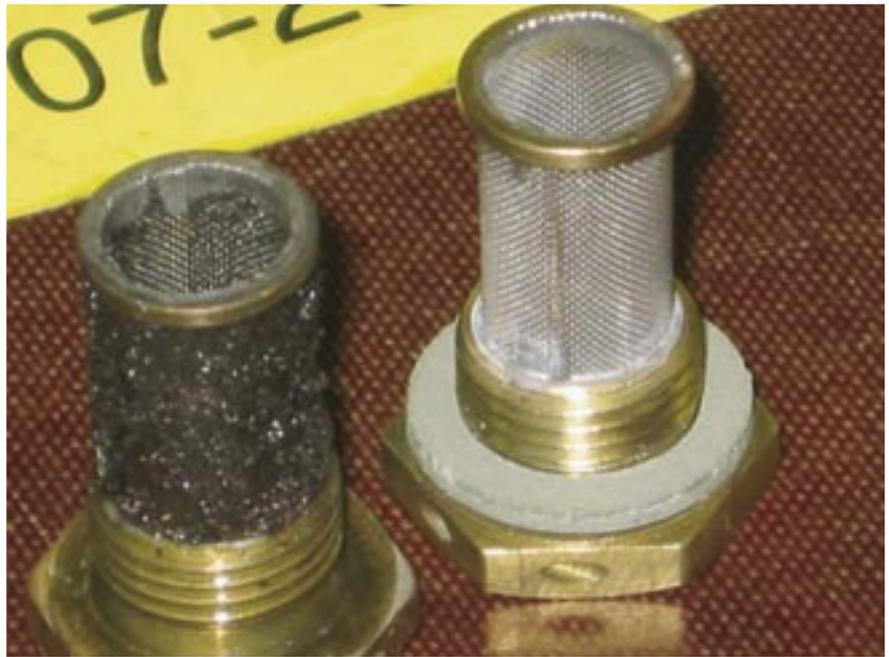
Figure 3

The fuel metering unit filter was removed and was found to be 80% to 85% blocked with debris, as indicated in Figure 3.

Contaminated filter removed from G-GBED (left) and identical clean filter (right)

fuel leakage¹. The fuel metering unit was bench tested with the contaminated filter installed, and then re-tested with a clean filter in its place. Although the unit did produce a flow of fuel, this was below the normal value. Disassembly of the unit revealed internal damage consistent with being occasioned during the impact and this damage had the effect of restricting the flow of fuel through the unit. The aircraft service information requires the fuel metering unit filter to be checked every 100 hours, but this check was not required to be done during maintenance prior to the accident as it had been carried out during the Annual Check on 5 March 2004.

The fuel system in G-BGED, was found to contain a significant amount of debris of unknown origin in the fuel metering unit filter which, during the previous 50 hour check, was not scheduled to be examined. Therefore, the debris, or a good proportion of it, was considered likely to have been present at the time of the power loss on the flight prior to the most recent maintenance, as the aircraft had only flown for some 1 hour 10 minutes since the check. Post that event, engine runs showed that full power could be obtained and, indeed, the aircraft had flown to and from Exeter Airport and performed two parachutist dropping flights prior to the accident flight, without any reported engine power problems. Also, operating a new engine with this contaminated filter installed did not cause any performance loss. Therefore, debris in the filter would not appear at first sight to have been responsible for the earlier reported engine problem, and was unlikely to have caused the engine to fail on the accident flight, unless it had built up suddenly during the last flight.

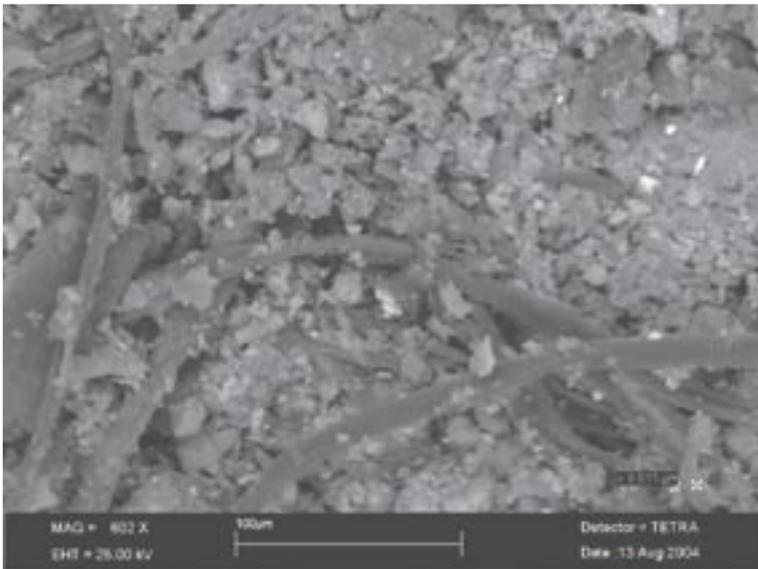
Figure 4

'the evidence suggested that the particulate on the blocked filter was typical of debris found in fuel systems. It is probable that the presence of the fibres effectively reduced the porosity of the filter, thus capturing particles that would normally have passed through and therefore increasing the concentration above a level that would normally be seen. The origin of the fibres could not be determined.'

Magnified image of the fibres and debris removed from the filter

aluminium flake were also found. The particulate was predominantly composed of silicon with some magnesium and aluminium. Their report concluded that:

'the majority of the debris consisted of fibres and flakes, the appearance and composition of which suggest are organic in origin. The remaining chunky particulate is typical of dust, sand and grit. This debris is typical of external contaminants and is to be expected in a filter. The paint flakes and aluminium particle are likely to have originated from the aircraft, again are typical of what is found in a filtration system and are not cause for concern. The quantity of debris examined is very small compared to the amount present in the original filter examined from G-BGED and the lack of elements found in the original analysis suggests that this is a cleaner system.'

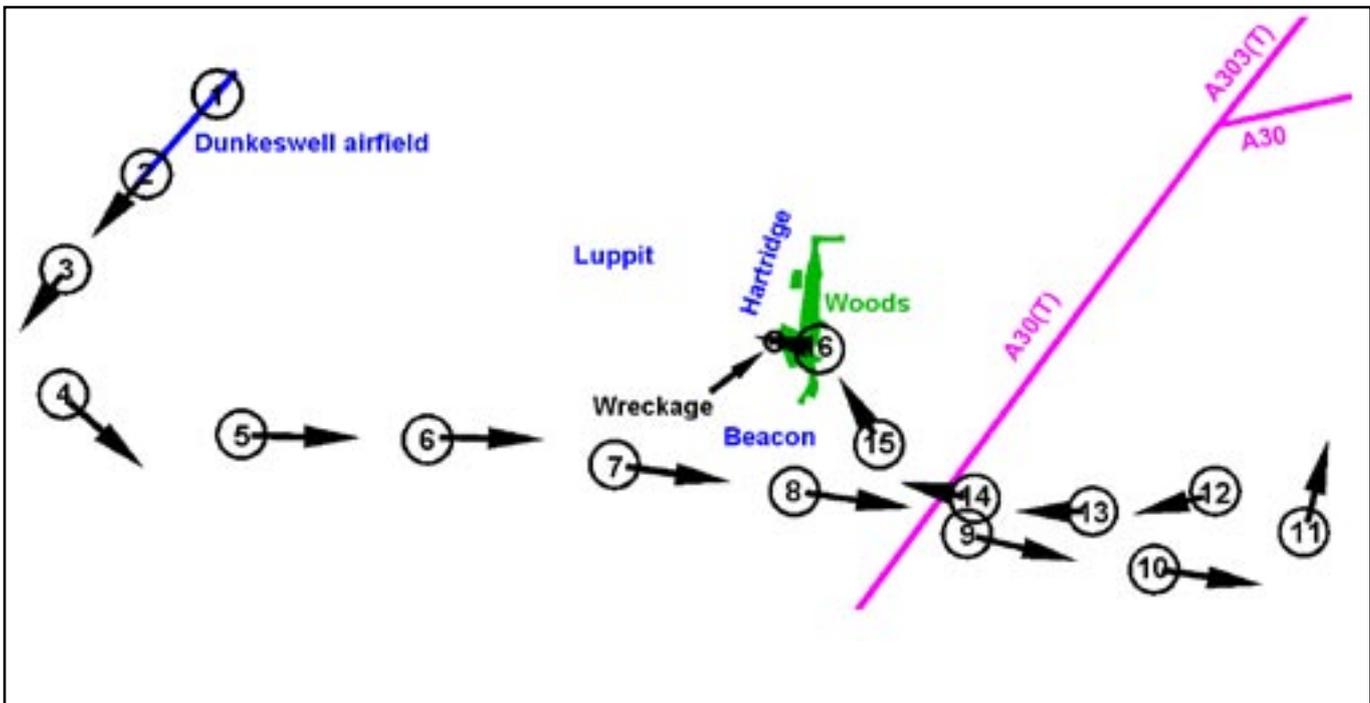
Figure 5 shows the plan view of the accident flight which identifies the last GPS position before equipment power or antenna connectivity was lost. This location is consistent with the wreckage location. The recorded track shows that the aircraft turned away from an area of high ground near Dumpdon Hill. This track took the aircraft towards another area of high ground, Hartridge, upon which it crashed.

Plan view of the accident flight
Accident to G-BGED on 27 June 2004 at Beacon Village

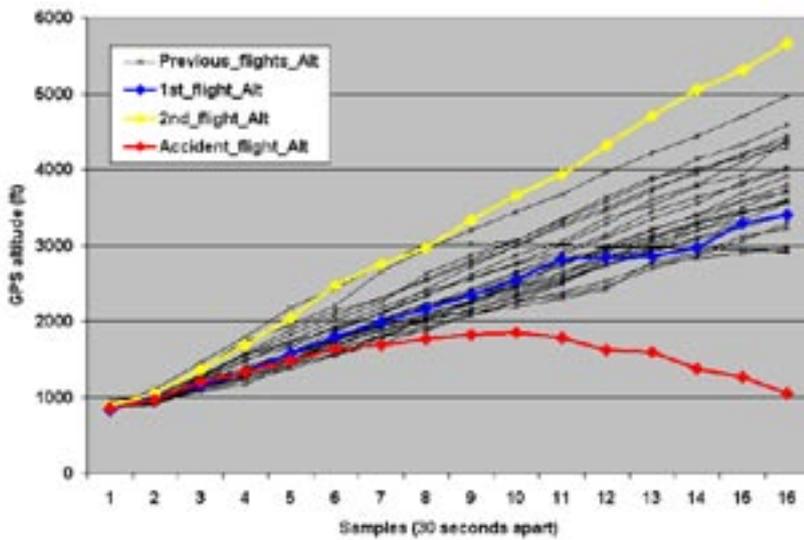
Figure 6

Take-off altitude profile of the 1st and 2nd flights of the day, the accident flight (3rd) and other previous flights.

Note: The 1st flight had similar passenger loading to the accident flight. The 2nd flight was with two less passengers. Fuel loading unknown.

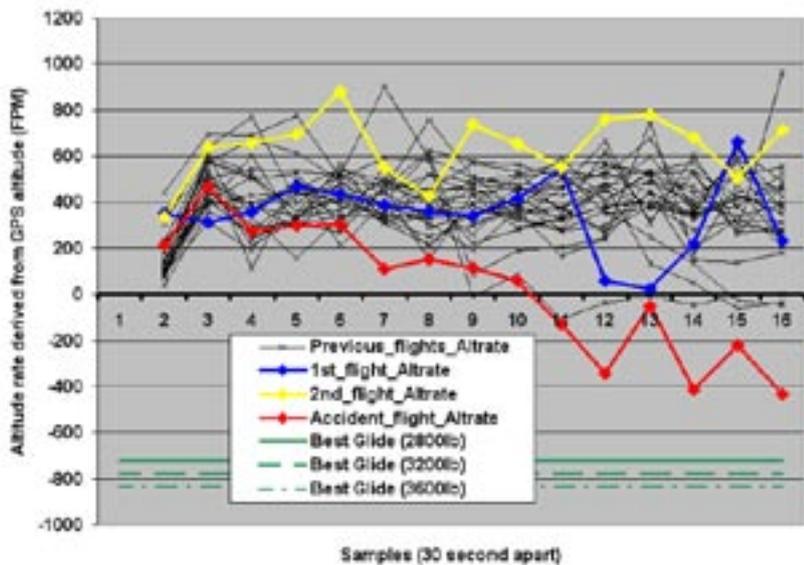
Figure 7

Take-off altitude rate profile of the 1st and 2nd flights of the day, the accident flight (3rd) and other previous flights.

Note: The 1st flight had similar passenger loading to the accident flight. The 2nd flight was with two less passengers. Fuel loading unknown.

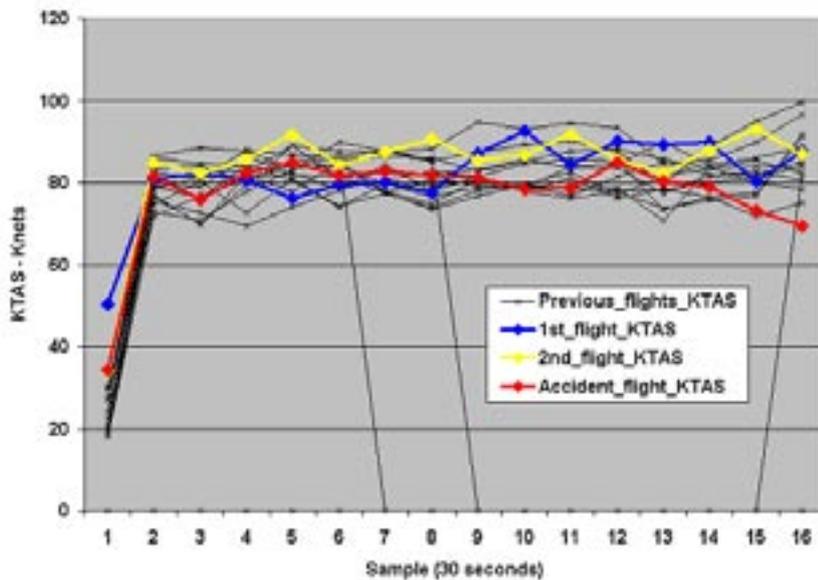
Figure 8

Take-off true airspeed profile of the 1st and 2nd flights of the day, the accident flight (3rd) and other previous flights.

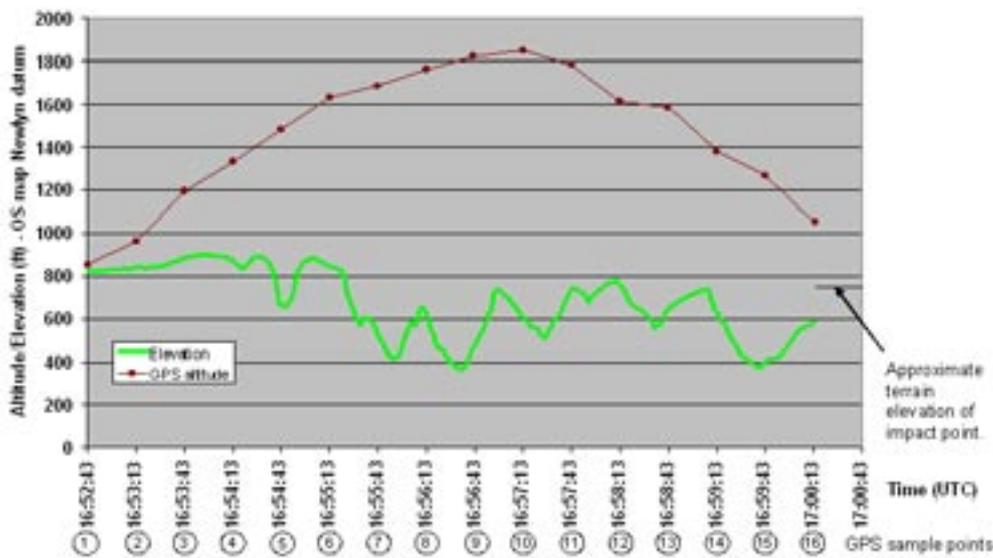
Figure 9
Aircraft altitude relative to terrain
Accident to G-BGED on 27 June 2004 at Beacon Village.

Note: GPS altitude is not as accurate as GPS horizontal position accuracy. Both the GPS altitude and the Terrain elevation shown are with reference to the Newlyn altitude datum (as per OS maps) and so can be compared on the same scale.
