ACCIDENT

Aircraft Type and Registration:	Gardan GY80-180 Horizon, G-BYME	
No & Type of Engines:	1 Lycoming O-360-A1A piston engine	
Year of Manufacture:	1967	
Date & Time (UTC):	23 August 2008 at 1750 hrs	
Location:	Easingwold, Yorkshire	
Type of Flight:	Private	
Persons on Board:	Crew - 1	Passengers - 3
Injuries:	Crew - None	Passengers - None
Nature of Damage:	Collapsed nose leg, bent propeller and both wings badly damaged	
Commander's Licence:	Private Pilot's Licence	
Commander's Age:	46 years	
Commander's Flying Experience:	141 hours (of which 20 were on type) Last 90 days - 9 hours Last 28 days - 3 hours	
Information Source:	Aircraft Accident Report Form submitted by the pilot

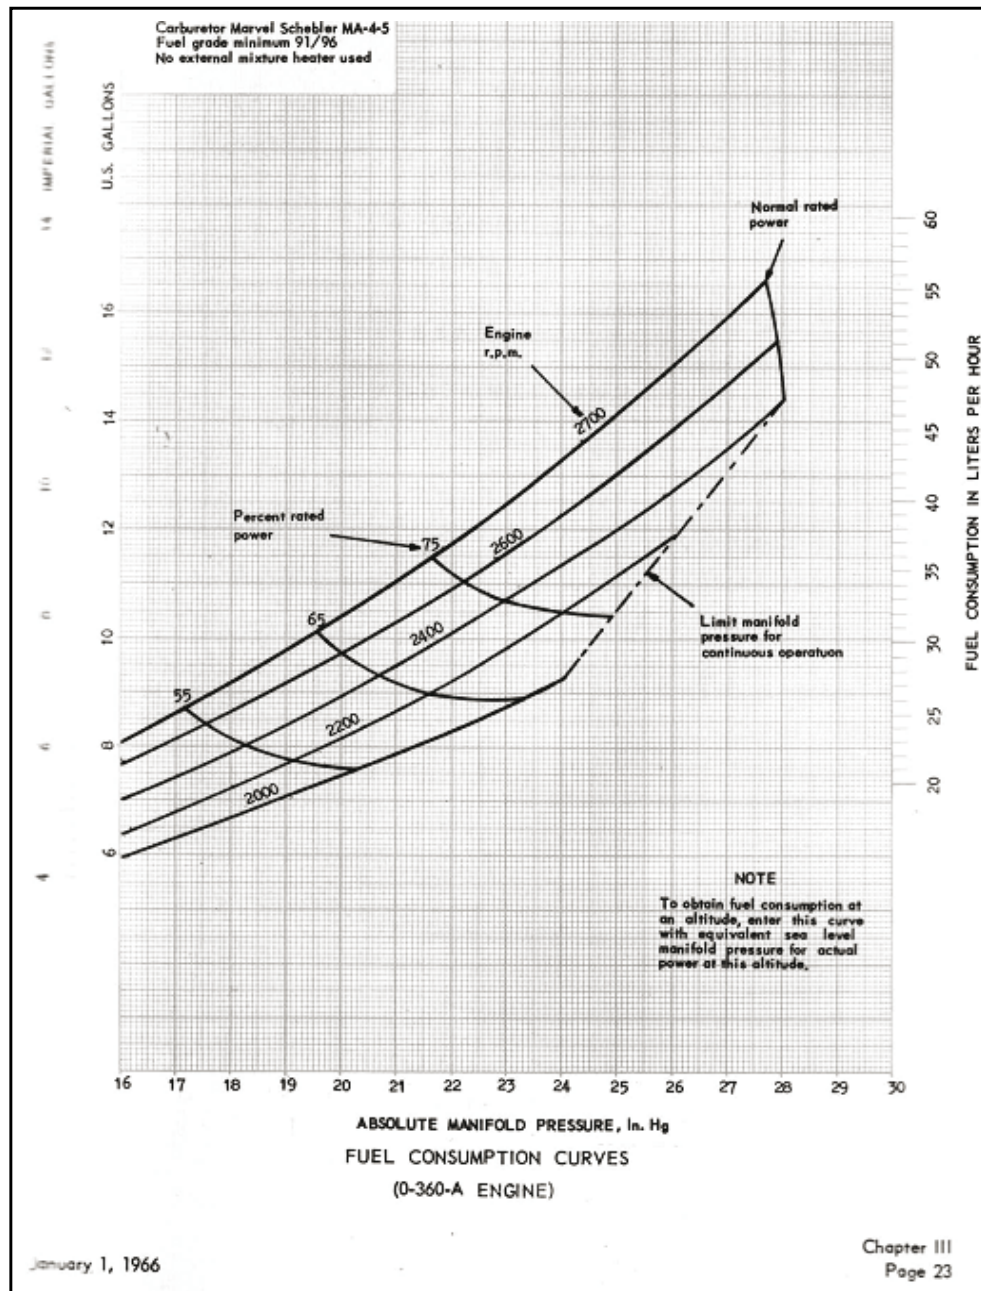
Figure 1

The pilot used the fuel consumption curves from the Operating Manual (Figure 1) to calculate the fuel

However, the fuel consumption curves in the Operating Manual contained an error, where the data 'fuel consumption in litres per hour' was incorrectly aligned with the graph. It can be seen that, for example, 10 US gallons is incorrectly aligned with 30 litres, whereas it should be aligned with 37.8 litres. The net effect of this is that whereas the pilot had calculated his consumption, including the 20% margin, to be approximately 38 litres per hour, the figure should have been approximately 46 litres per hour.

In an honest report the pilot acknowledged that his poor fuel planning caused the accident, although he was not helped by the incorrect conversion data that were published in the Operating Manual. In addition, had he selected the auxiliary tank when the engine started to falter, it is likely that the accident could have been averted.

The European Aviation Safety Agency (EASA) was advised of the error in the fuel consumption curves through the UK Civil Aviation Authority. EASA have subsequently issued an Airworthiness Directive, effective 17 November 2008, which forbids the use of the existing conversion curves and provides correct conversion data which is to be inserted into the Operating Manual.
