**ACCIDENT**

<b>Aircraft Type and Registration:</b>	Hawker Cygnet replica, G-EBJI	
<b>No &amp; Type of Engines:</b>	1 JAP J.99 piston engine	
<b>Year of Manufacture:</b>	1977 (Serial no: PFA 077-10240)	
<b>Date &amp; Time (UTC):</b>	16 April 2012 at 1700 hrs	
<b>Location:</b>	Old Warden Aerodrome, Bedfordshire	
<b>Type of Flight:</b>	Private	
<b>Persons on Board:</b>	Crew - 1	Passengers - None
<b>Injuries:</b>	Crew - None	Passengers - N/A
<b>Nature of Damage:</b>	Crankshaft fractured at propeller attachment hub	
<b>Commander's Licence:</b>	Private Pilot's Licence	
<b>Commander's Age:</b>	59 years	
<b>Commander's Flying Experience:</b>	1,553 hours (of which 100 were on type) Last 90 days - 15 hours Last 28 days - 9 hours	
<b>Information Source:</b>	Aircraft Accident Report Form submitted by the pilot

**Synopsis**

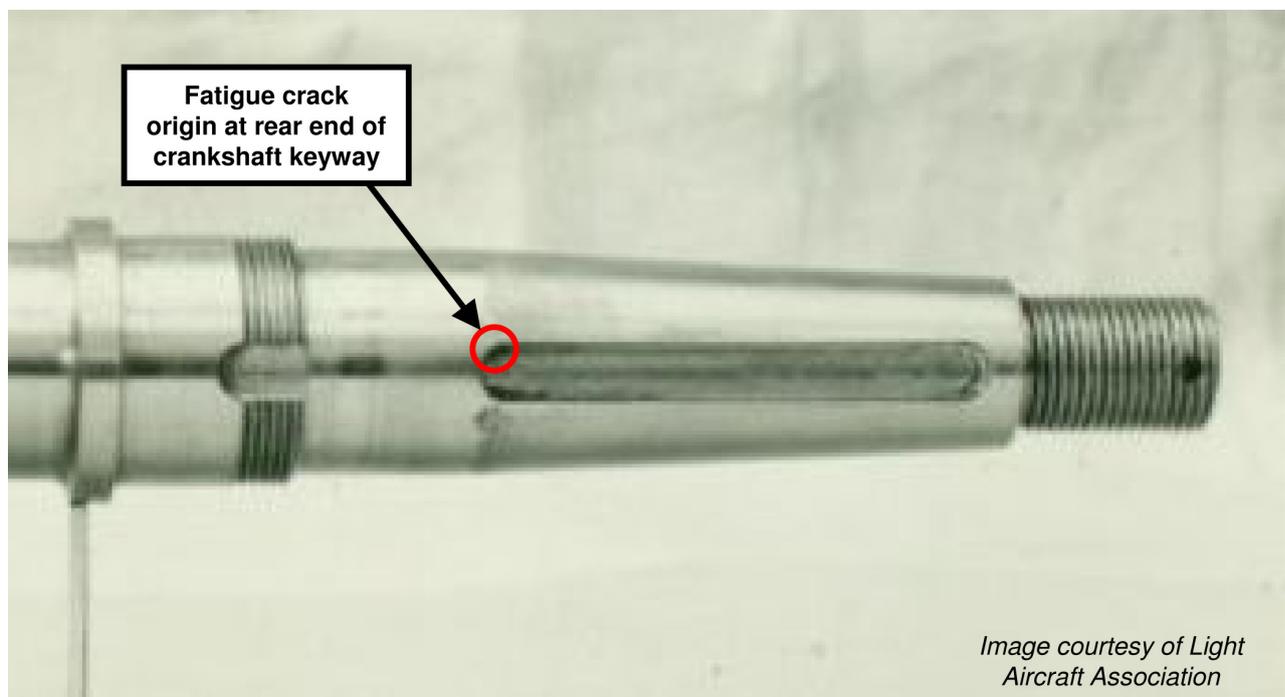
**Figure 1**

The two-cylinder JAP J.99 engine is rated at 36 hp and features a tapered crankshaft, onto which a mating propeller hub is fitted. The propeller hub is restrained in rotation by means of a propeller hub key, which locks into machined keyways in the propeller hub and the crankshaft (Figure 1). The crankshaft, minus the missing tapered portion that was lost with the propeller, is shown in Figure 2.

surface (Figure 3) and by tracing the pattern of these beachmarks it was possible to identify the origin of the fatigue crack, at the left side of the rear end of the crankshaft’s machined keyway. The fracture surface was heavily discoloured, consistent with the crack having been present for a considerable period of time.

An intact JAP J.99 crankshaft, showing location of G-EBJI's fatigue crack

The LAA Engineering department will alert owners of aircraft fitted with JAP J.99 and Aeronca E-113

series engines to the potential for crankshaft fatigue cracking and additionally will include a reference to Service Memorandum M-36 for affected engines on the Type Acceptance Data Sheet (TADS) section of the LAA website. This is currently being updated to reflect the aircraft-specific technical information currently contained in the LAA SPARS document. LAA Engineering is also in the process of defining the inspection interval and method for non-destructive testing of in-service J.AP J.99 and Aeronca E-113 series crankshafts.

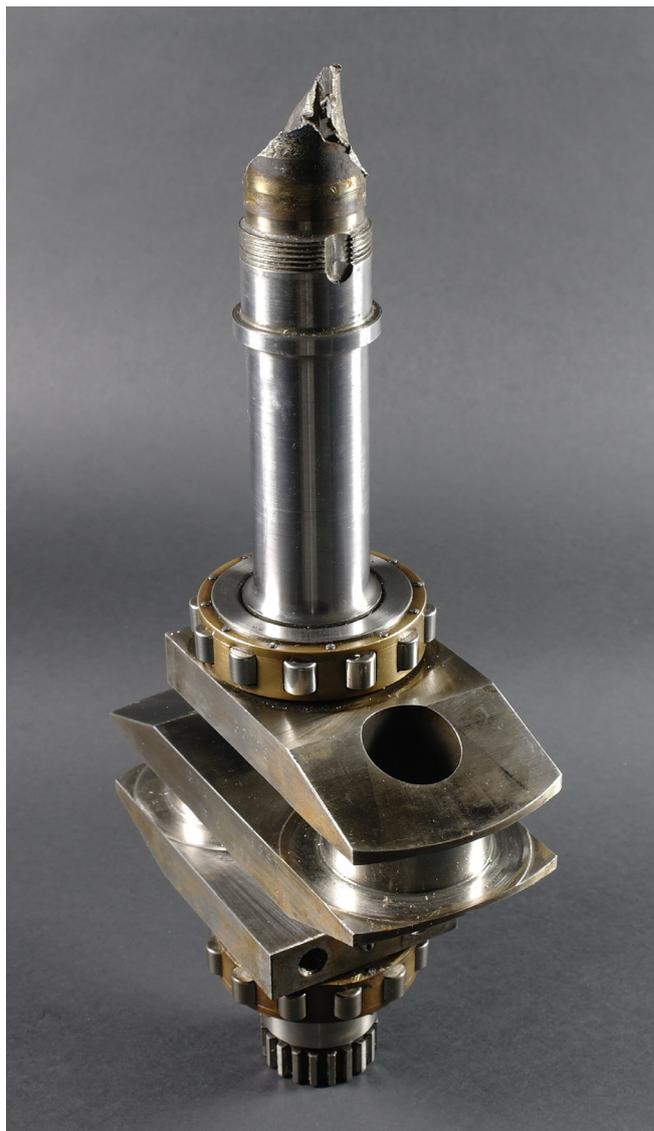
**Figure 2**

Recovered portion of the fractured crankshaft, following disassembly of the engine

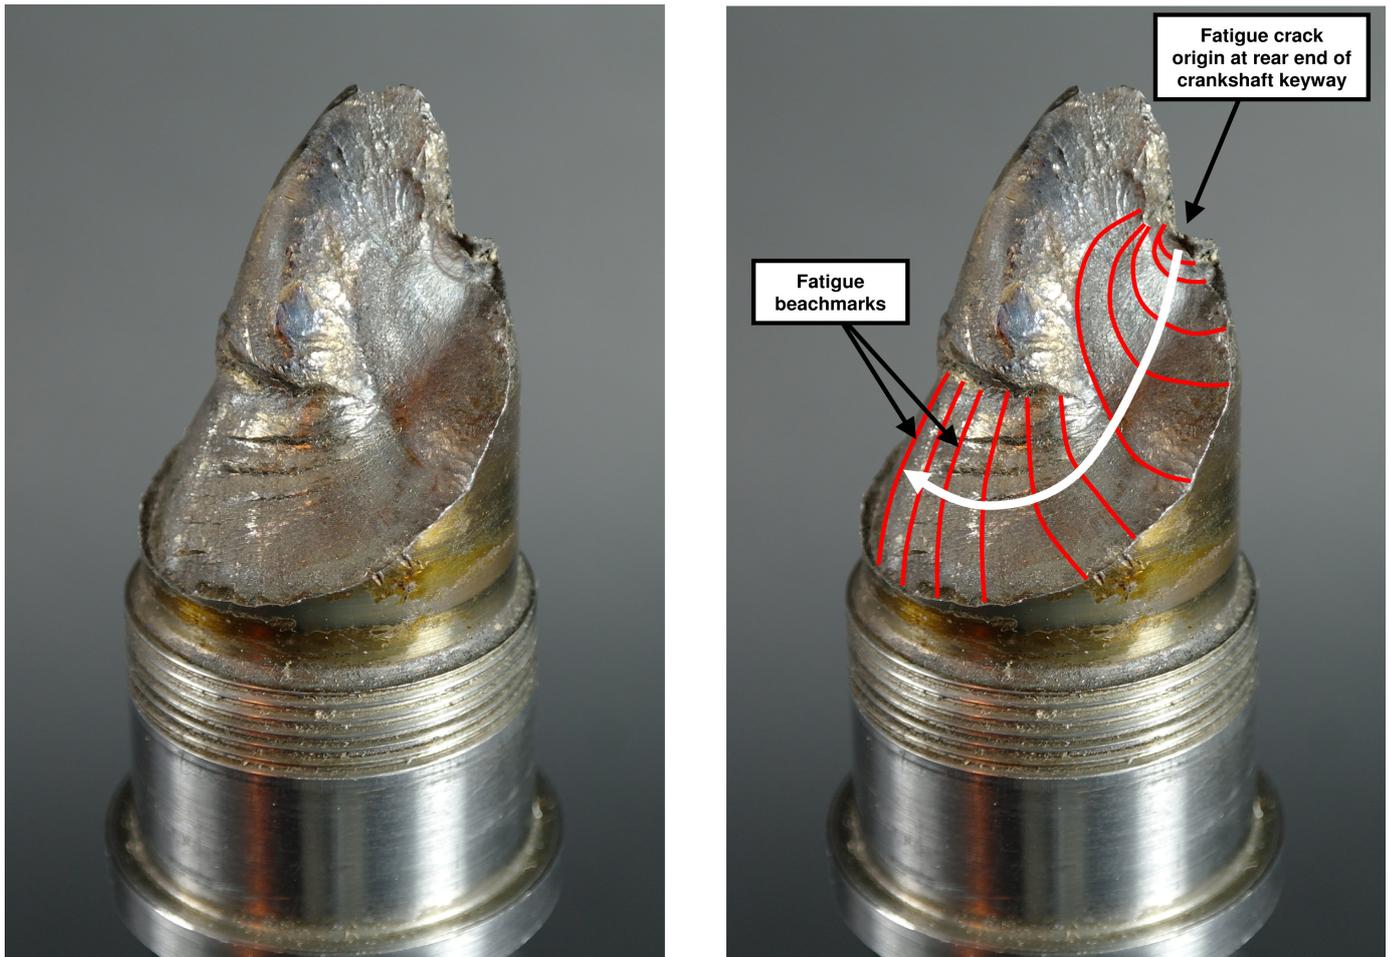
**Figure 3**

The fracture surface was found to be inclined at approximately 45° to the longitudinal axis of the crankshaft, which is characteristic of crack propagation under torsional loading. Clear metal fatigue ‘beachmarks’ were visible on the fracture

The aircraft's propeller detached due to fatigue cracking of the engine's crankshaft. The crankshaft fatigue crack initiated from the rear end of the machined crankshaft keyway and discoloration of the fracture surface indicated that the crankshaft had been cracked for a considerable period of time. Despite two recorded events in the engine's history, some 45 and 47 years previously, it was

Crankshaft fracture surface
