ACCIDENT

Aircraft Type and Registration:	MCR-01, G-TBEE	
No & Type of Engines:	1 Rotax 912 ULS piston engine	
Year of Manufacture:	2000	
Date & Time (UTC):	2 October 2005 at 1159 hrs	
Location:	Near Lymington, Hampshire	
Type of Flight:	Private	
Persons on Board:	Crew - 1	Passengers - 1
Injuries:	Crew - 1 (Fatal)	Passengers - 1 (Fatal)
Nature of Damage:	Aircraft destroyed	
Commander's Licence:	Private Pilot's Licence	
Commander's Age:	53 years	
Commander's Flying Experience:	1059 hours (estimated - of which 290 were on type) Last 90 days - 8:30 hours estimated Last 28 days - 6:30 hours estimated	
Information Source:	AAIB Field Investigation

Synopsis

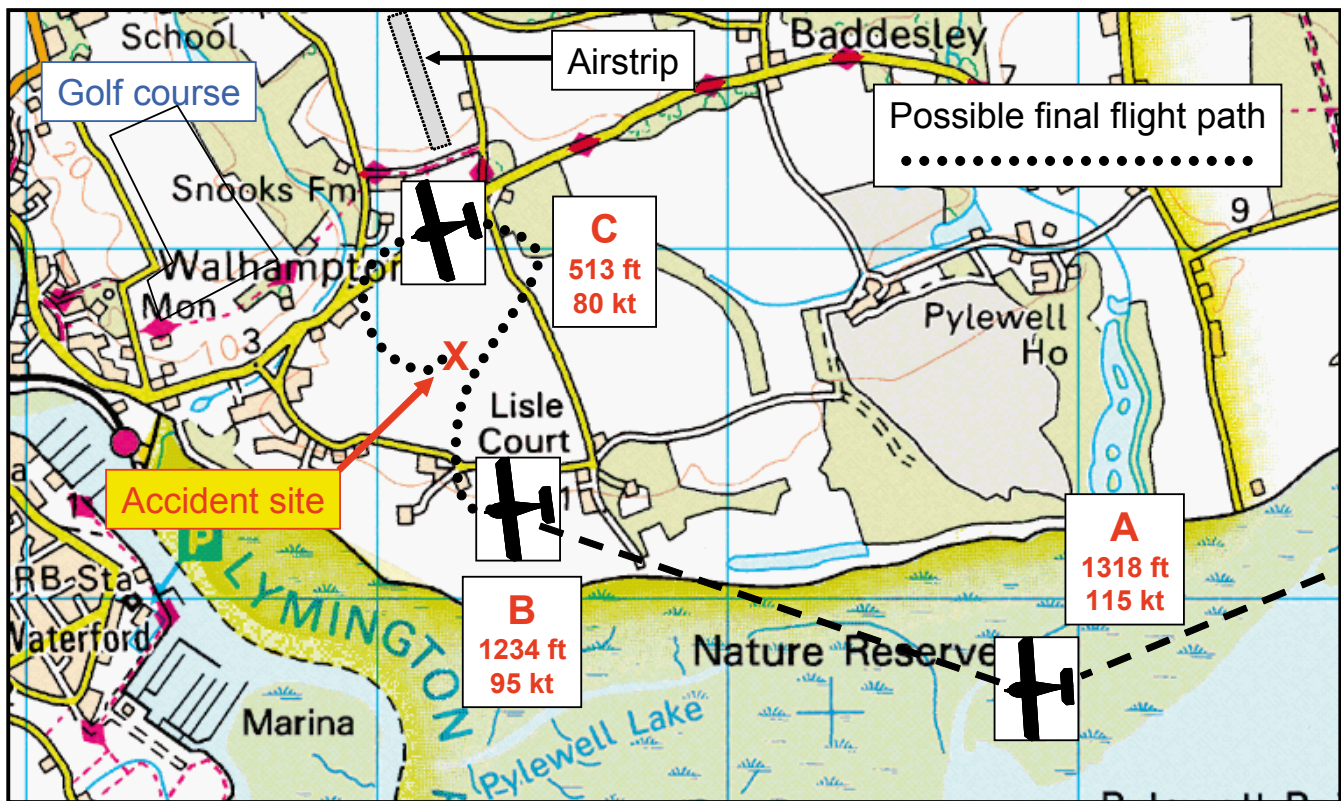
Figure 1
Accident area and GPS derived data

Point A was the last recorded point on the aircraft's original track. The next and penultimate point (B) showed a GPS altitude of 1,234 ft and a reduced groundspeed of 95 kt. The average rate of descent from A to B was less than 200 ft per minute (ft/min), though this increased to about 1,400 ft/min between B and C. The next and final recorded point was 800 m from the previous, and almost due north of it, though the aircraft's track at this stage was just south of west, similar to that of the previous position. Groundspeed at C was 80 kt and the recorded GPS altitude was 513 ft. Based on the position

Analysis of the GPS data provided information regarding the final stages of the flight. The average ground speed between points A and B (Figure 1) is 105 kt, and a direct time/distance calculation between the points provides a groundspeed of 105.6 kt. Therefore it is probable that the aircraft flew a fairly direct line between A and B, and in this case point A is the point at which the aircraft deviated from its initial track.

Based on the available evidence, the most likely flight path between points B and C was in the form of an 'S' turn, whilst descending. The maximum time from point C to the point of impact is 30 seconds, since this is the time interval of the GPS recordings. The minimum time, based on a groundspeed of 80 kt and the most direct feasible flight path to the accident site is about 13 seconds. Information from a witness that the aircraft appeared to cross the extreme south-eastern edge of the golf course in a left turn whilst descending only gradually suggests that the aircraft flew the longer of the two options. This would also mean that at least some power was being produced by the engine and this is supported by the cockpit switch positions. As the aircraft turned through a south or south-easterly heading, it appears to have entered the final manoeuvre which resulted in the accident.

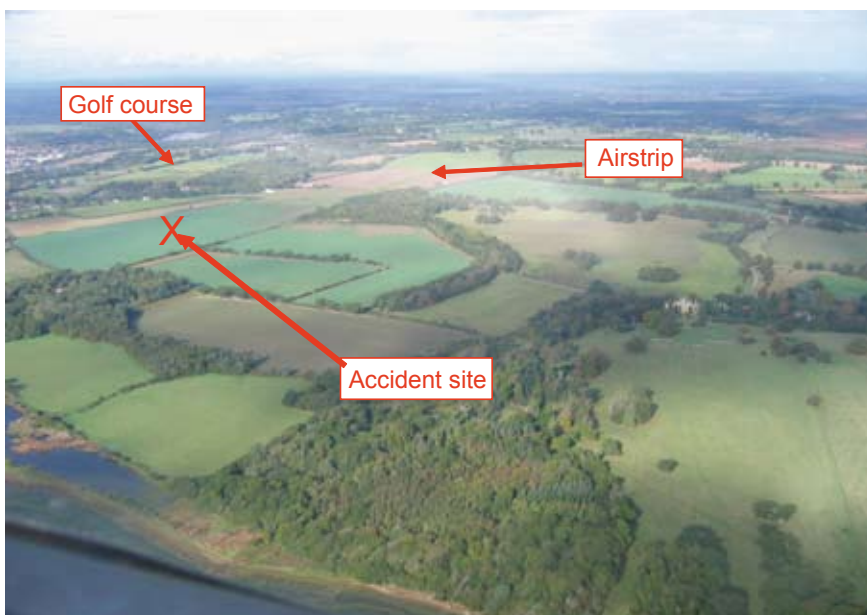
Figure 2 (left)

A general view of the accident area from about point A is at Figure 2. The accident site can be seen to be in the largest field in the area and would have been an obvious choice for a landing, even before the aircraft reached point A. With the northerly wind, the pilot would have been well positioned to land in the field without extended manoeuvring. At this point, it is doubtful whether the airstrip to the north would have been obvious and, in any case, it would not necessarily have presented a better option than the large field.

Accident area as seen from point 'A' of Figure 1 (page 96)

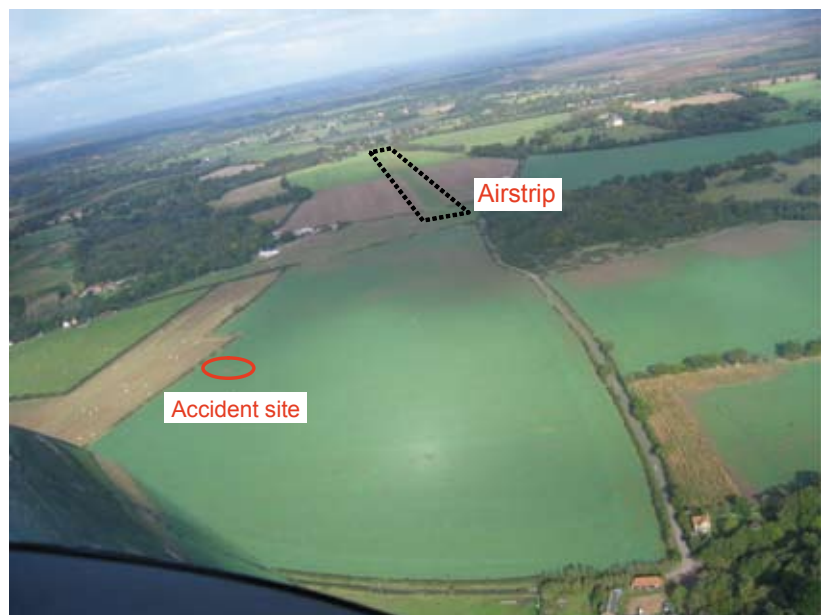
Figure 3
Accident area as seen from point 'B' of Figure 1 (page 96)
