ACCIDENT

Aircraft Type and Registration:	Piper PA-38-112 Tomahawk, G-BYLE	
No & Type of Engines:	1 Lycoming O-235-L2C piston engine	
Year of Manufacture:	1982	
Date & Time (UTC):	22 October 2005 at 0839 hrs	
Location:	Near Biggin Hill Airport, Kent	
Type of Flight:	Training	
Persons on Board:	Crew - 2	Passengers - None
Injuries:	Crew - 2 (Fatal)	Passengers - N/A
Nature of Damage:	Aircraft destroyed	
Commander's Licence:	Commercial Pilot's Licence with Flying Instructor Rating and CAA authorised Flight Examiner	
Commander's Age:	60 years	
Commander's Flying Experience:	4,451 hours (no record of any experience on type) Last 90 days - 39 hours Last 28 days - 18 hours	
Information Source:	AAIB Field Investigation

Synopsis

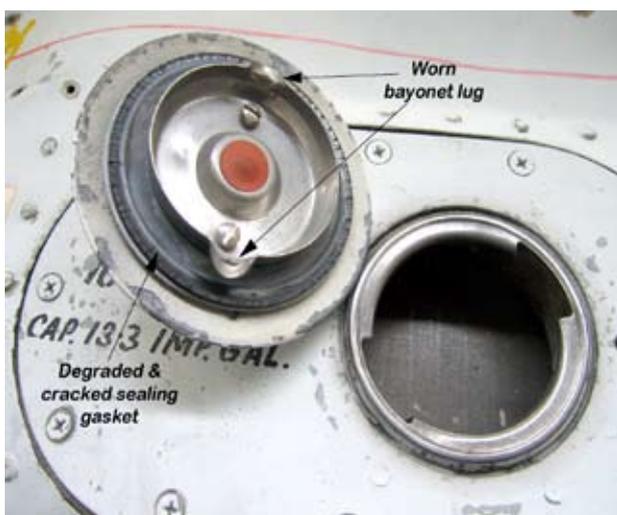
Figure 1
Fuel filler cap

The PA-38 filler cap is a deceptively complex mechanism. The seal assembly comprises a stack of three gaskets: a thin rubber gasket seal which abuts the face of the filler neck, backed by two very thin and stiff spring gaskets. The stack is clamped centrally within the concave underside of the fuel cap housing resulting in the stack adopting a slightly conical profile. When the cap is locked down into position by the action of a bayonet mechanism, the rubber sealing gasket is pressed down onto the face of the filler neck. The relatively soft material of this gasket accommodates any small surface imperfections whilst the thin (slightly conical) backing gaskets act as a circumferential spring which pushes the gasket down around the whole periphery to accommodate any larger-scale undulations which may exist at the seal interface.

Examination of the filler cap bayonet mechanisms revealed that on each cap the projecting lugs (which abut the bayonet-cams) were grossly worn, to the extent that each lug was worn right through, beyond its full thickness, see Figures 1 and 2. The effect of this wear was to reduce significantly the extent to which the cap was pulled down onto its seat, with a commensurate reduction in the amount of compression of the seal assembly and an associated loss of seal effectiveness.

Age-related cracking was clearly visible around the periphery of the rubber sealing gasket from the left cap, but for the most part these cracks did not extend into the working (contact) area of the seal. This cracking was less significant in terms of the deterioration in seal performance than the reduced compression of the seal assembly caused by the wear in the bayonet mechanism.

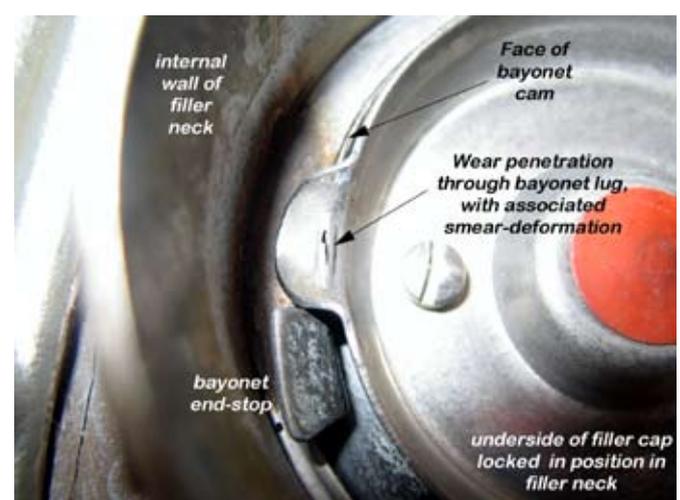
Figure 2
Underside of filler cap showing worn bayonet cams

Whilst the rubber sealing gasket on the left cap had visibly degraded and cracked, for the most part these cracks did not extend into the interface region, and were not in themselves responsible for the absence of an effective seal. Rather, the loss of seal effectiveness was almost wholly caused by wear in the bayonet fittings, which reduced the distance through which the cap was pulled down onto its seat in the filler neck as it was locked down. It was not possible to measure precisely the extent of this wear, but the depth of wear in the lugs alone, illustrated in Figure 3, exceeded the rubber gasket's thickness by some 40% and approached the total thickness of the complete gasket

stack. The reduced compression of the fitted cap meant that the seal was no longer in proper contact with the seat and the cap would be prone to leakage. Any appreciable wear in the bayonet cam faces would also have contributed to a poor seal.
