ACCIDENT

Aircraft Type and Registration:	RAF 2000 GTX-SE, G-REBA	
No & Type of Engines:	One Subaru EJ22 piston engine	
Year of Manufacture:	2001	
Date & Time (UTC):	1 June 2006 at 0927 hrs	
Location:	West of Simon's Stone, Colliford Lake, Bodmin Moor, Cornwall	
Type of Flight:	Private	
Persons on Board:	Crew - 1	Passengers - None
Injuries:	Crew - 1 (Fatal)	Passengers - N/A
Nature of Damage:	Gyroplane destroyed	
Commander's Licence:	Private Pilot's Licence	
Commander's Age:	69 years	
Commander's Flying Experience:	242 hours (of which 191 were on type) Last 90 days - 5.4 hours Last 28 days - 1.5 hours	
Information Source:	AAIB Field Investigation

Synopsis

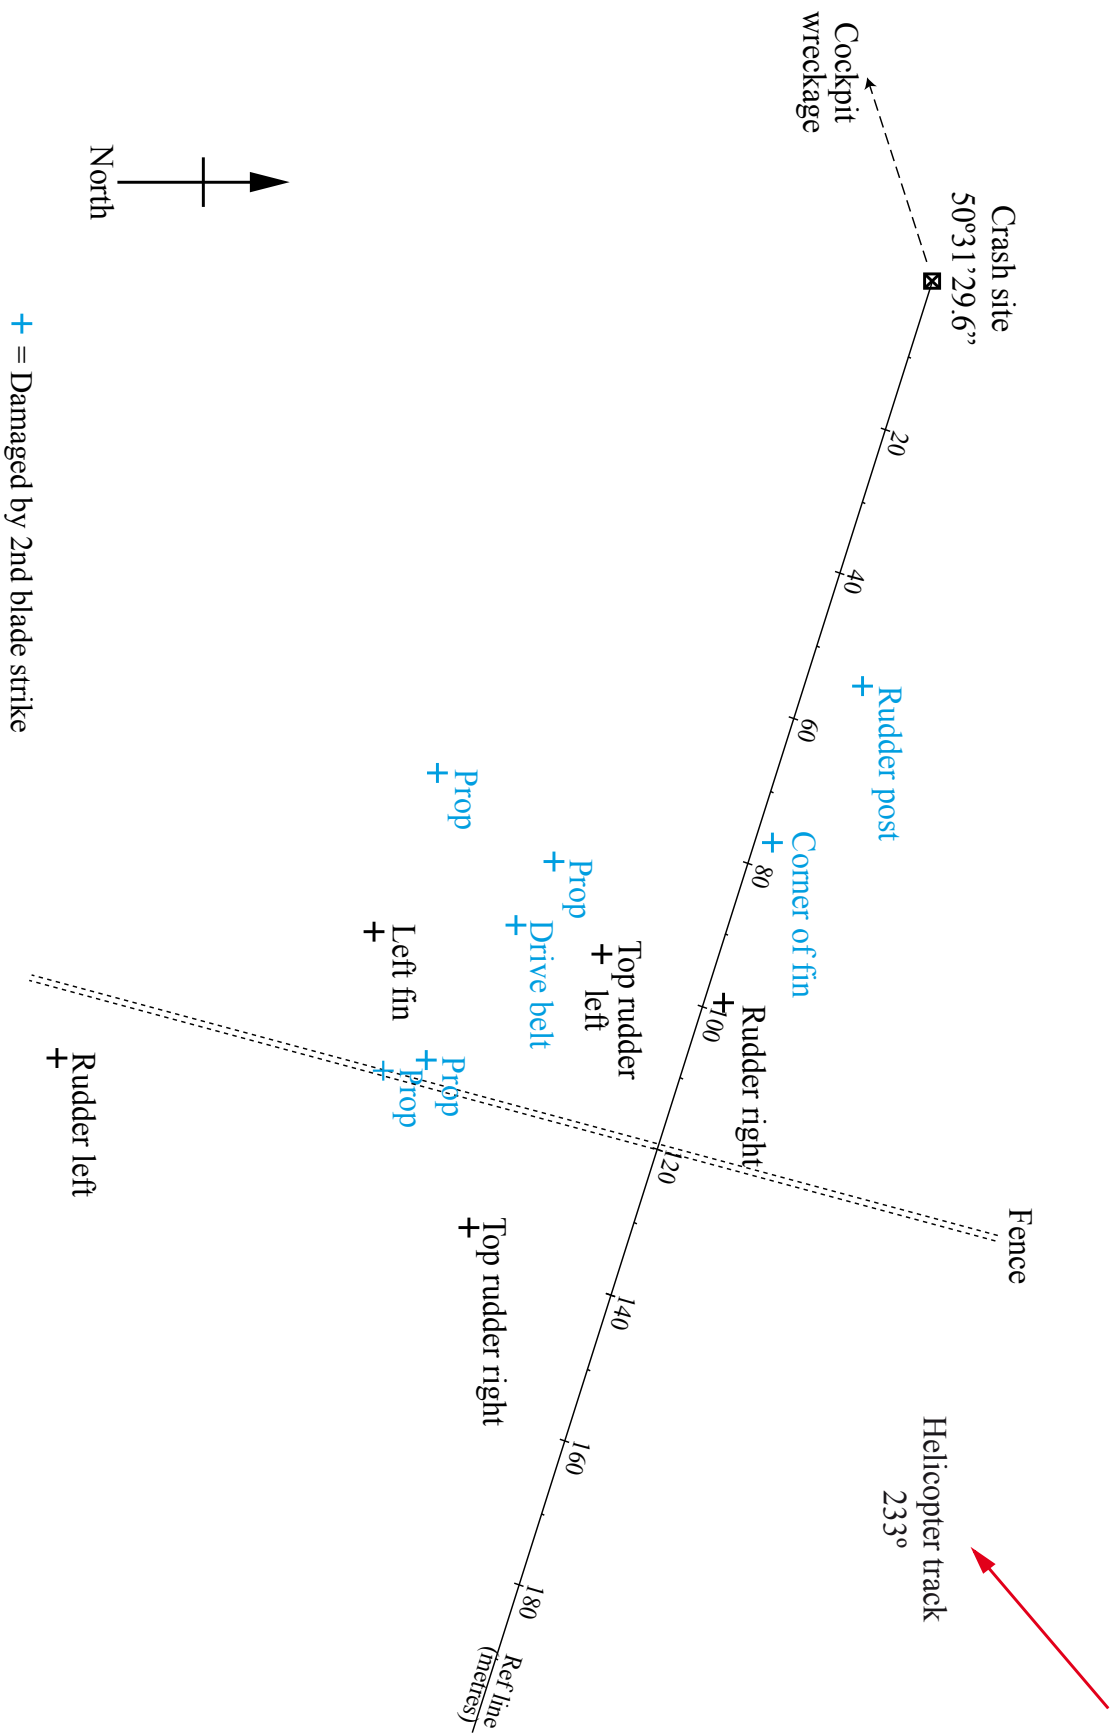
Figure 1
Wreckage distribution

The gyroplane crashed on the edge of an area of marsh land to the West of Colliford Lake on Bodmin Moor (see Figure 1) and came to rest on its left side on a heading of 287° M. Ground marks indicated that the

it struck the ground from a near vertical descent with some sideways movement to its left.

The left side of the gyroplane was extensively damaged, the fuel tank had ruptured and there was a strong smell of fuel in the area. There was localised damage to the leading edges of both main rotor blades. One blade was trapped under the engine and both blades were bent downwards along the majority of their length. All three of the propeller blades had broken off close to the hub.

Pieces of the canopy and items from the cockpit had been thrown forward by approximately 25 m on a heading of 211° M. A second wreckage trail consisting of the broken propeller blades and parts of the fin and rudder were found approximately 54 m to 150 m from the crash site. Most of the items were found between 90 m and 120 m on bearings of between 272° M and 316° M to the gyroplane.

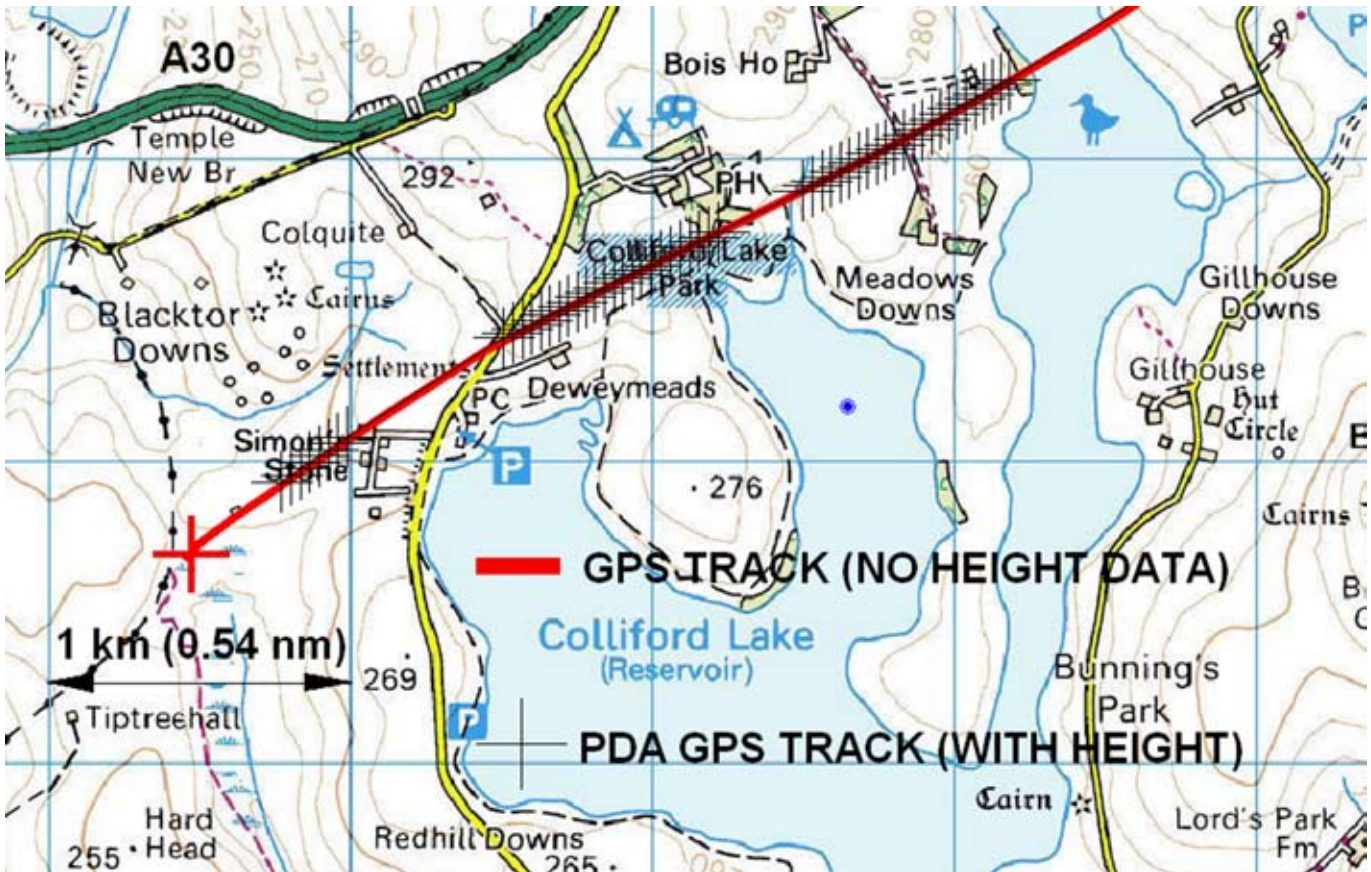
Figure 2
GPS and PDA GPS tracks

The last four GPS data points recorded on the accident flight are indicative of the gyroplane pitching nose-up then nose-down. The points recorded are groundspeeds of 83 mph, 72 mph, 80 mph and 35 mph. From these ground speeds a tail wind component of 4 mph should be subtracted in order to obtain airspeed, although it should be noted that GPS based speeds are subject to errors arising from inaccuracies in GPS position data. Nonetheless, on that basis the gyroplane was slowed from 79 mph to 68 mph in 4 seconds. This could have been the result of aft cyclic to climb or a reduction in power to slow down or a combination of both. The gyroplane then accelerated from 68 mph to 76 mph in one second. This represents either a large nose-down attitude change and/or an increase in tail wind component. The final data point recorded three seconds later was 31 mph.

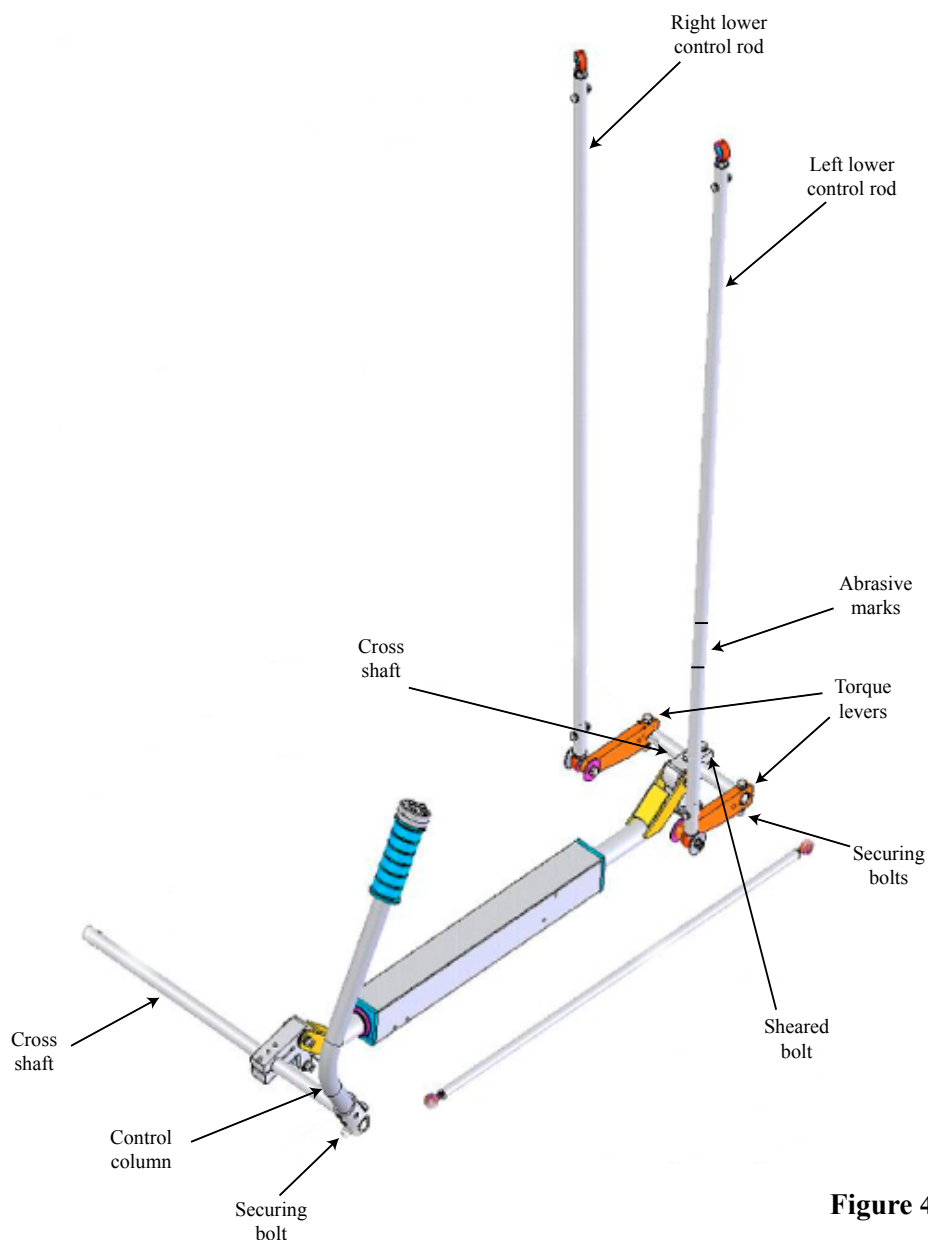
Figure 4
RAF 2000 flying controls

With the exception of the torque levers, continuity of the cyclic control was confirmed between the control column and the gimble activation arm. Both torque levers, which are mounted at the base of the mast, had failed at the point where the bolts secure the levers to the cross shaft (see Figure 4). The left lower control rod was badly bent during the impact and broke during the recovery of the gyroplane. At 34 cm from the bottom of the rod there were deep abrasion marks along the rod for approximately 40 mm. The lock nut on the lower fitting on the left upper control rod had been

fully wound off and the fitting was loose. Abrasion marks were also discovered at 80 mm and 35 cm from the bottom of the right lower control rod. The lock nut on the fitting on the right upper control rod was found to be loose. The bolt used to secure the pilot's control column to the cross shaft had four washers between the column and the nut. The bolt which secured the torque lever to the cross shaft had failed in shear. Both trim springs were still connected to the control rods. The trim indicators were in the fully down position and the trim cables were unwound from the barrels inside the trim mechanism, so that there was no tension in the trim springs and no trim force applied to the control system.

The left lower control rod failed as a result of bending overload separation. The deep abrasion marks 34 cm from the bottom of the control rod were identified as longitudinal fretting corrosion damage which had resulted from high contact pressures and large sliding movements. The metallurgist considered that the restriction resulting from this contact could have been sufficient to overload the torque levers.

The comparison also established that the abrasion marks at the base of the right lower control rod were probably caused by the trim springs rubbing against the control rod. It was noted that a number of other owners of RAF 2000 gyroplanes had identified this problem and introduced their own modifications using plastic sheaths and blade tape to protect the control rods from the trim springs. Whilst it is unlikely that the rubbing of the trim springs against the control rod played any part in this accident, on the 14 July 2006, in AAIB Special Bulletin S6/2006, the following Safety Recommendation was made to the Popular Flying Association.

The left lower control rod from G-REBA, which had the deep abrasion marks 34 cm from the bottom of the control rod, was compared with the equivalent control rod on another gyroplane where it was noted that the marks were in line with the battery tray. It is, therefore, probable that the marks on the engine frame adjacent to the battery tray and the control rod were caused by these two items rubbing against each other.

Whilst operating the controls on one of the gyroplanes used in the comparison, it was noted that the excess safety chain, fitted to one of the trim springs, jammed between the lower control rod and undercarriage strut thereby restricting the roll control of the gyroplane. The chain on G-REBA had been set up such that there was no free hanging excess chain and, therefore, it is unlikely that it would have caused the control to jam. However, on the 14 July 2006, in AAIB Special Bulletin S6/2006, the following Safety Recommendation was made to the Popular Flying Association.

It is recommended that the Popular Flying Association considers introducing a modification to the lower control rods of the RAF 2000 to protect them from being damaged by the trim springs.

It is recommended that the Popular Flying Association takes the necessary immediate steps to ensure that the safety chain connected to the trim springs on the RAF 2000 does not jam the moving parts in the control system.
