INCIDENT

Aircraft Type and Registration:	Robinson R22 Beta, G-DERB	
No & Type of Engines:	1 Lycoming O-320-B2C piston engine	
Year of Manufacture:	1989	
Date & Time (UTC):	15 November 2004 at 1400 hrs	
Location:	Biggin Hill, Kent	
Type of Flight:	Training	
Persons on Board:	Crew - 2	Passengers - None
Injuries:	Crew - None	Passengers - N/A
Nature of Damage:	Main rotor blade cracked	
Commander's Licence:	Air Transport Pilot's Licence	
Commander's Age:	35 years	
Commander's Flying Experience:	2,950 hours (of which 2,080 were on type) Last 90 days - 252 hours Last 28 days - 71 hours	
Information Source:	AAIB Field Investigation

Synopsis

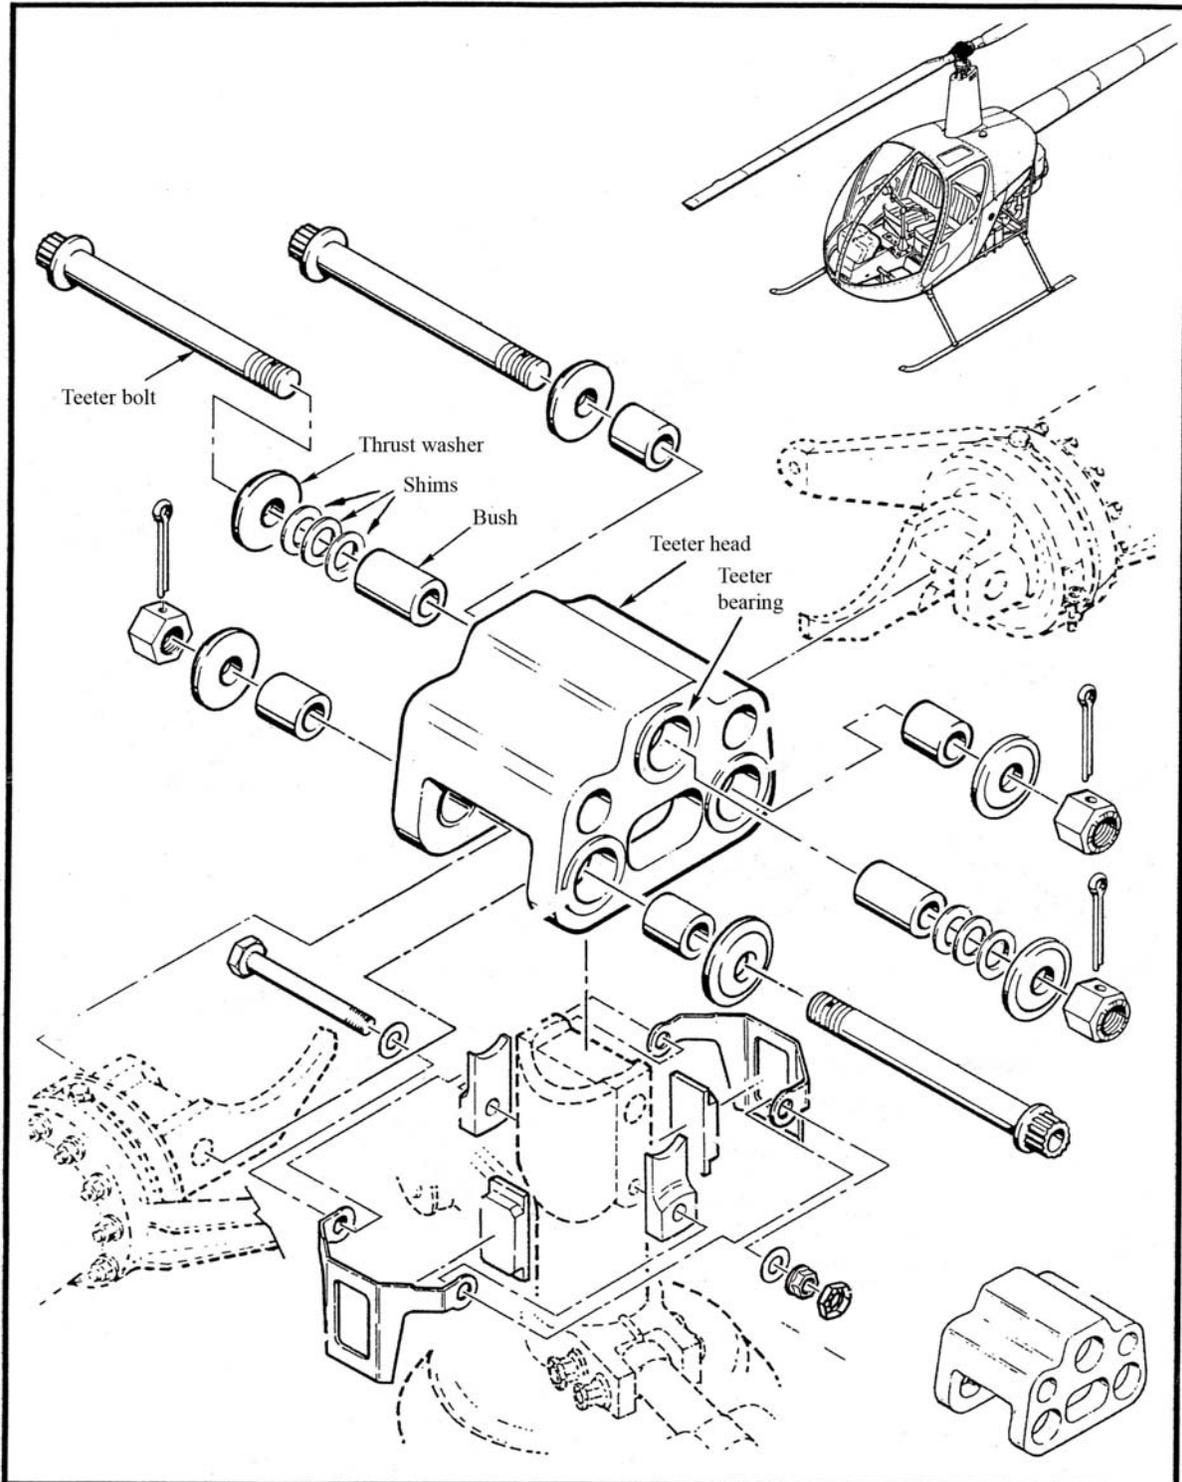
Figure 2

The rotor system was disassembled and examined, Figure 2. It was found that the cadmium plated surface of the teeter bolt was damaged, that the thrust washers at the teeter hinge and the associated bushes in the main rotor head were deformed. The teeter hinge assembly should be assembled with shim washers, the thickness of which are determined on assembly, but no such washers were found in the assembly from G-DERB when examined by the AAIB. During assembly, the teeter bolt is pre-loaded by torque loading its nut until the extension of the bolt, due to elastic strain³, achieves a

set value. On disassembly, the residual strain in the bolt was measured and this was found to be sufficiently close to the required value to suggest that the teeter bolt had been correctly pre-loaded. As a consequence of its assembly without the required shims, the bushes on the teeter bolt were not properly clamped, resulting in the thrust washers applying an excessive load directly to the teeter head itself. This caused the teeter motion to occur between the teeter bolt and its bushes rather than, as intended, between the bushes and the head itself. Using information from the Maintenance Manual and the finished dimensions of the detail parts, the required thickness of shims for correct assembly was calculated. It was found that a total of 0.059 inches of shim material was required.

When the head was initially assembled it was rejected by the mechanic, because the teeter hinge was very stiff to move. On inspection of the parts after the incident, it was found that the thrust washers were plastically deformed (bowed) and the mating bushes in the head were distorted to a concave shape. This most probably occurred as the teeter bolt was tightened when first assembled. These plastic deformations would have resulted in changed clearances on re-assembly, even without any shims, and there may also have been some surface grease on the parts which are normally assembled dry. The assembly may have been less stiff after re-assembly for these reasons, resulting in the recorded pull-off values remaining higher than normal due to the absence of the shims, but this time within limits. There was no clear reason established why, over the last 20 flying hours, the teeter hinge had progressively stiffened. It would appear that during this period, it was sufficiently free for the blade tips to be moved down to be inspected from the ground during the daily inspection, although the teeter hinge might have been stiffer than normal. Immediately after the incident, it was found to be extremely stiff. Upon disassembly, damage was observed to the cadmium plated surface of the teeter bolt, about which the teeter motion had been occurring in preference to the bushes and it was found that the bolt did not move freely in the bushes. Cadmium is a soft metal and will 'flow'

under heat and pressure. It is likely, therefore, that the soft cadmium was displaced and flowed into the available clearance, causing high friction between the teeter bolt and the bushes.

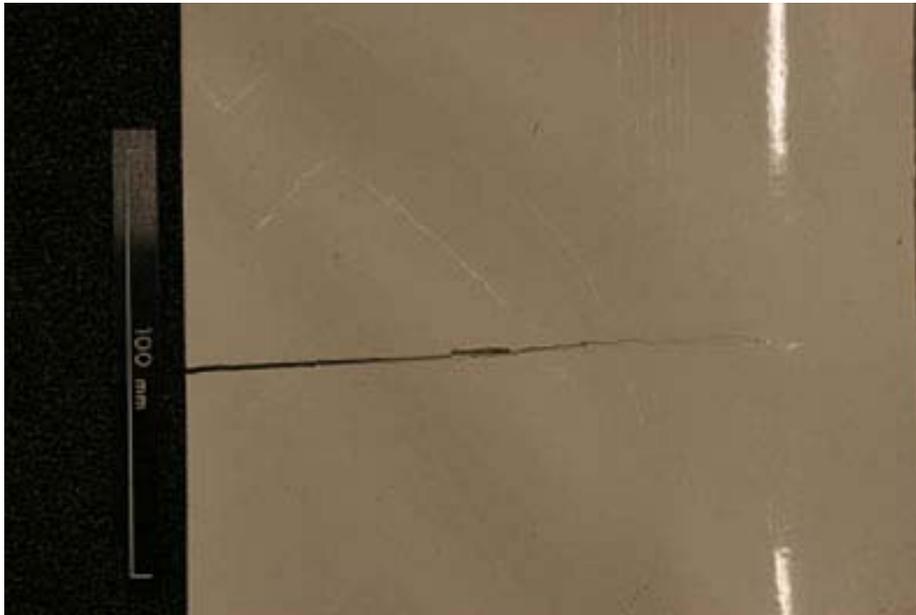
Figure 3

The cracked blade was examined by a specialist laboratory, Figures 3 and 4. Their report concluded that the crack had initiated in the trailing edge of one skin of the blade by a fatigue mechanism, which had then progressed, relatively slowly, forward and into the other skin. It then advanced rapidly through the top and bottom skins forward as far as the blade spar. The spar itself showed no evidence of cracks. The origin of the fatigue crack was not associated with damage, corrosion or material defect, but appeared to be due to higher than normal stresses and was in the area of a local stress concentration at the end of an internal doubler.

'The 'stiff' teeter hinge condition caused by the assembly of the hub to the rotor without proper shims is believed by RHC to have been a major factor in the cracking of the blade...' and...'The absence of corrosion or other stress riser at the fatigue origin is an indicator of higher than normal loading'.

Photograph showing the crack observed on the upper surface of the rotor blade, as received, trailing edge on the left hand side of the photograph

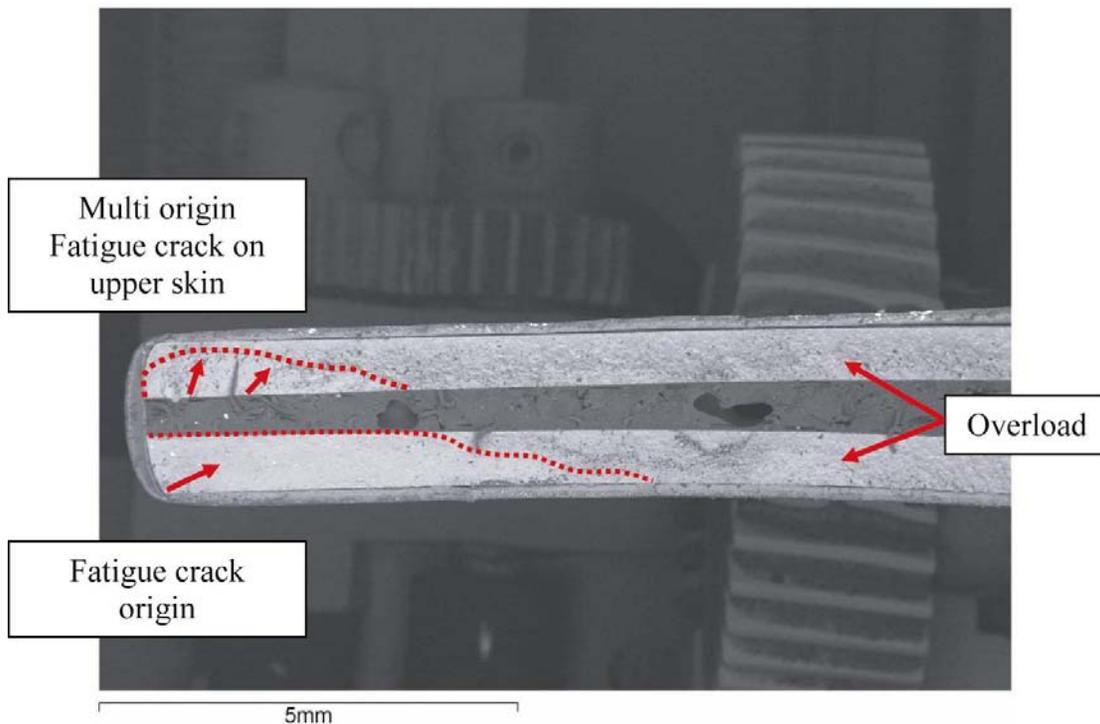
Figure 4

Backscattered electron micrograph of the fracture at the trailing edge location, showing the extent of the fatigue cracks
