AAIB Bulletin S2/2007

ACCIDENT

Aircraft Type and Registration:	Boeing 777-222, N786UA
No & Type of Engines:	2 Pratt & Whitney PW4090 series turbofan engines
Year of Manufacture:	1997
Date & Time (UTC):	26 February 2007 at 1000 hrs
Location:	London (Heathrow) Airport
Type of Flight:	Commercial Air Transport (Passenger)
Persons on Board:	Crew - 20 Passengers - 185
Injuries:	Crew - None Passengers - None
Nature of Damage:	Heat and fire damage to the right main power distribution panel, surrounding structure and components inside the Main Equipment Centre
Commander's Licence:	Airline Transport Pilot's Licence
Commander's Age:	52 years
Commander's Flying Experience: (Hours all approximate)	18,000 hours (of which 2,800 hours were on type) Last 90 days - 215 hours Last 28 days - 65 hours
Information Source:	AAIB Field Investigation

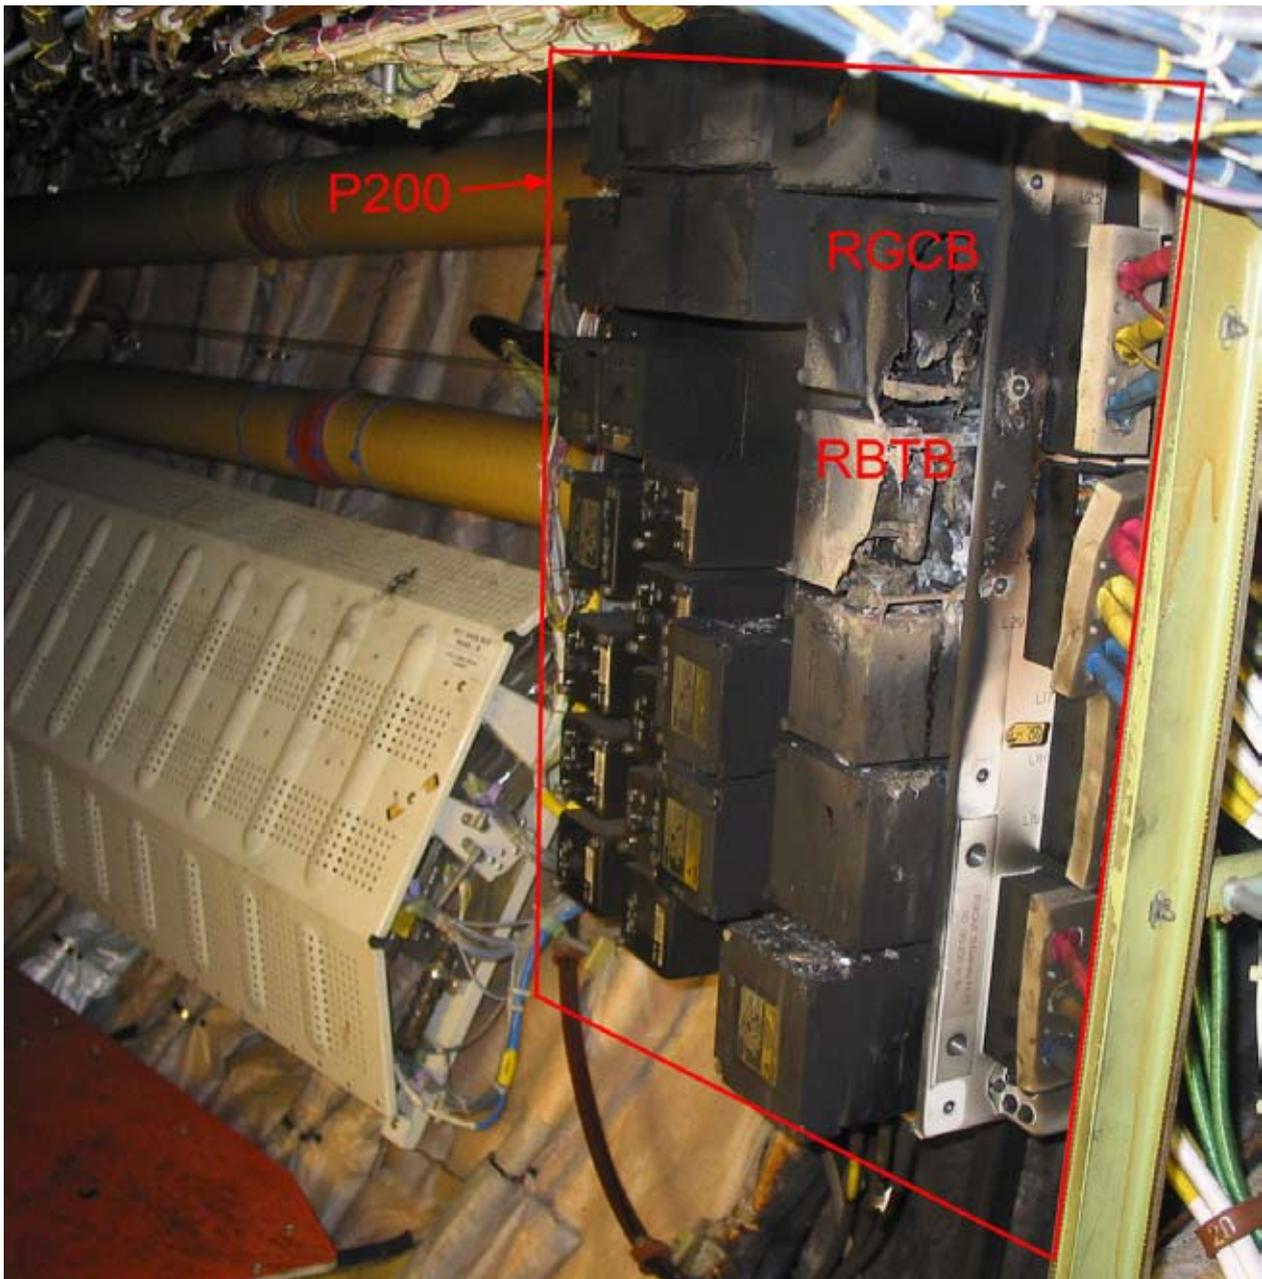
Figure 2

An inspection inside the MEC after the accident revealed extensive heat and fire damage to the P200 power panel as shown in Figure 2. The worst affected components of the power panel were the RGCB and RBTB contactors, parts of which had melted and vaporised. There was evidence that molten metal had dripped down onto the insulation blankets beneath this panel. Extensive fire damage to the fire-retardant insulation blankets located behind and beneath the power panel under the floor, had occurred as shown in Figure 3. Nearby components including a floor panel, equipment cooling system ducting, other wire bundles and some structural frames and stringers in the vicinity were later determined to have suffered sufficient heat damage to require replacement.

Fire damage to P200 panel, showing burnt-out RGCB and RBTB contactors
(panel cover has been removed in this photograph)

main moveable contacts within both contactors were destroyed. There was some insulation damage to the bus bars within the panel in the vicinity of the RBTB. The damage to the surrounding components of the power panel appeared to be a consequence of a failure within either the RBTB or RGCB.

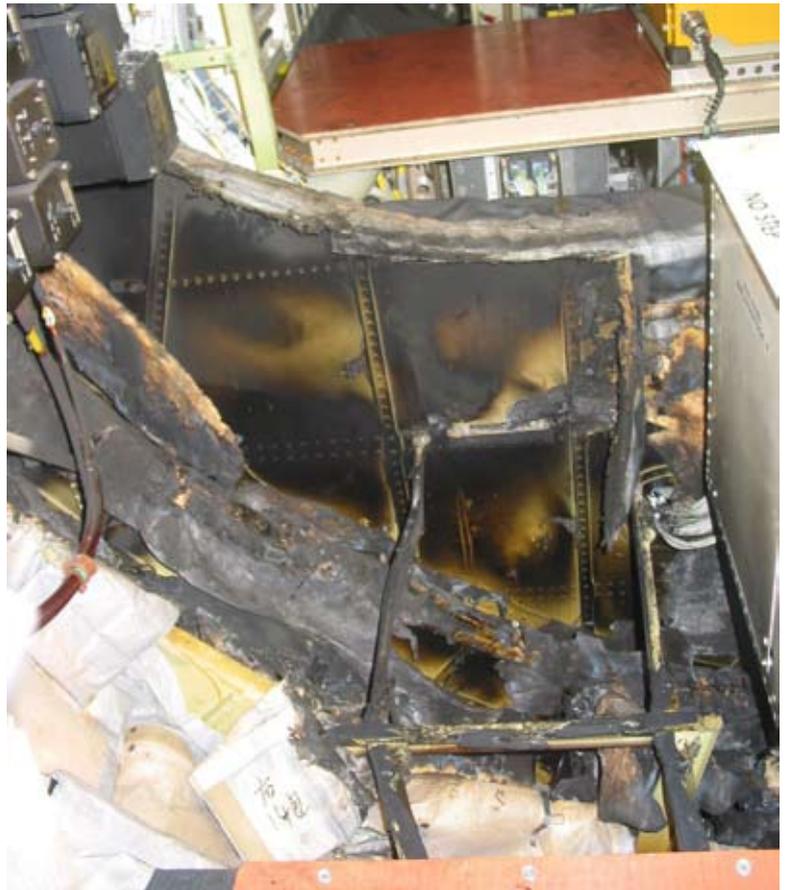
Figure 3

Burnt aircraft structure and insulation blankets located directly below P200 panel (viewed looking aft with floor panel removed)
