INCIDENT

Aircraft Type and Registration:	Slingsby T67M260, G-EFSM
No & Type of Engines:	1 Lycoming AEIO-540-D4A5 piston engine
Year of Manufacture:	1989
Date & Time (UTC):	23 November 2006 at 0945 hrs
Location:	Near Cambridge Airport, Bedfordshire
Type of Flight:	Public Transport (Training)
Persons on Board:	Crew - 2 Passengers - None
Injuries:	Crew - None Passengers - N/A
Nature of Damage:	Possible cracking of the cockpit floor
Commander's Licence:	Commercial Pilot's Licence
Commander's Age:	36 years
Commander's Flying Experience:	2,000 hours (of which 300 were on type) Last 90 days - 38 hours Last 28 days - 20 hours
Information Source:	Aircraft Accident Report Form submitted by the pilot, information from the maintenance organisation and manufacturer and AAIB examination of the aircraft

Synopsis

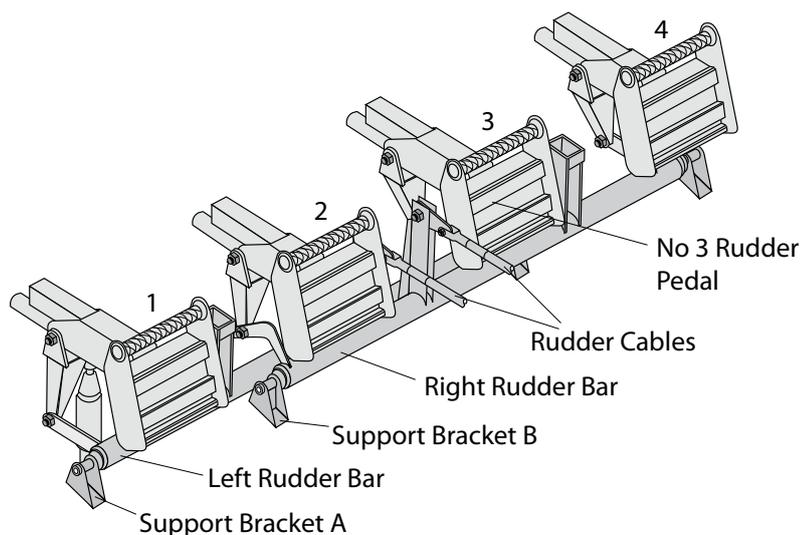
Figure 2

Primary flight controls are conventional, operated by dual cockpit controls. Rudder pedal assemblies are numbered from 1 to 4 across the aircraft from left to right (Figure 2). The pedals are mounted on two rotatable cross-shafts in the cockpit, known as rudder bars, with the left pedal of each pair (Nos 1 and 3) fixed to the left bar and the right pedals (Nos 2 and 4) fixed to the right bar. A crank arm on each bar is connected to rudder operating levers by a cable-fairlead system. Thus, a forward displacement of the No 1 pedal, for example, rotates the left bar and moves the No 3 pedal forward in unison, while the connection through the cable loop causes the right bar to rotate in the opposite direction and displace the Nos 2 and 4 pedals aft.

Each rudder bar is supported on two rotation bearings, each mounted on a bracket bolted to the cockpit floor structure. The support bracket bolts pass through the floor panel into captive nuts fixed to the underside of the GRP structure. Rudder bar end-float can be adjusted by fitting packing washers of varying thickness between the brackets and the ends of the bar.

Cases of distortion of Bracket A had occurred previously, attributed by the manufacturer to an excessive steering angle during towing. It was noted that, whereas the left mounting bracket for the right rudder bar (Bracket B, Figure 2) had a lateral web member that would increase its resistance to either elastic or permanent lozenging under lateral loads, this feature was not present on Bracket A.

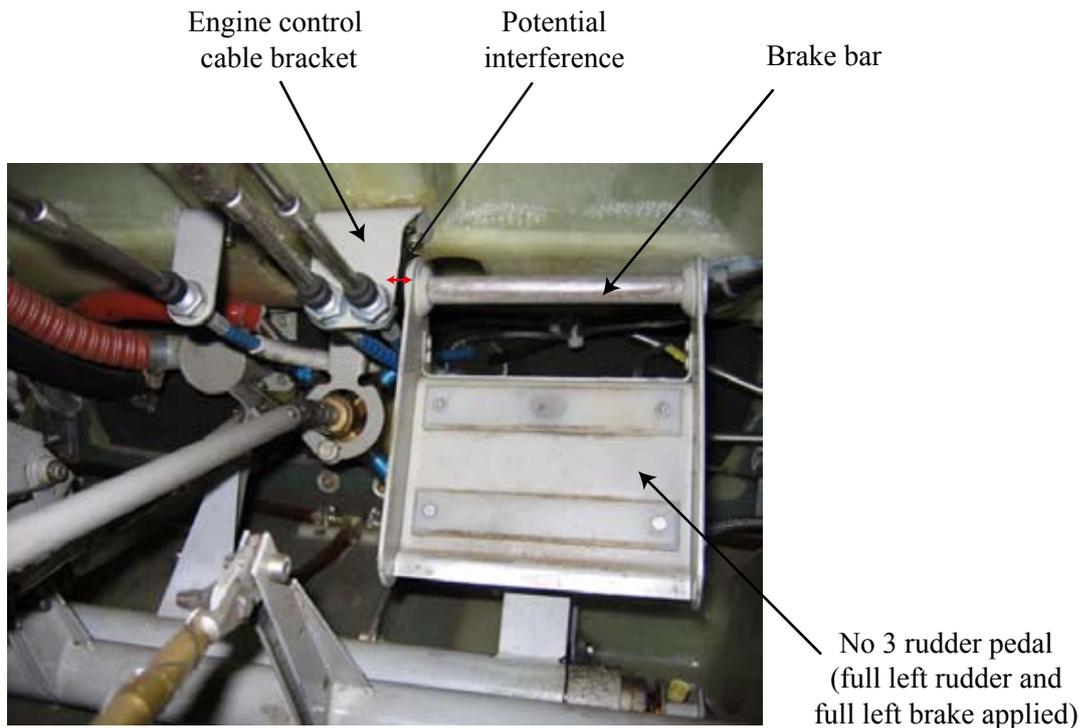
Figure 3

The maintenance organisation reported that, after prolonged attempts, it was found possible to produce interference between the No 3 pedal and a fixed bracket supporting engine control cables. With the No 3 pedal adjusted fully forward, pushing the brake bar of this pedal fully forward (thus applying full left rudder and full left wheel brake) positioned the top part of the pedal close to the bracket. If a left side force was simultaneously applied to the No 3 pedal, its edge could contact the bracket (Figure 3). It appeared that the pedal could possibly get caught behind the bracket and that a significant force on the right pedal could be required to clear the foul.

No signs were found that the engine control cable bracket was incorrectly sized or positioned. The aircraft manufacturer reported that, although no witness marks could be found to confirm a positive foul, their inspection showed there was excessive end-float (ie lateral movement) of the left rudder bar, estimated at around 1.5 mm, and that the left support bracket for the left bar (Bracket A in Figure 2) was angled over to the left. After removal of the rudder bars from the aircraft, cracking of the floor beneath Bracket A was found. No

No 3 pedal clearance (similar aircraft)

The reported unloaded end-float in the left rudder bar, which was an estimated 0.7 mm (0.028 inch) outside the manufacturer's limits, should not have been sufficient on its own to result in a foul. However, only a small amount of additional lateral displacement of the No 3 pedal would be needed for interference to occur, given the minimal allowable clearance (3 mm (0.12 inch)) between the pedal and the cable bracket.

The European Aviation Safety Authority should require changes to the engine control cable bracket on relevant Slingsby T67 aircraft to increase its clearance from the No 3 rudder pedal, in order to prevent possible interference with the free movement of the rudder pedals.

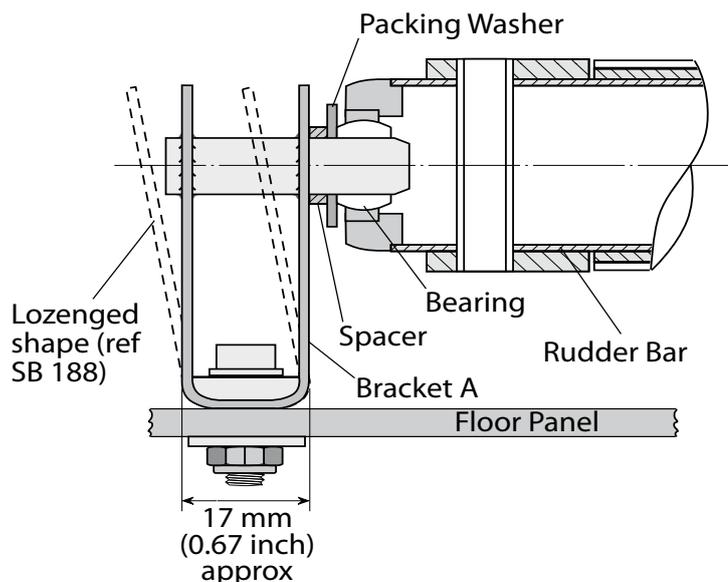
Figure 4
Rudder bar support bracket

SB 187 and SB 188 also specified a check of the rudder bar end-float and adjustment to a maximum of 0.8 mm for all aircraft, irrespective of pedal clearances. They also required a check that Bracket A was square to the floor, not 'lozenged' (Figure 4) and without deformation to its base. The SBs noted that:

displacement could result from wear in the No 3 pedal slider and/or excessive end-float of the left rudder bar. An increase in end-float could be caused by wear, by lozenging distortion of Bracket A and/or by tilting of Bracket A on its mountings.

It was also apparent that the base of Bracket A was relatively narrow (Figure 4), and that side loads applied to the bracket would therefore be expected to generate higher loads in the bracket attachments and thus in the local floor structure than if the base were wider. In G-EFSM's case, weakening of the bracket attachment because of floor cracking could possibly have allowed the bracket to tilt and could therefore have contributed to displacement of the No 3 pedal. However, this could not be confirmed as it was unknown whether the floor cracking found had occurred before or as a consequence of the incident.

The European Aviation Safety Authority should review the rudder pedal system of the Slingsby T67 aircraft. Consideration should be given to improving both the lateral stiffness and strength of the rudder bar support brackets and the integrity of the attachments for the brackets, in order to prevent possible interference with the free movement of the rudder pedals. Consideration should also be given to requiring means to limit the loads applied to the rudder system during towing.
