**AIRCRAFT ACCIDENT REPORT 3/90**

**Air Accidents Investigation Branch**

**Report on the accident to  
Sikorsky S-61N, G-BEID  
29 nm north east of Sumburgh,  
Shetland Isles  
on 13 July 1988**

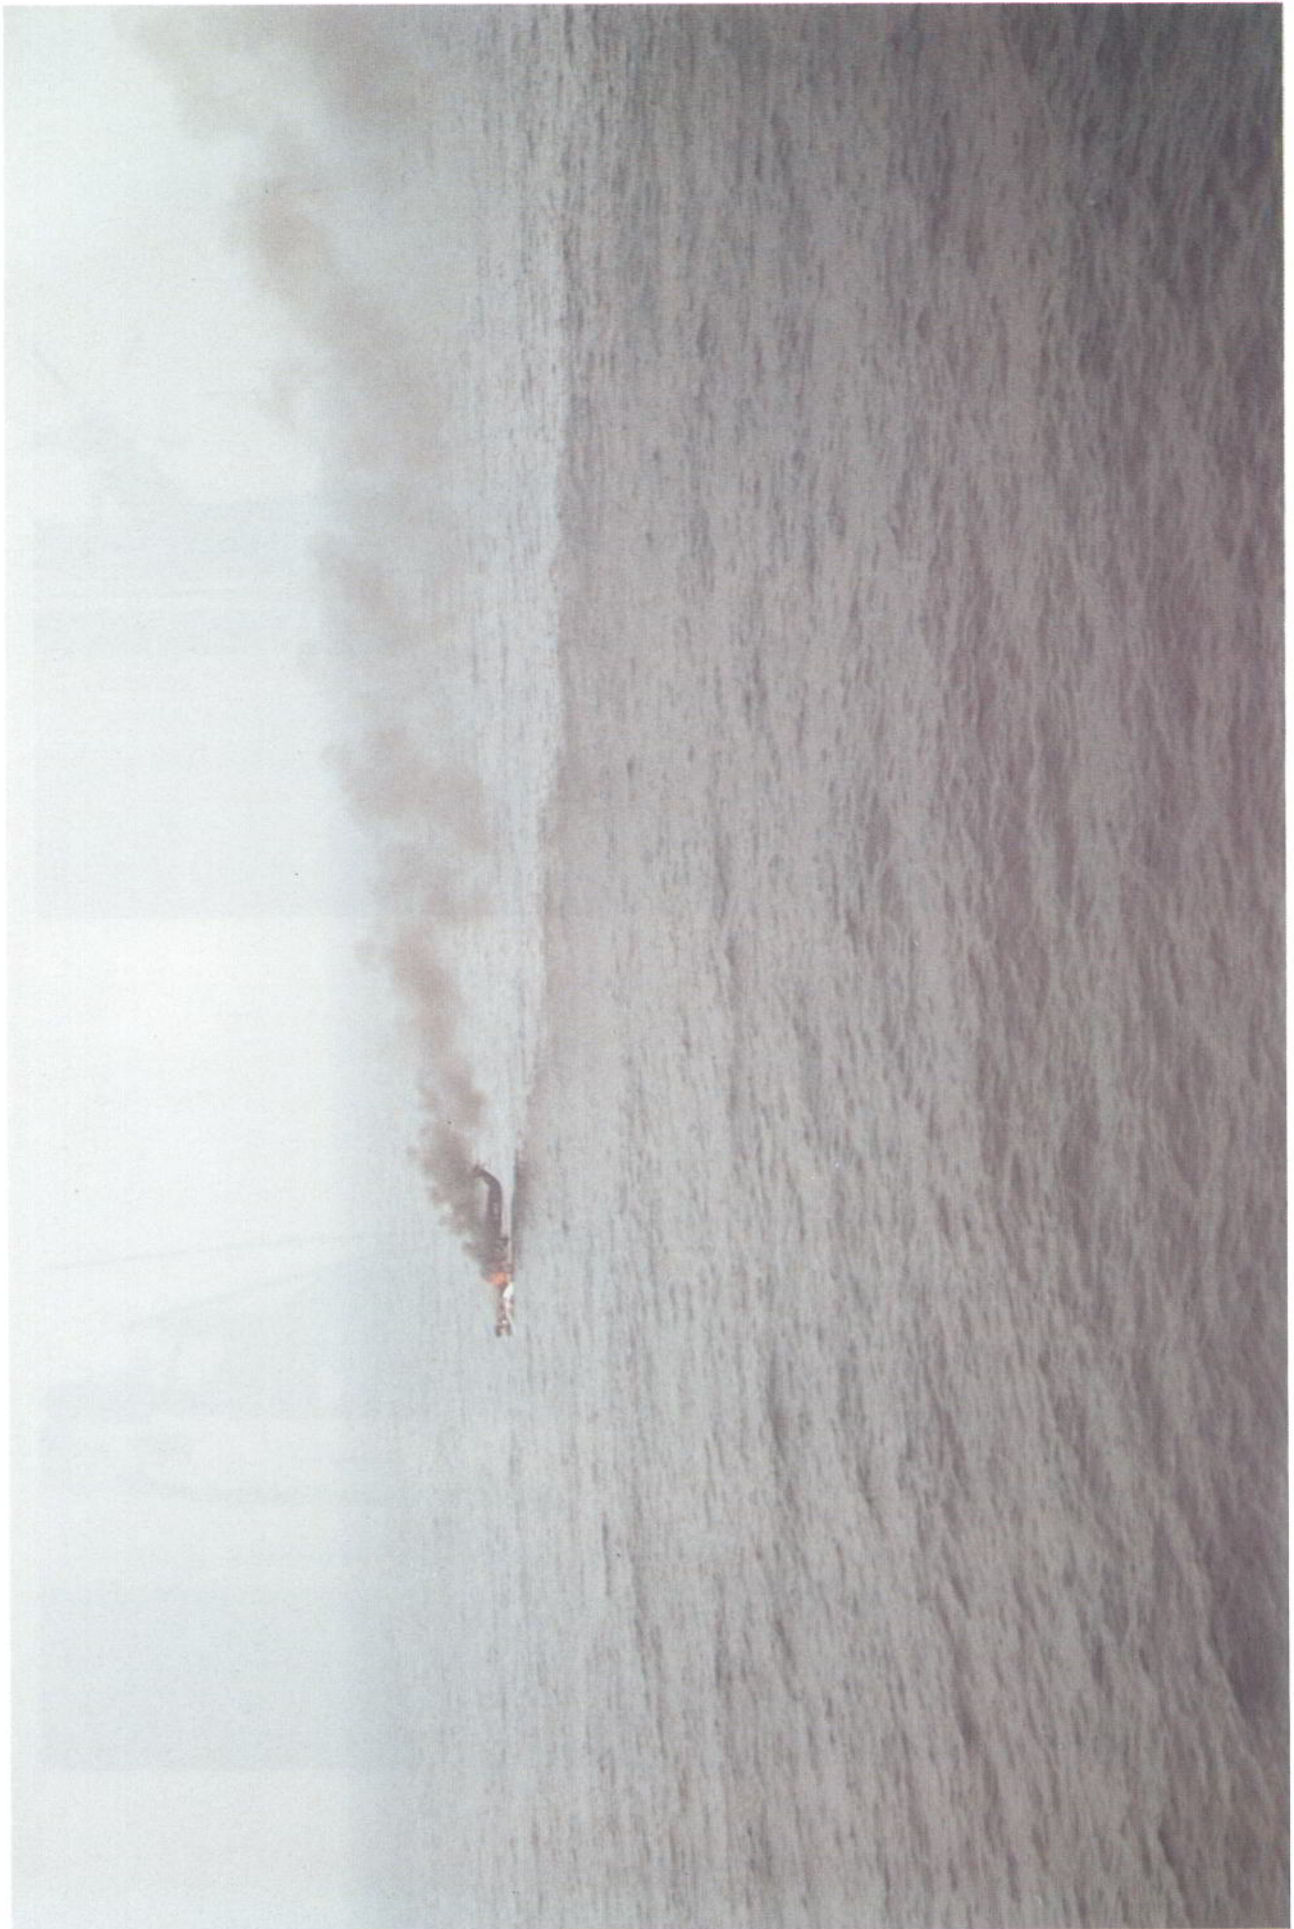
**G-BEID APPROXIMATELY 45 MINUTES AFTER DITCHING**

After ditching, ID drifted under the influence of tidal currents and wind with the fire growing. The fire spread within a few minutes into the cabin and about 15 minutes after touchdown the main rotor head and main transmission were seen to subside into the cabin. Approximately one hour after the ditching, when the fire had destroyed most of the fuselage structure above floor level, the remnants of the aircraft capsized and floated with only the tail boom above the sea surface. After an unknown period of flotation in this configuration, with the tail boom sustaining damage from a surface-borne fire, the fuselage remains parted at a position close to the attachment points of the main landing gear sponsons and the forward portion of fuselage sank to the seabed.
