ACCIDENT

Aircraft Type and Registration:	Piper PA-28-151 Warrior, G-BCTF	
No & Type of Engines:	1 Lycoming O-320-E3D piston engine	
Year of Manufacture:	1974 (Serial no: 28-7515033)	
Date & Time (UTC):	25 March 2012 at 1225 hrs	
Location:	Durham Tees Valley Airport, North Yorkshire	
Type of Flight:	Training	
Persons on Board:	Crew - 2	Passengers - None
Injuries:	Crew - None	Passengers - N/A
Nature of Damage:	Right main landing gear leg separated from the wing	
Commander's Licence:	Commercial Pilot's Licence	
Commander's Age:	79 years	
Commander's Flying Experience:	21,760 hours (of which 5,000 were on type) Last 90 days - 40 hours Last 28 days - 16 hours	
Information Source:	Aircraft Accident Report Form submitted by the pilot and further investigation by the AAIB

Synopsis

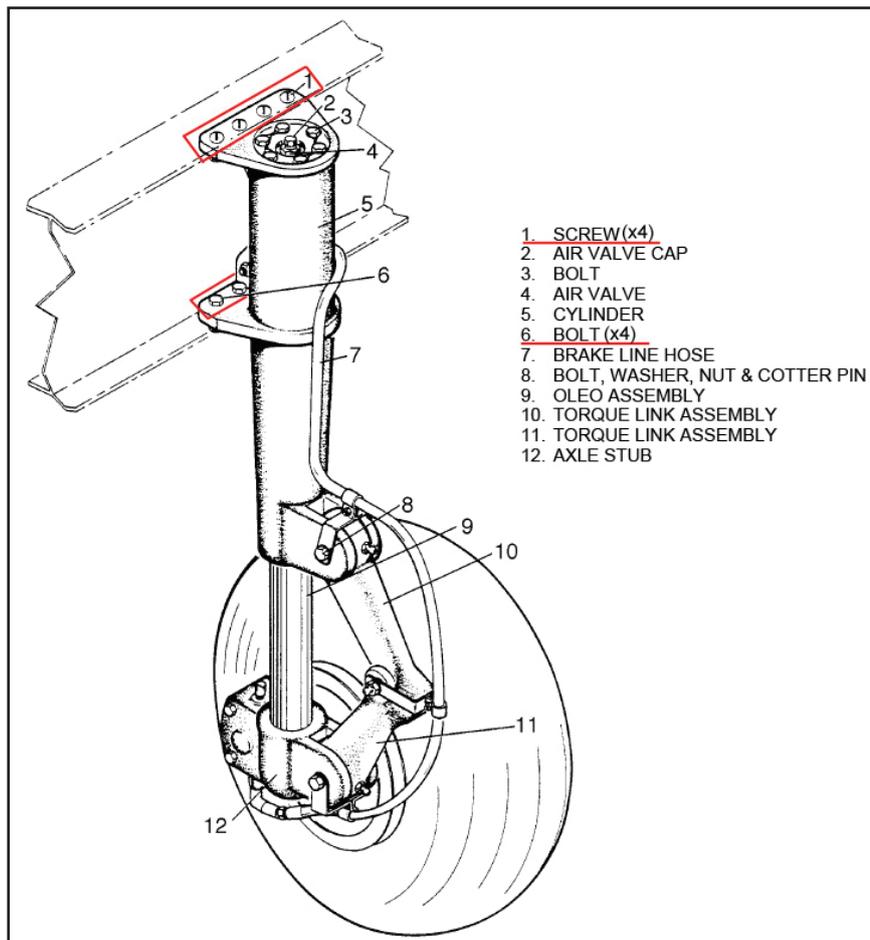
Figure 2

The right main landing gear leg was found to have separated from its wing spar attachment (Figure 1). After the aircraft was recovered it was examined by an engineering organisation. They determined that the landing gear leg had separated due to failure of the four upper screws and four lower bolts (items 1 and 6 in Figure 2) which secured the leg to the right wing main spar.

Diagram highlighting upper attachment screws and lower attachment bolts of the right main gear leg

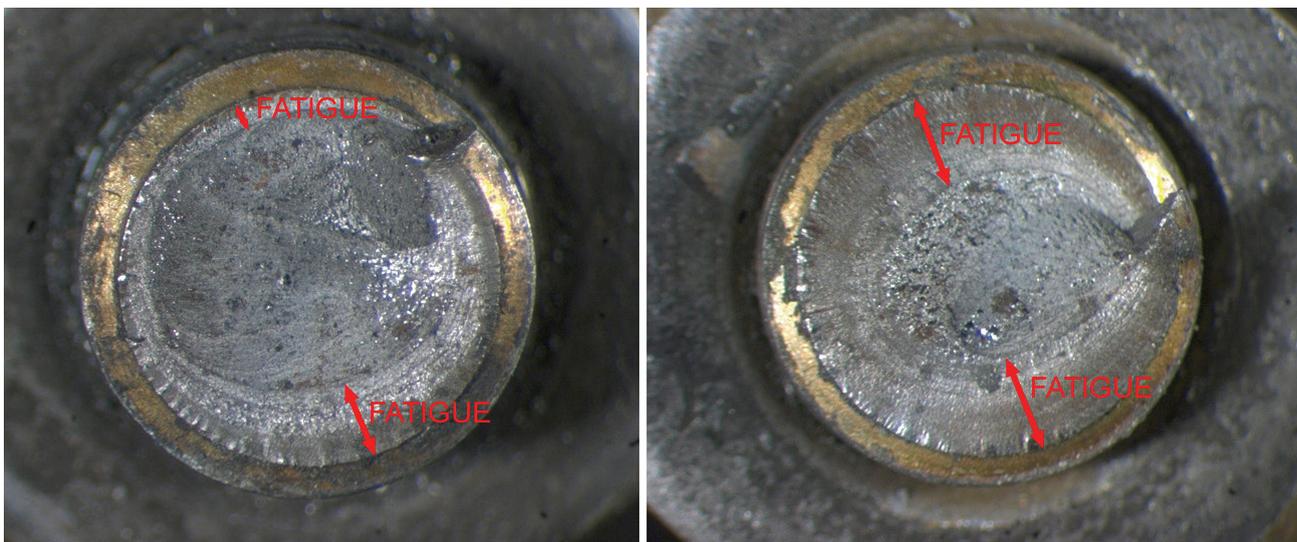
Figure 4

Some of the failed parts were lost during the recovery. Three of the upper screws (AN525-416-R20) were recovered and were found to have failed in overload at the screw head. One lower bolt (AN4-11A) was recovered which had a corroded head and a fracture at its thread, but the fracture surface was smeared so it was not possible to determine its failure mechanism. Two further bolt/screw ends were recovered which had failed at the thread just above the nut (Figure 3). The AN4 bolts and the AN525 screws have the same 4/16” diameter and use the same nut in this location so it was not clear if these failed ends were from the upper or lower attachment, but as there are only four AN525 screws and three were already accounted for, one of these failed ends was part of a lower attachment bolt. Both of these bolt ends had a fracture surface consistent with a fatigue failure (Figure 4).

Fracture surfaces of the failed bolt ends showing fatigue features at the thread

There was no evidence of corrosion on these fracture surfaces and the circumferential nature of the fatigue cracking indicated a combined tensile and bending load failure mode. Bending loads would have been

The gear attachment bolts had been visually inspected 35 hours prior to the accident, but a visual inspection would not have detected a slight loosening or any cracking above the nut. However, a torque check of the nuts would have detected if the bolts had loosened due to stretch and were susceptible to a fatigue failure. The aircraft manufacturer was asked to consider whether such a torque check should be part of the recommended maintenance schedule, but they stated that, given the size of the PA-28 fleet, there was insufficient evidence of a problem to warrant such a change.
