Boeing 727-46 G-BAEF

Take-off accident at Luton Airport on 21st June 1974

Analysis of Flight Recorder Data

**CAA-AD Research Note No. 14
B.727 G-BAEF. Take-Off
accident on 21 6 74:
Analysis of F.R. Data
Issue 3 : February 1975**

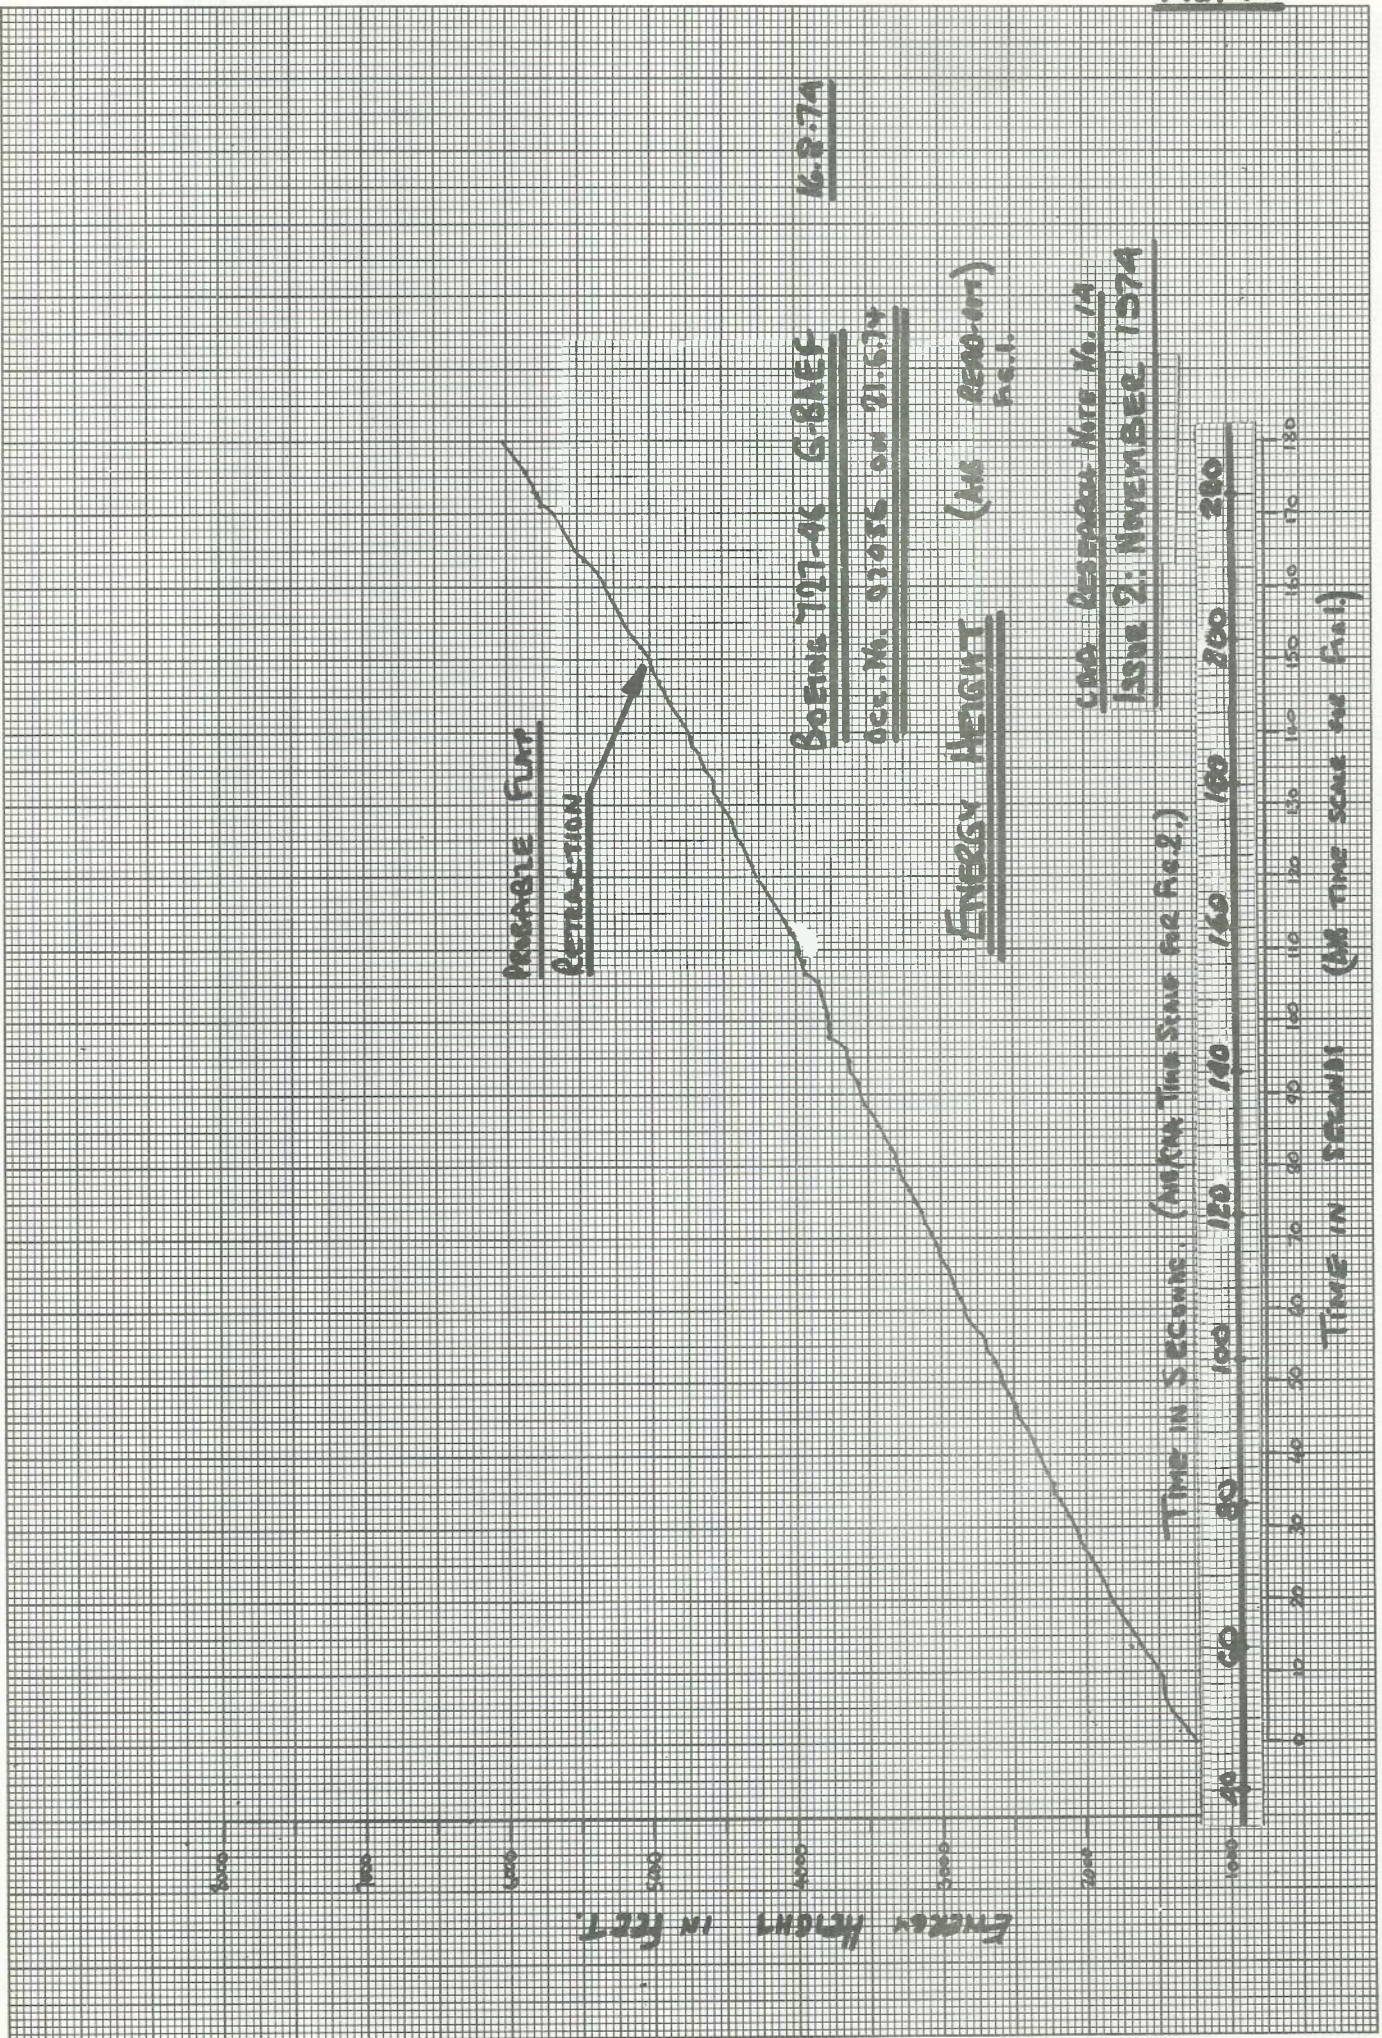
Energy Height, using the AIB read-out of Fig 1, was calculated and is shown in Fig 10. An increase in the slope of the line at time 197 secs is an indication of a change in the (Thrust-Drag) relationship. Assuming no thrust change then the implied drag change is consistent with a flap retraction from 15° to 5° . However, if there were no flap change then it is doubtful if the implied thrust change would be possible especially if the total drag had been increased by damage to the landing gear doors.

A reported engine power reduction at about Flight Recorder time 110 is not confirmed by the Energy Height plot.

F.P.R. TIME IN SECONDS FROM AIRBORNE STARTUP

ENERGY HEIGHT IN FEET
