ACCIDENT

Aircraft Type and Registration:	LS1F Glider, BGA4665	
No & Type of Engines:	None	
Year of Manufacture:	1976	
Date & Time (UTC):	9 August 2005 at 1725 hrs	
Location:	Near Husbands Bosworth Airfield, Leicestershire	
Type of Flight:	Private	
Persons on Board:	Crew - 1	Passengers - None
Injuries:	Crew - None	Passengers - N/A
	Others - 1 (Fatal)	
Nature of Damage:	Extensive damage to the left wing, left aileron separated from the wing and damaged right winglet	
Commander's Licence:	BGA Glider Pilot's Certificate (Gold and Three Diamonds)	
Commander's Age:	24 years	
Commander's Flying Experience:	692 hours (of which 317 were on type) Last 90 days - 111 hours Last 28 days - 46 hours	
Information Source:	AAIB Field Investigation

Synopsis

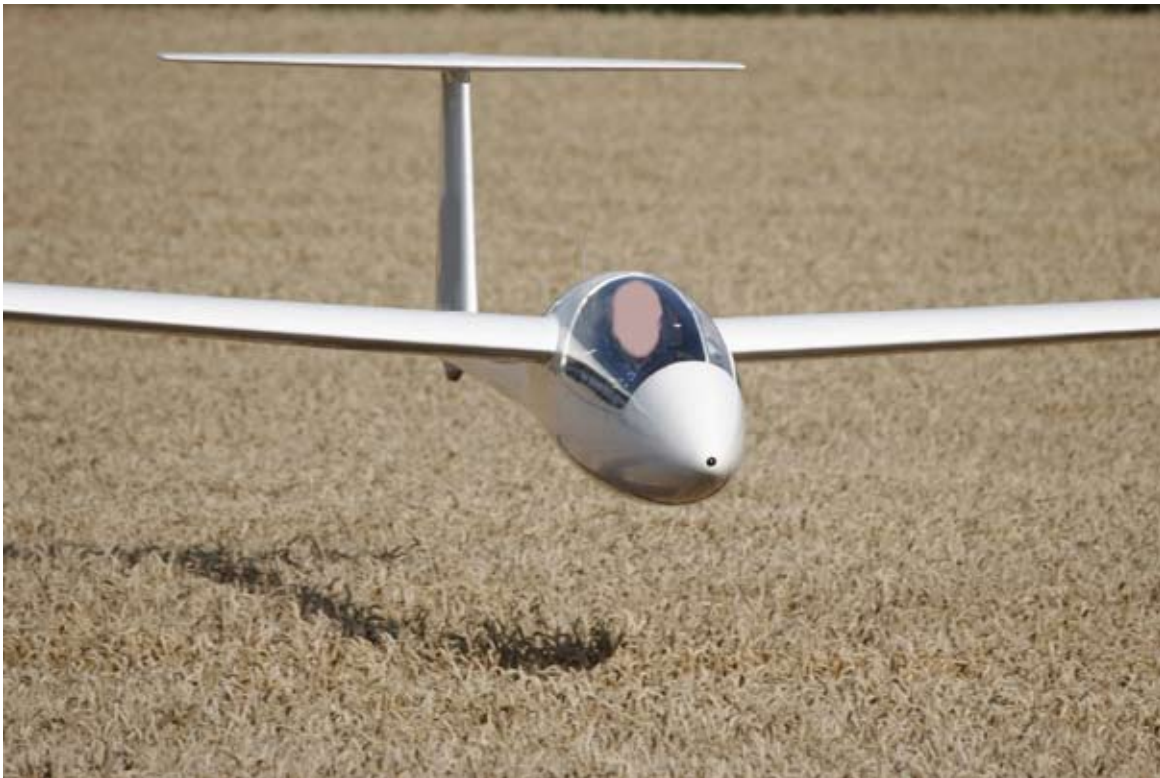
Figure 6

Photograph of an approaching glider

The last two photographs on the photographer's camera are of the glider that struck him. These, together with other video imagery, showed that he had the camera up to

his eye whilst the glider crossed the field in front of him. Video evidence showed the photographer was standing upright, ducking at the last moment before being struck by the glider's left wing.

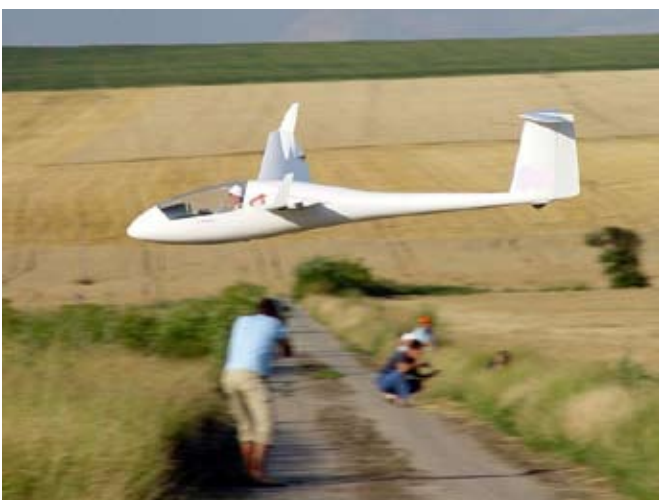
Figure 8

Glider and spectators

On the day of the accident, no attempt was made to control or influence the presence of spectators beneath the final approach path. Moreover, evidence was found of low flying in close proximity to people during the final approach phase of other international competitions. For instance, photographs published on the Internet of the 2005 FAI European Championships held overseas show spectators close to gliders in the late stages of the final glide to the finishing line. Two examples are shown in Figures 8 and 9 below; the gliders and their pilots in these examples have been deliberately disidentified.

It is not possible to determine from the photographs the distance of these spectators from the finish line but the

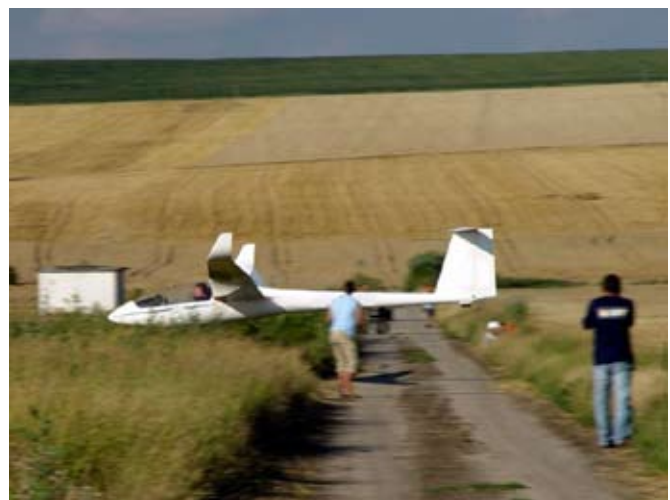
Figure 9

Glider and spectators
