Fragmentation and other damage features of the fan of No.1 engine from G-OBME

Aircraft Type and Registration:	Boeing 737-400, G-OBME	
No & Type of Engines:	2 CFM 56-3C high by-pass turbo-fan engines	
Year of Manufacture:	1988	
Date and Time (UTC):	8 January 1989 at 2025 hrs	
Location:	Kegworth, near East Midlands Airport, Leicestershire	
Type of Flight:	Scheduled passenger	
Persons on Board:	Crew - 8	Passengers - 117 + 1 infant
Injuries:	Crew - 7 (serious)	Passengers - 47 (fatal).
	1 (minor)	66 + 1 infant (serious)
		4 (minor)
Nature of Damage:	Aircraft destroyed	
Commander's Licence:	Airline Transport Pilot's Licence	
Commander's Age:	43 years	
Commander's Total Flying Experience:	13180 hours (of which 765 were on Boeing 737-300/400 types)	
Information Source:	AAIB Inspector's Investigation under the Civil Aviation (Investigation of Accidents) Regulations 1983

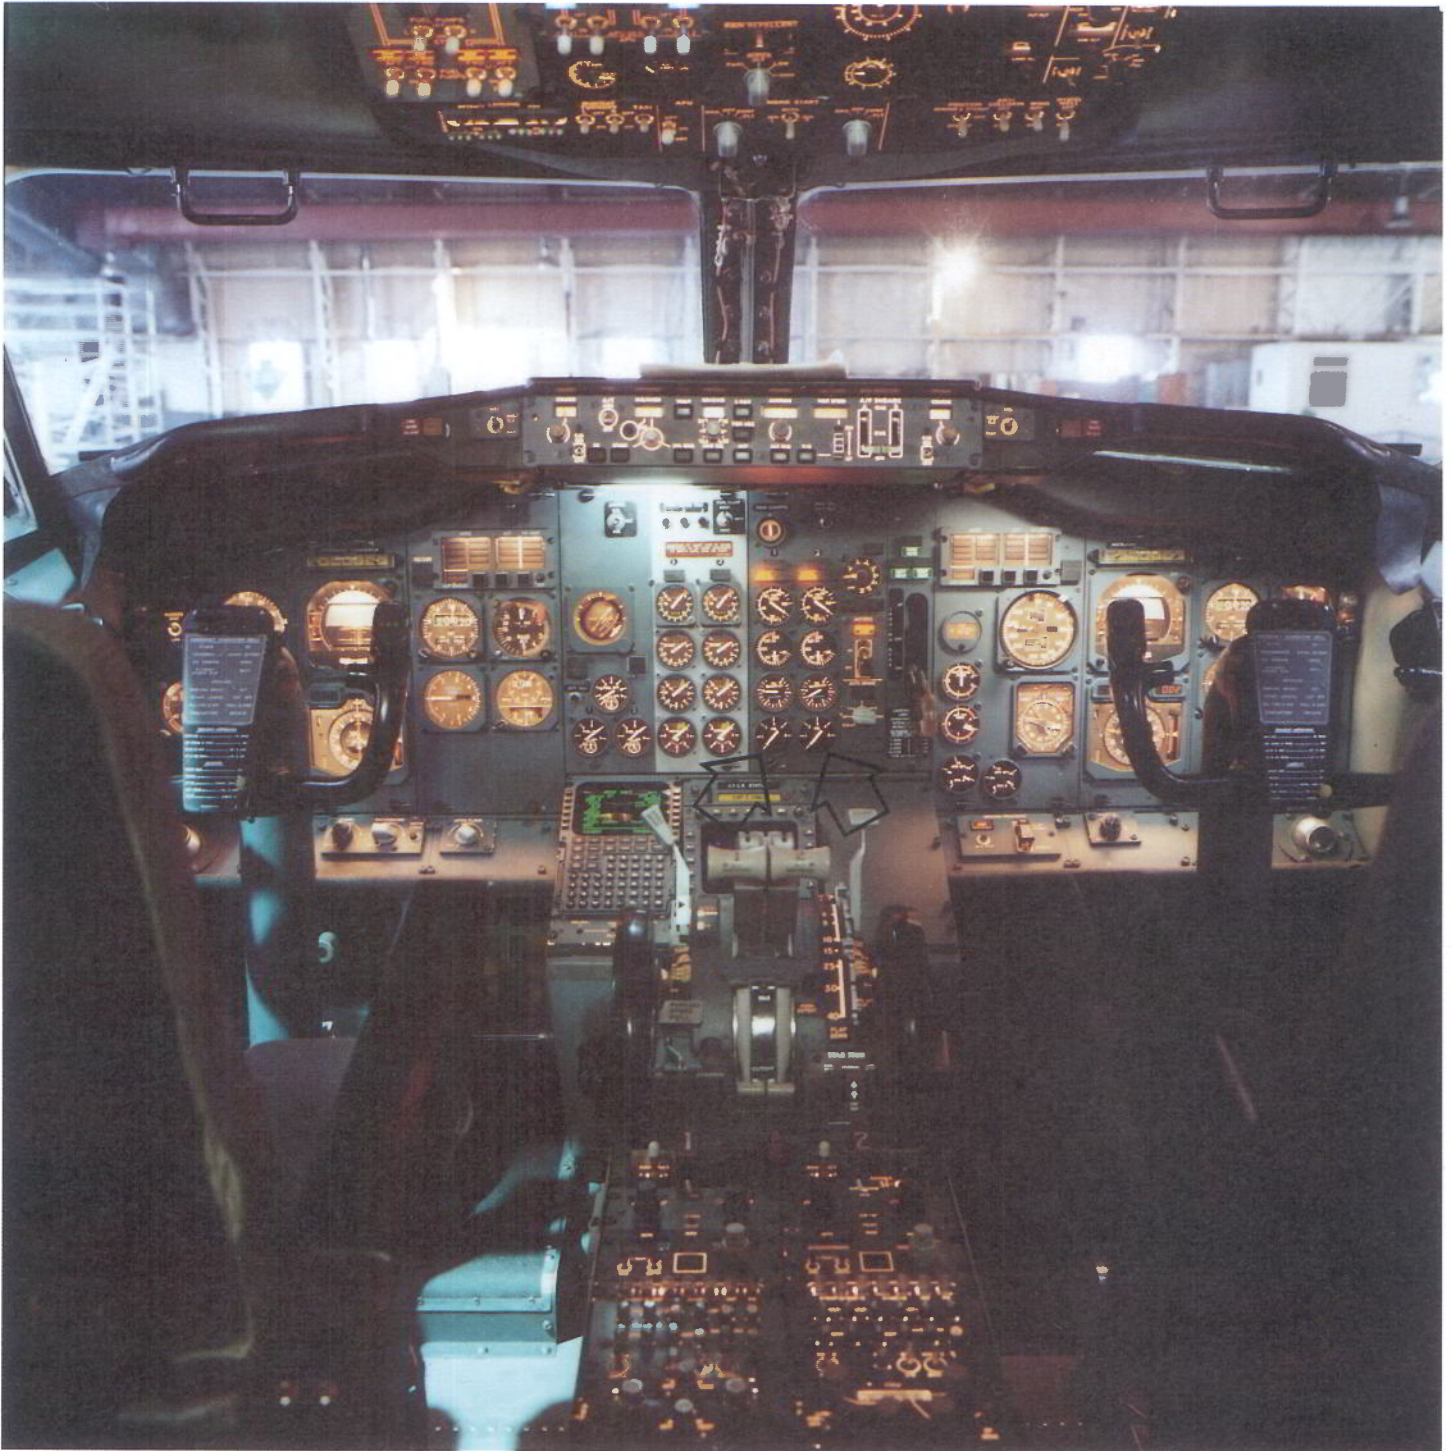
FIG 1: SHOWING HYBRID ELECTROMECHANICAL POINTER/LED COUNTER INSTRUMENTS USED FOR DISPLAY OF ENGINE PARAMETERS WITH VIBRATION INDICATORS ARROWED

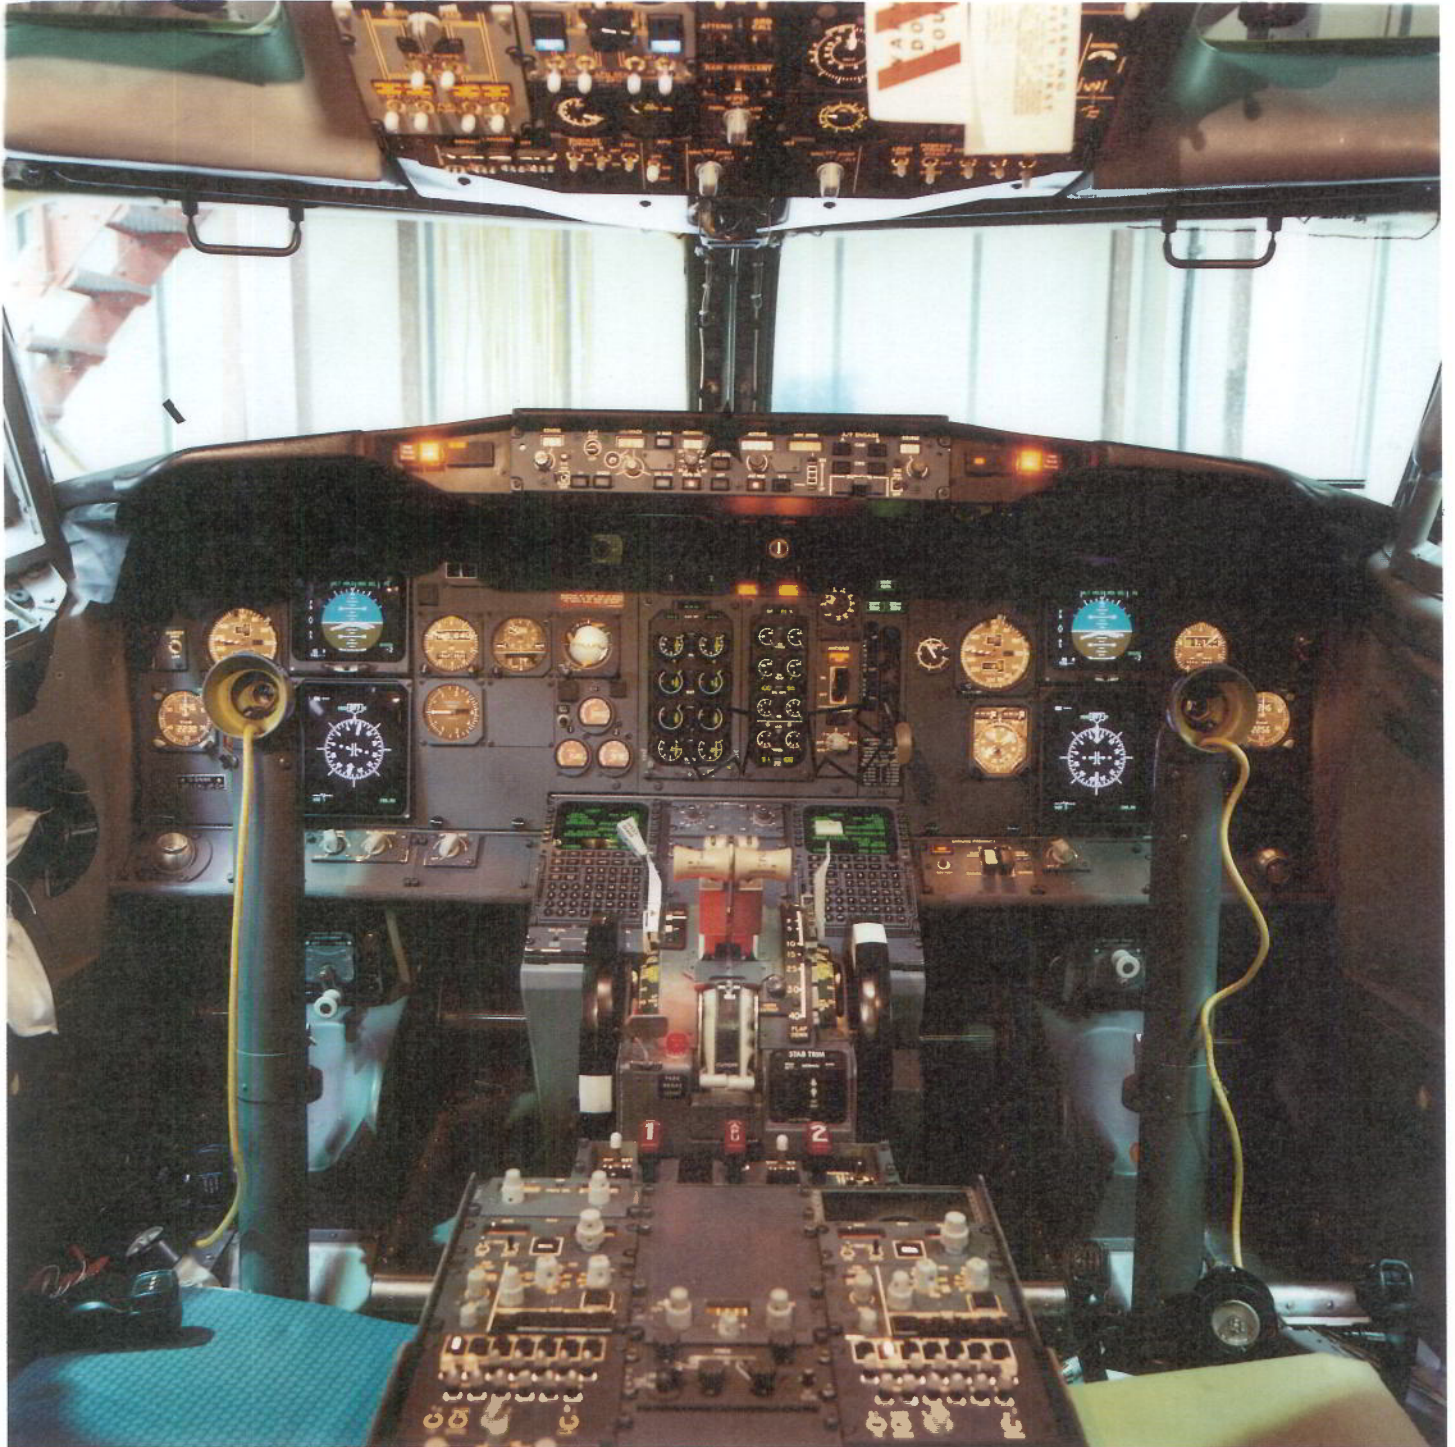
FIG. 2: SHOWING SOLID-STATE ELECTRONIC ENGINE INSTRUMENT SYSTEM (EIS), AS FITTED TO G-OBME, WITH VIBRATION INDICATORS ARROWED

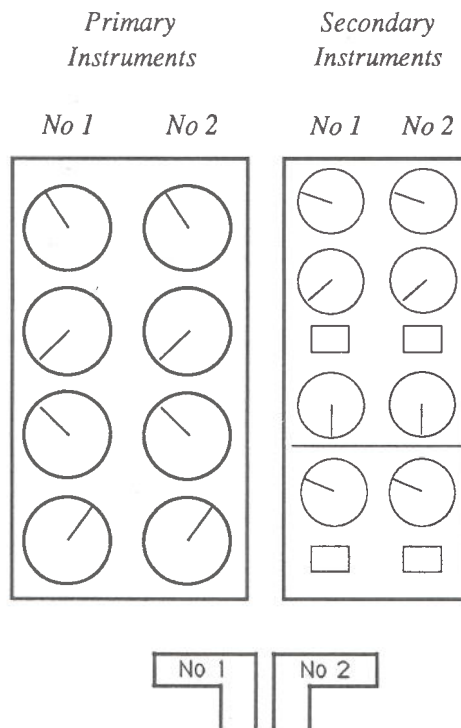
If the instruments are all to be located on the front panel, two possibilities are apparent. The first is to mount the secondary instruments to one side of the primary instruments as in Figure 2.

Figure 2 achieves the goal of keeping the instruments paired together, and thus maximises the chances of disparate readings being detected, but does so at the price of splitting up the instruments associated with a given engine, and of losing the advantage of having all instruments cognitively aligned with their corresponding throttle levers.

The layout of the EIS in the Boeing 737 Series 300/400 conforms to Figure 2, which has been widely used without apparent difficulty in many two-engined, two-pilot aircraft. The illumination of the display, however, might aggravate the problem of perceived misalignment of the instruments with their respective throttles. On the hybrid instruments (LED counters with electro-mechanical pointers) fitted to other aircraft of this type, the faces of the instruments needed to be lit from in front to show the pointers, dials and scale marks. Such lighting does not, of course, illuminate only the legends and pointers on the instruments but also the general structure and limits of the display, so that the instruments could be argued to be viewed within a structured visual frame. In the EIS display, all symbology is edge-lit and set against a heavily contrasting background which, in an aircraft at night will be, to all intents and purposes, black. This may have the effect of enhancing the extent to which the instruments are seen as a single display rather than as two separate displays, and may degrade the extent to which deviant readings in, say columns 1 and 3 of the matrix could readily be associated with the No 1 engine.

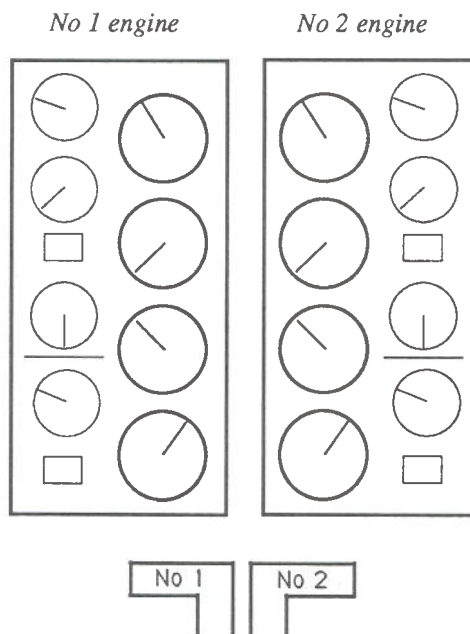
The second is to split the secondary instruments and mount them outboard of their respective primary instruments, as in Figure 3.

The advantage of the layout in Figure 3 is that the instruments for a given engine are all mounted together and are, if not spatially, at least cognitively, aligned with their associated power levers. This is achieved at the price of splitting the secondary instruments apart, with the associated possibility of disparate secondary readings going undetected.

Thus, Figure 3 could fairly be judged to maximise the probability that a given failure will be correctly identified by the crew as belonging to a given engine, at the possible cost of less efficient error detection on the secondary instruments, whereas Figure 2 may be judged as maximising the probability that disparate readings will be detected at the cost of degrading the probability that this detected failure will be associated by the crew with the correct engine.

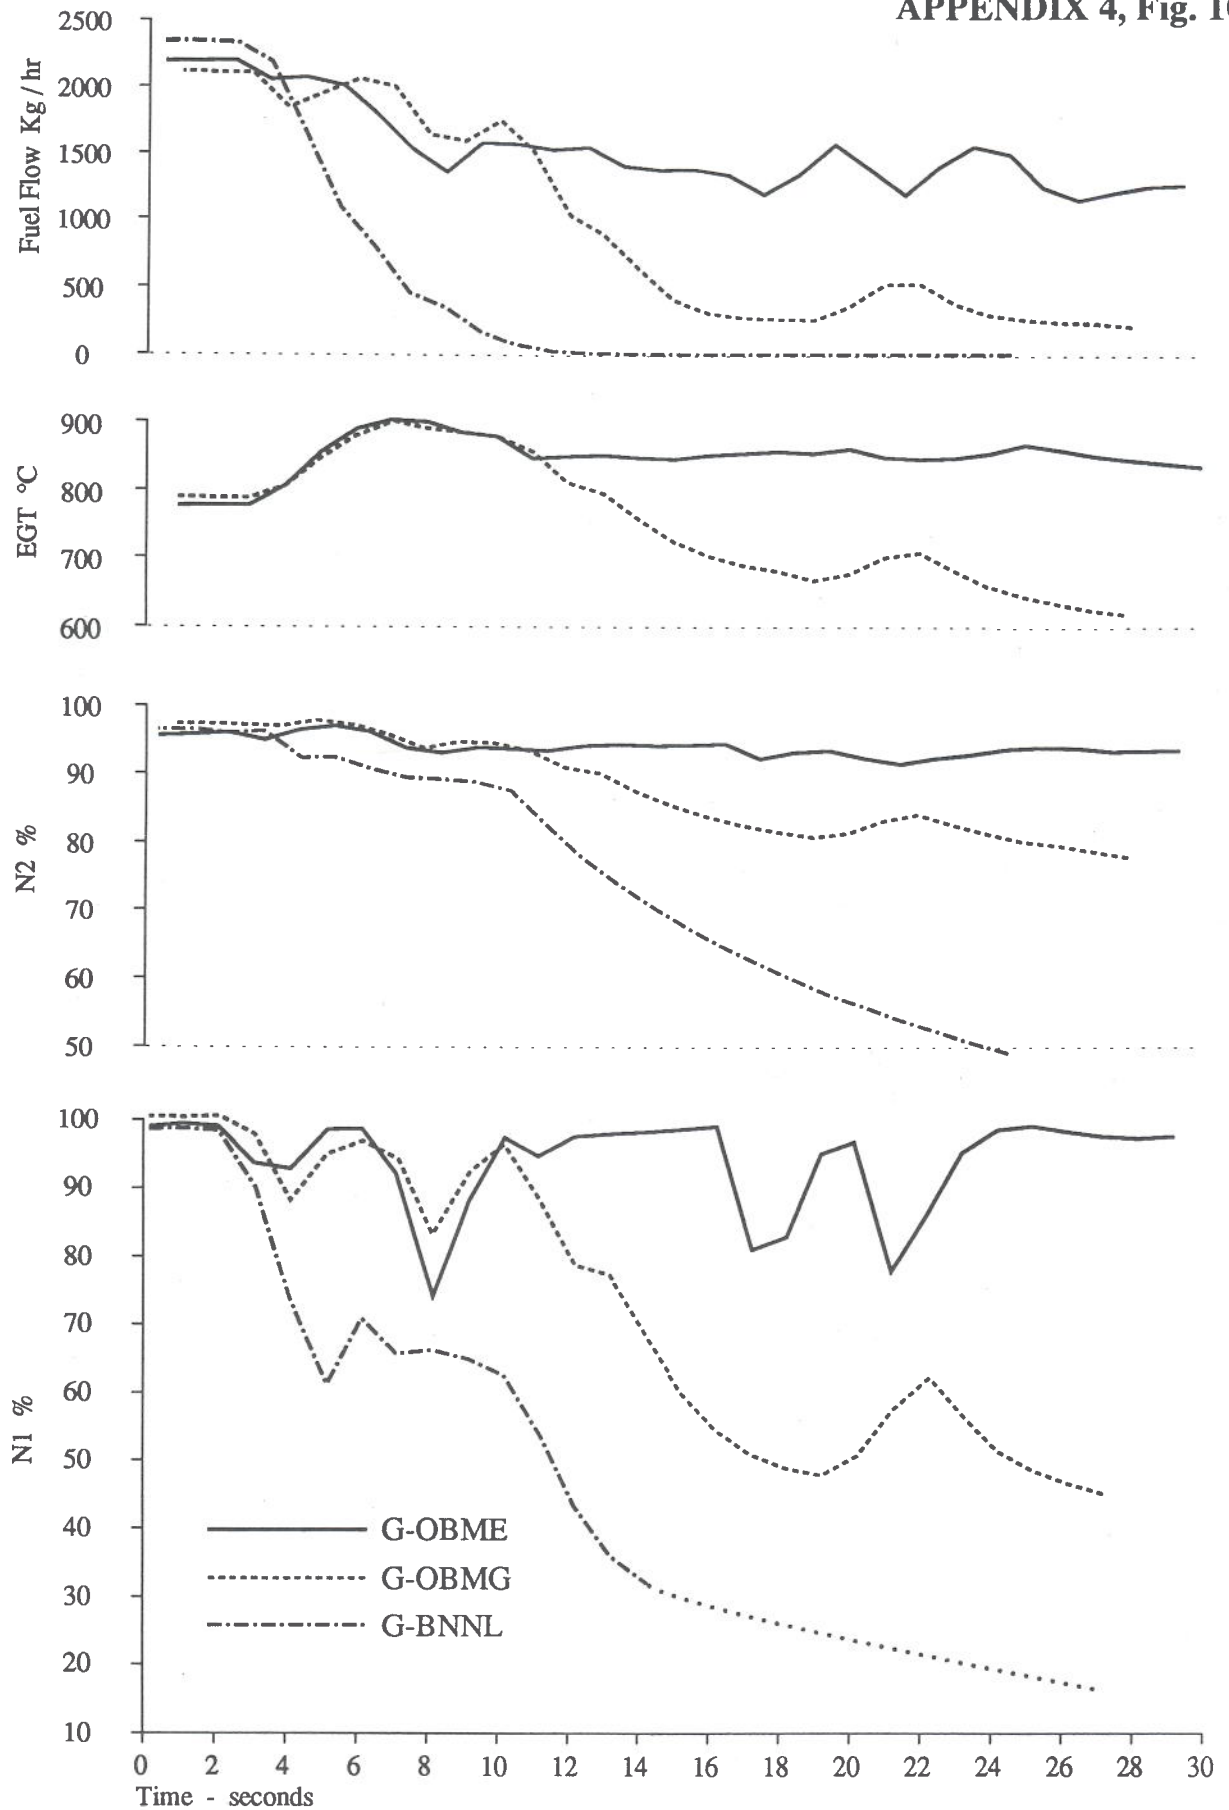
Comparison of engine parameter response following fan blade outer panel separation on three aircraft (G-OBME, G-OBMG, G-BNNL)

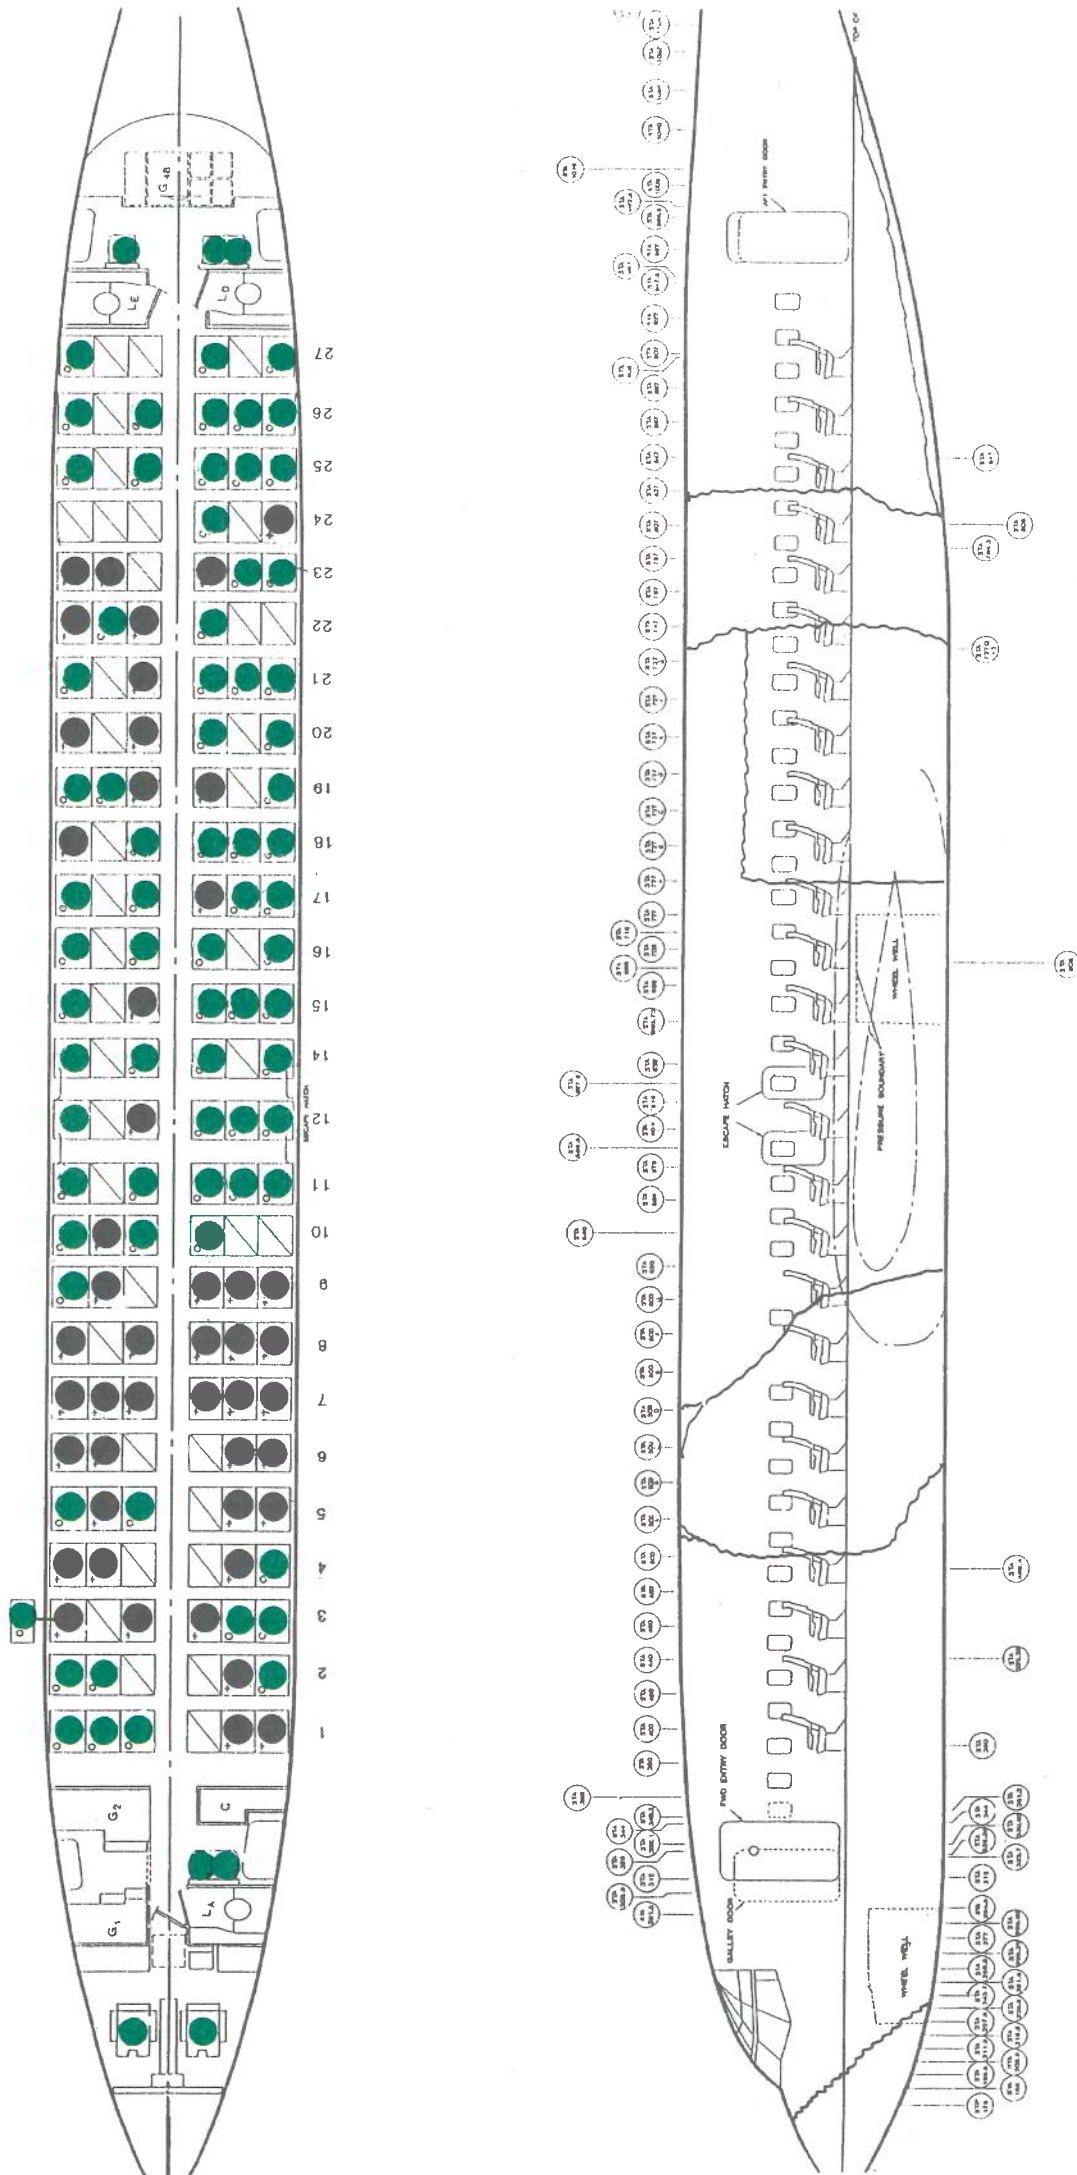
FIG 1: SHOWING SEAT POSITIONS OF FATALITIES AND SURVIVORS

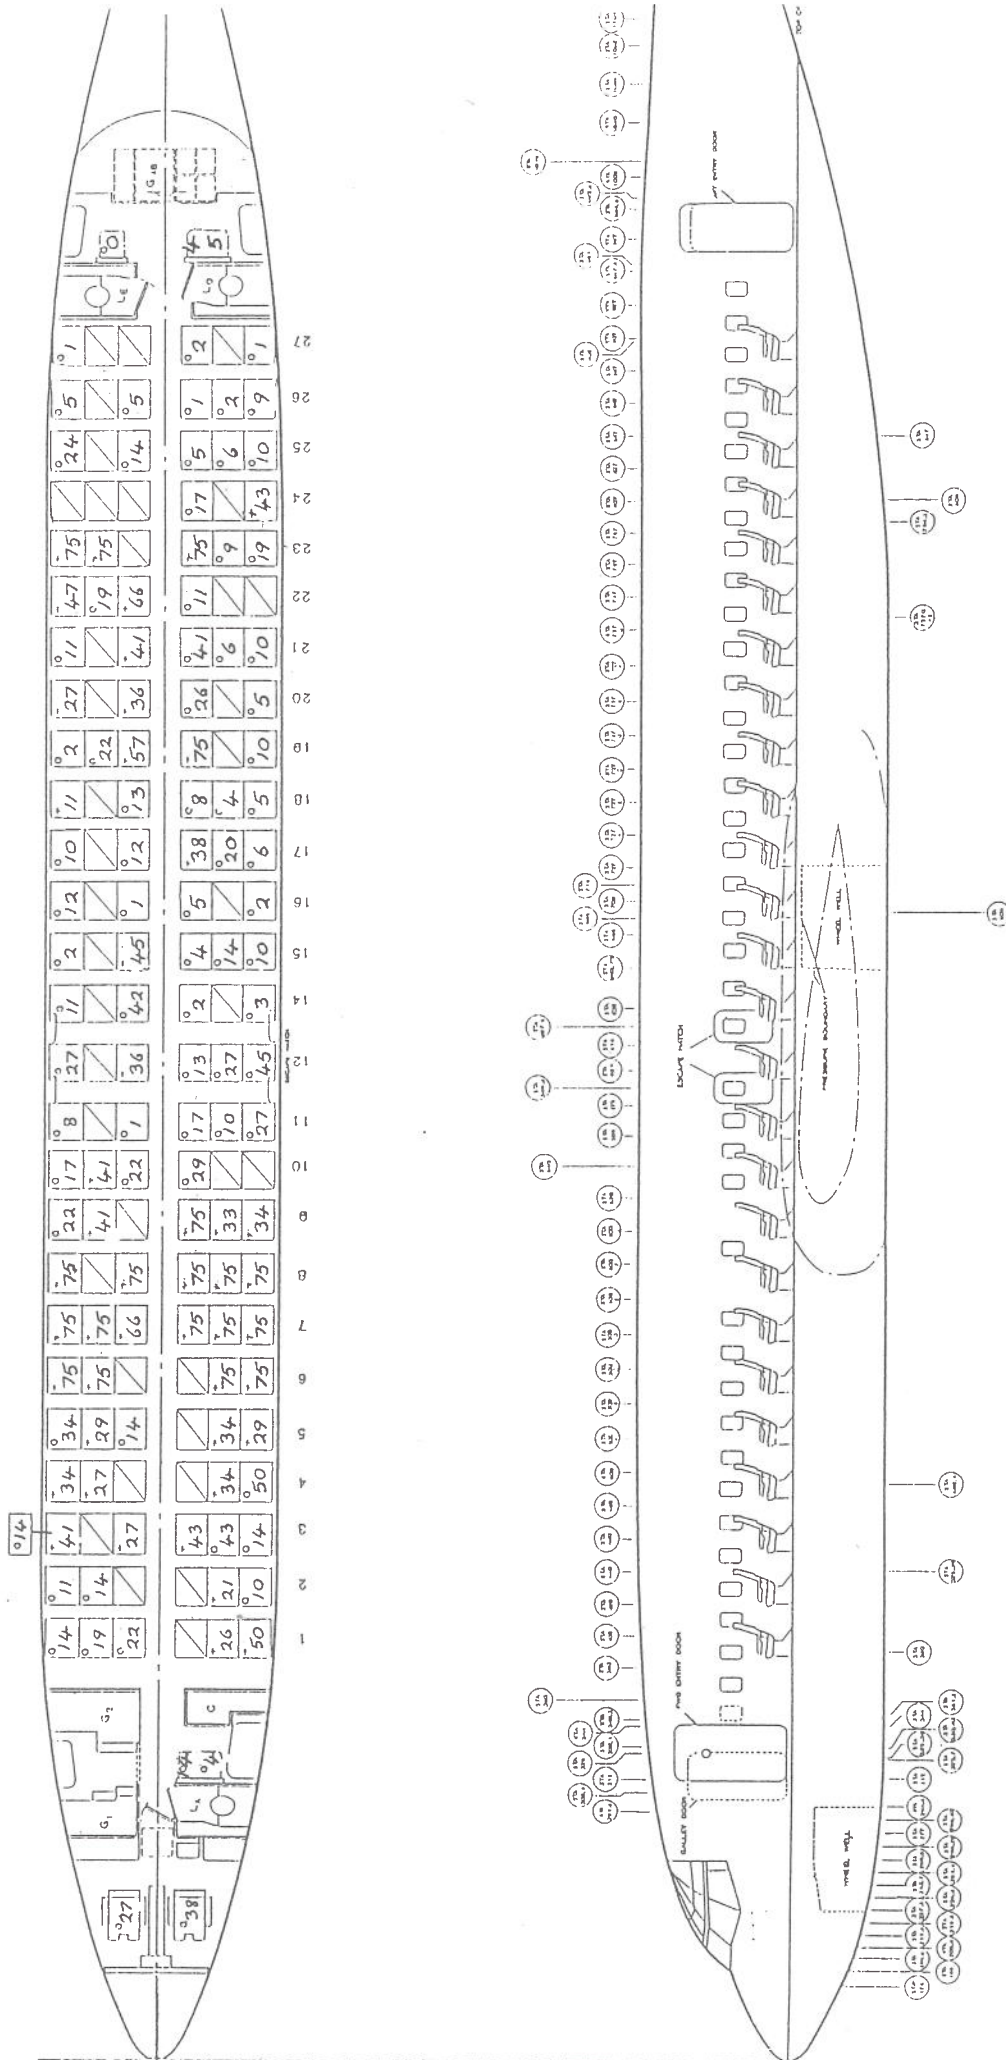
FIG 2: SHOWING INJURY SEVERITY SCORES FOR OCCUPANTS

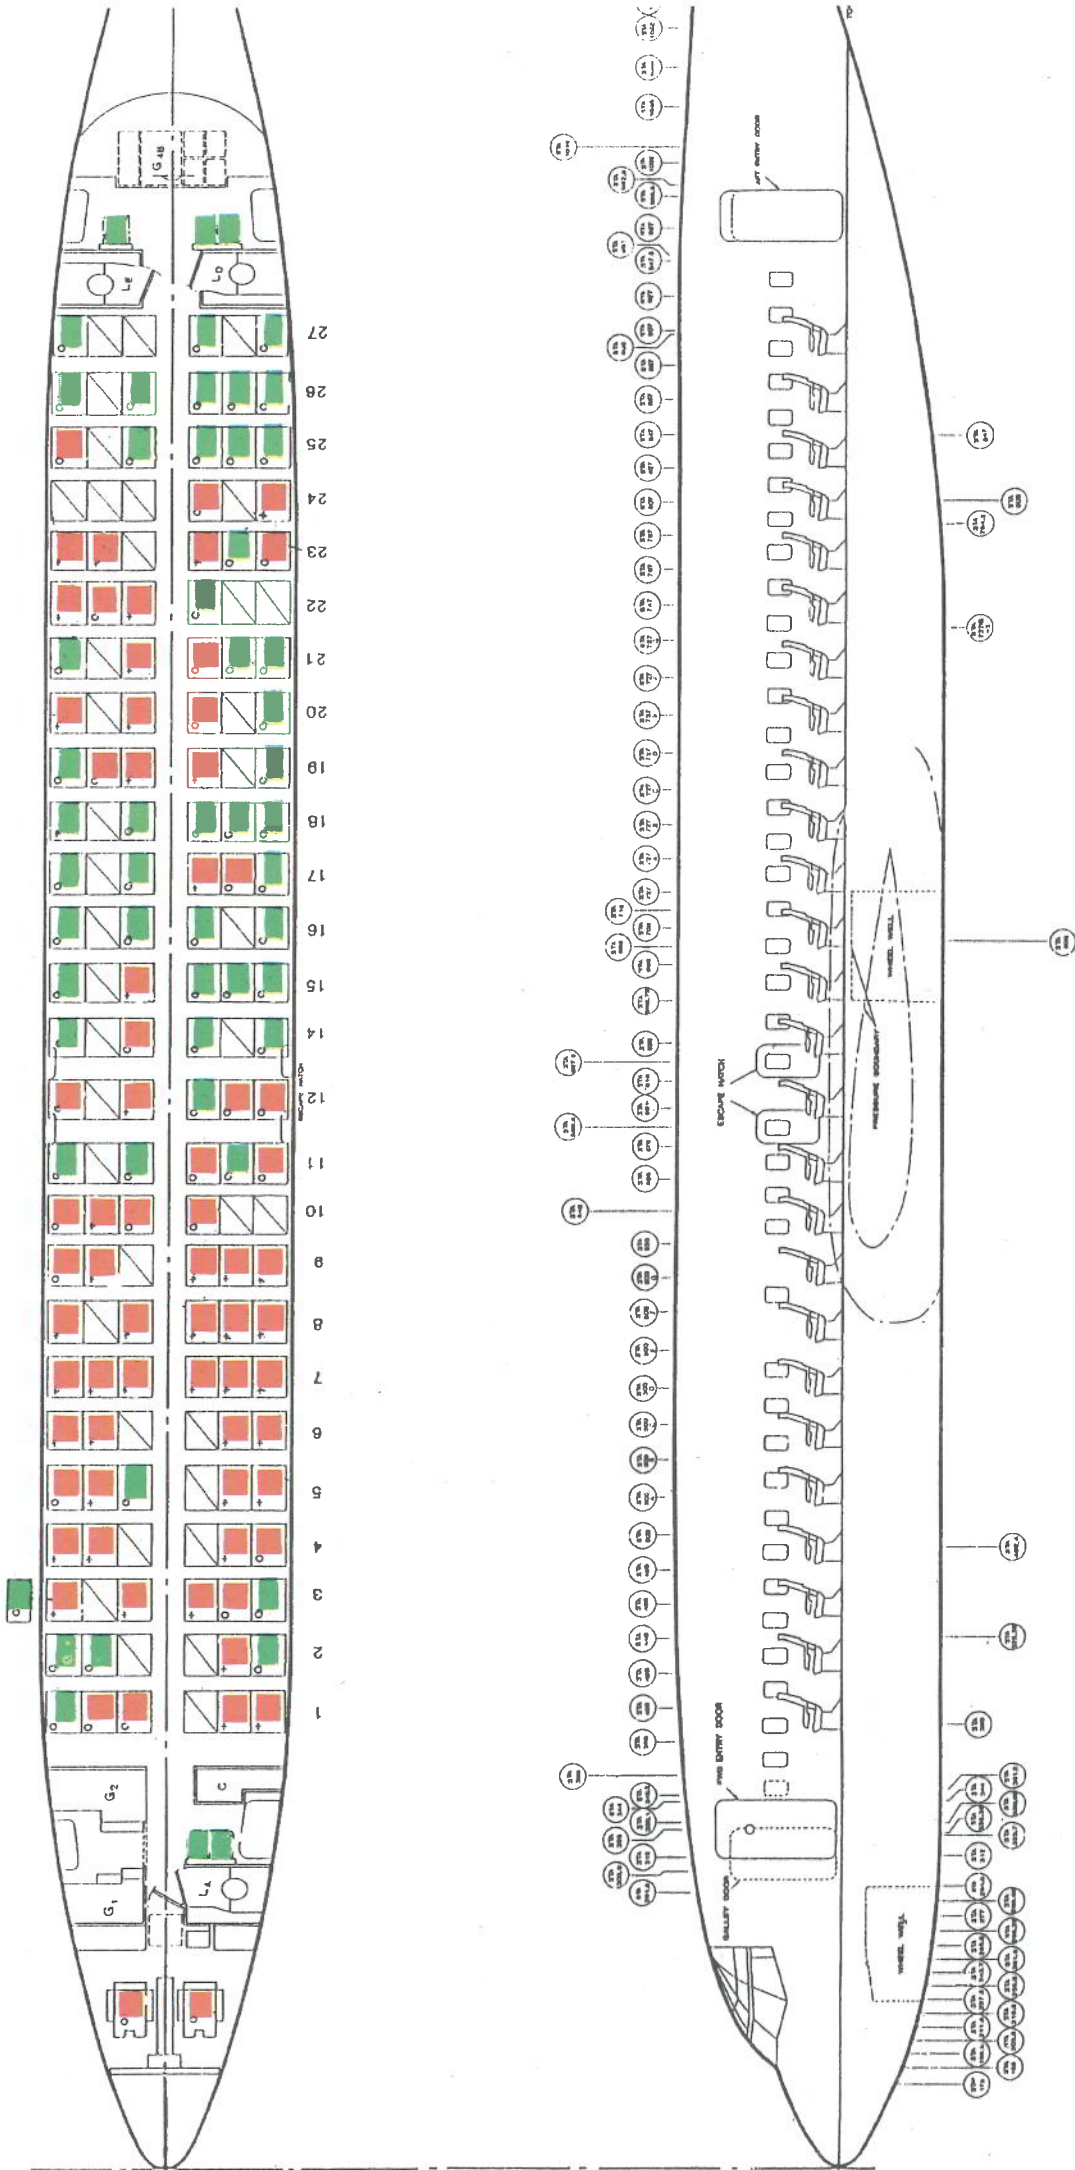
FIG 3: SHOWING DISTRIBUTION OF INJURY SEVERITY
