ACCIDENT

Aircraft Type and Registration:	Boeing 767-324, G-OOBK	
No & Type of Engines:	2 General Electric CO CF6-80C2B7F turbofan engines	
Year of Manufacture:	1995	
Date & Time (UTC):	3 October 2010 at 0536 hrs	
Location:	Bristol Airport	
Type of Flight:	Commercial Air Transport (Passenger)	
Persons on Board:	Crew - 12	Passengers - 258
Injuries:	Crew - None	Passengers - None
Nature of Damage:	Significant structural damage to fuselage crown skins	
Commander's Licence:	Airline Transport Pilot's Licence	
Commander's Age:	49 years	
Commander's Flying Experience:	14,433 hours (of which 1,355 were on type) Last 90 days - 225 hours Last 28 days - 92 hours	
Information Source:	AAIB Field Investigation

Synopsis

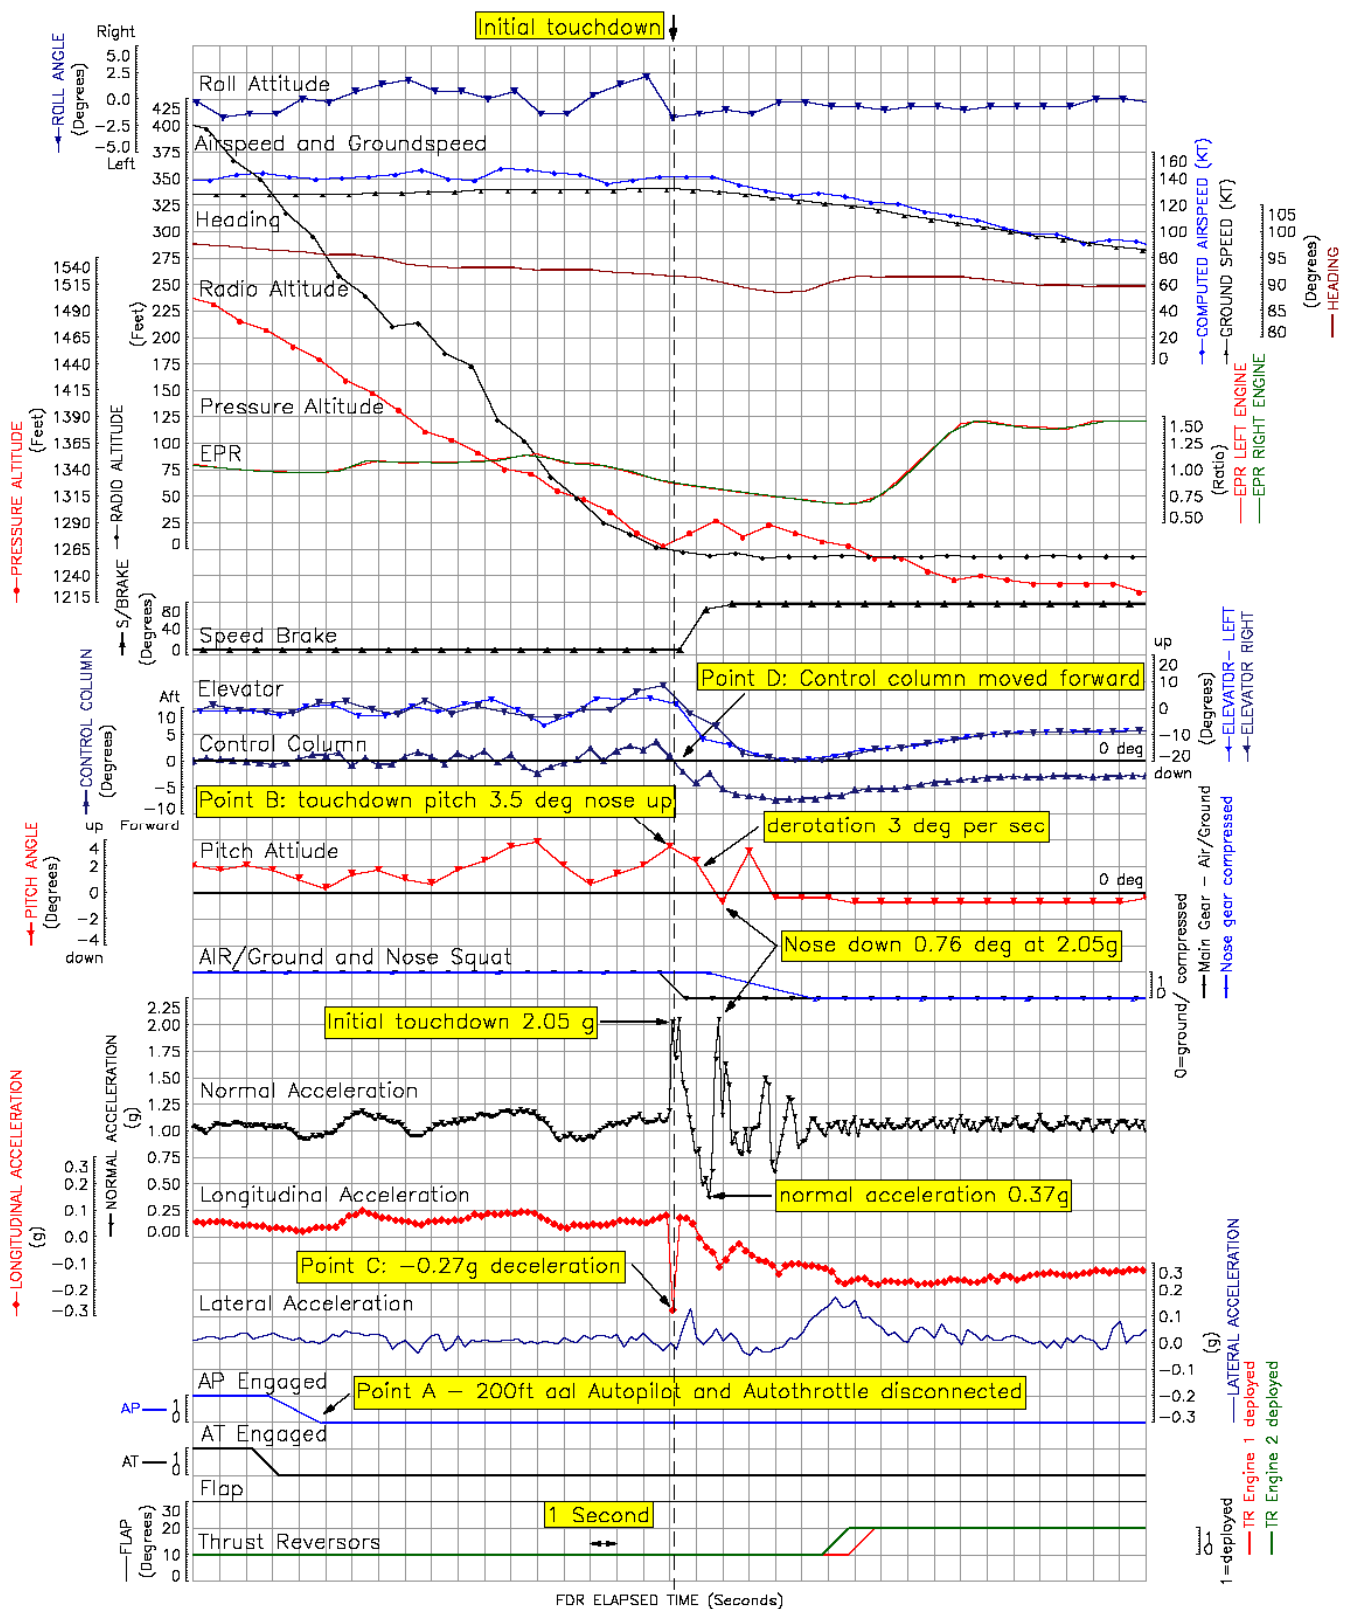
Figure 2

As the aircraft descended through 200 ft aal, the autothrottle and autopilot were manually disconnected (Figure 2 point A). The airspeed was 141 kt at the time and the wind calculated by the FMC was from 138° at 25 kt. At approximately 120 ft aal, there was a slight increase in engine EPR and the airspeed also increased from 138 kt to 146 kt. At about the same time, the aircraft pitch attitude increased from 2.5° to just less than 4° nose up. This was followed by a momentary nose down input on the control column and a coincident reduction in engine EPR.

(Figure 2 point B). However, there was only a gradual reduction in the rate of descent before the aircraft touched down on the main landing gear, registering a peak normal load of 2.05g. The aircraft weight calculated by the FMC was 271,000 lb (~123,000 kg) and the airspeed was 141 kt.

Coincident with the touchdown of the main landing gear, a momentary longitudinal deceleration of -0.27g was recorded (Figure 2 point C). Less than 0.5 second later, the control column was recorded as having been moved rapidly to a nose down position (Figure 2 point D)⁵. The spoilers also started to deploy at this time. The aircraft then became 'light' on its main landing gear whilst also de-rotating in pitch at about three degrees per second. At a nose down pitch attitude of just less than 1°, a normal load of 2.05g was recorded as the nose gear contacted the runway. The aircraft then rapidly pitched up and down, from between 3° nose up to just less than 0.5° nose down (indicating bouncing of the nose gear), before the aircraft eventually settled on the landing gear.

Final approach and landing at Bristol Airport Runway 09

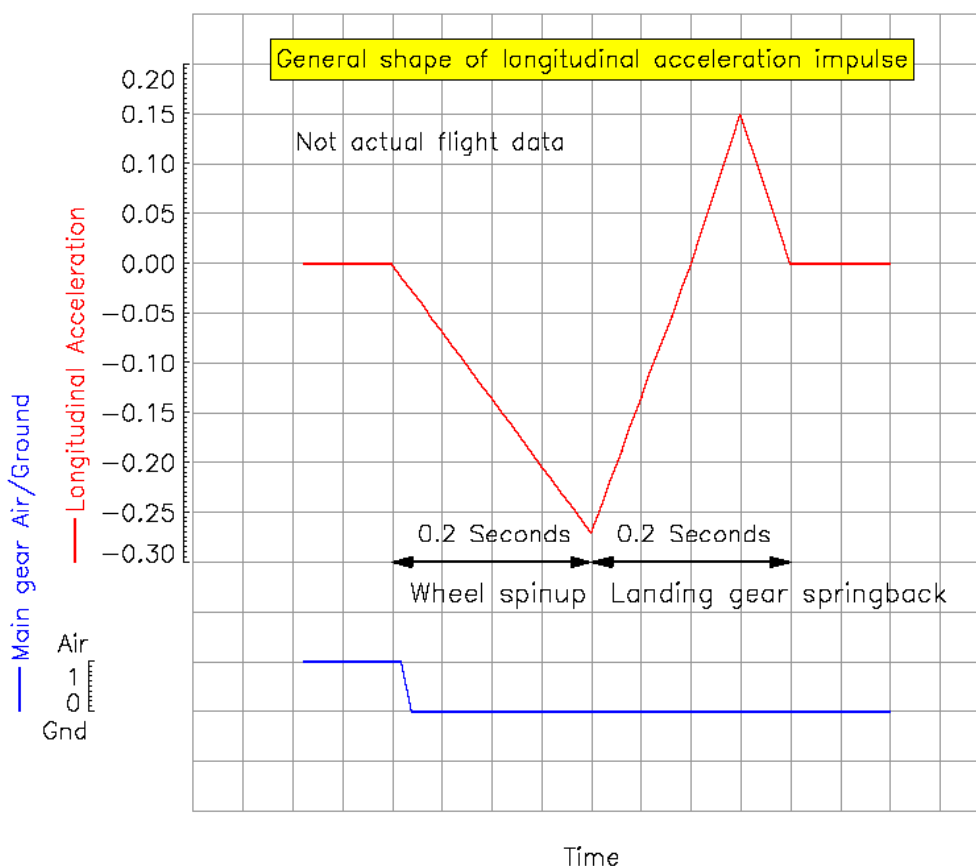
At touchdown, the aircraft will experience a short duration longitudinal deceleration impulse as a function of tyre spin-up and subsequent landing gear assembly spring-back. During flight testing of the Boeing 767, longitudinal acceleration was recorded at fifty times per second from a sensor installed in the forward equipment bay, which is near to the cockpit. Each of the landings contained a longitudinal impulse coincident with main landing gear touchdown. Further, the manufacturer had observed similar records of a longitudinal impulse during analysis of lower sample rate FDR data. From a sample of five flight test landings, the maximum longitudinal deceleration impulse was approximately -0.27 g, which was recorded during a touchdown measuring a peak normal acceleration of about 2.1g. The lowest amplitude impulse was about 0.15 g, which occurred during a touchdown having a peak normal acceleration of approximately 1.3 g. The total duration of the impulse was typically 0.4 seconds, with 0.2 seconds being attributed to wheel spin-up and 0.2 seconds landing gear assembly spring-back. Figure 3 depicts the general shape of the longitudinal impulse based on the five flights provided to the AAIB. The manufacturer further advised:

'insufficient magnitude and duration to cause a pilot to be thrown forward with sufficient force so that the control column would be inadvertently held in a nose down position.'

General shape of longitudinal acceleration impulse at touchdown

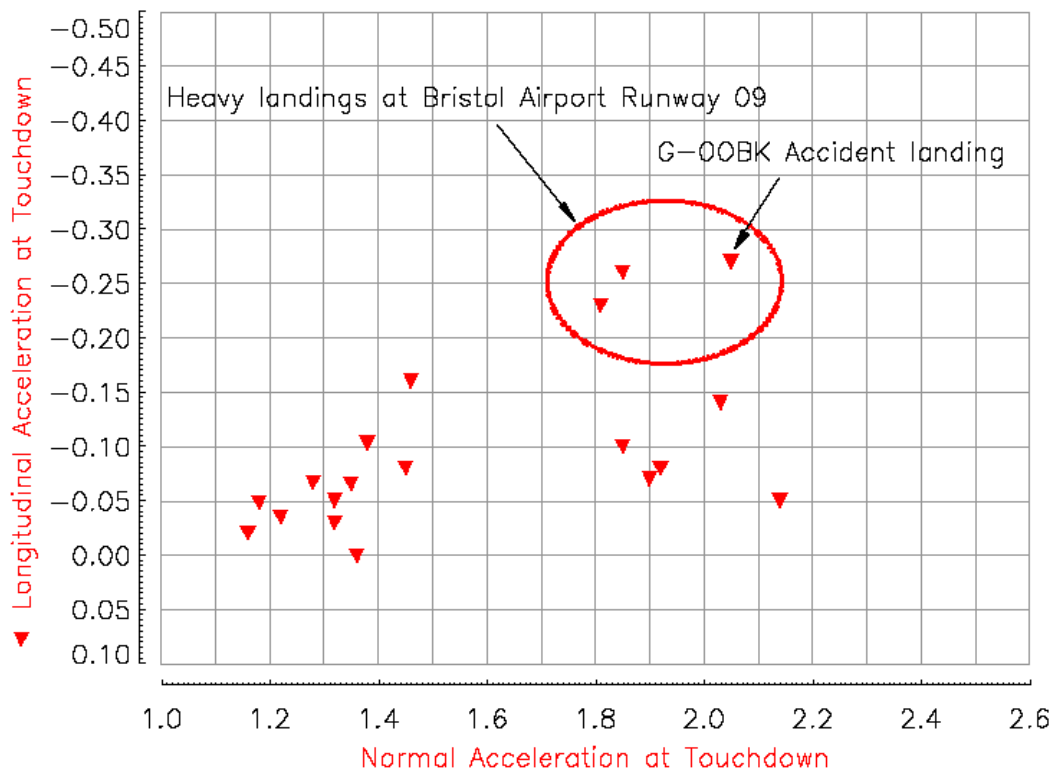
Figure 4

longitudinal deceleration at touchdown and runway gradient, although the three highest recorded values of longitudinal deceleration all occurred during landings at Bristol Airport (Figure 4). None of the hard landings, except that on the accident flight, exhibited rapid de-rotations after the initial touchdown.

Peak normal and longitudinal acceleration at touchdown
