**INCIDENT**

<b>Aircraft Type and Registration:</b>	DHC-8-402 Dash 8, G-JEDR	
<b>No &amp; Type of Engines:</b>	2 Pratt & Whitney Canada PW150A turboprop engines	
<b>Year of Manufacture:</b>	2003	
<b>Date &amp; Time (UTC):</b>	3 March 2011 at 1255 hrs	
<b>Location:</b>	Exeter Airport	
<b>Type of Flight:</b>	Commercial Air Transport (Passenger)	
<b>Persons on Board:</b>	Crew - 4	Passengers - 39
<b>Injuries:</b>	Crew - None	Passengers - None
<b>Nature of Damage:</b>	Right main landing gear inboard wheel detached	
<b>Commander's Licence:</b>	Airline Transport Pilot's Licence	
<b>Commander's Age:</b>	58 years	
<b>Commander's Flying Experience:</b>	6,778 hours (of which 3,417 were on type) Last 90 days - 103 hours Last 28 days - 24 hours	
<b>Information Source:</b>	AAIB Field Investigation

**Synopsis**

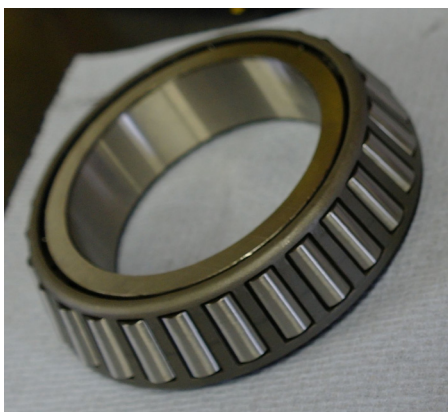
**Figure 4**

Each wheel bearing consists of a cup located in the wheel and an inner cone, roller and cage assembly which locates on the axle, Figure 4. The bore of the outer bearing cone is of a slightly smaller diameter than the inner bearing to prevent misassembly. The rollers and cups are common to both bearings. The bearings are lubricated on installation with specified high quality grease.

New wheel bearing cone assembly showing rollers located in the cage

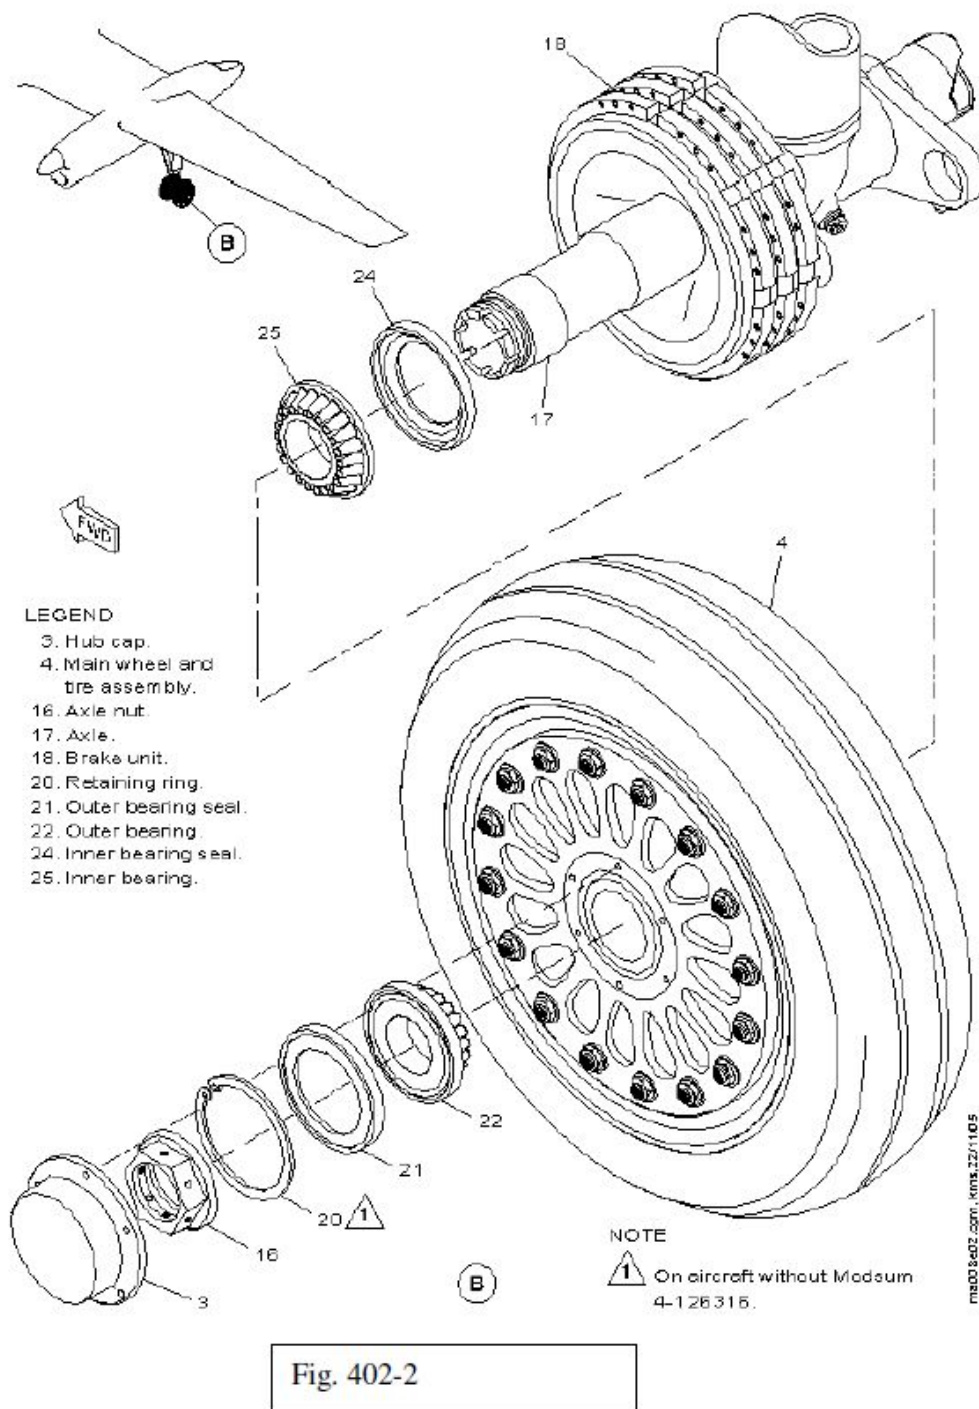
**Figure 3**

Each mainwheel is fitted with a pair of taper roller bearings arranged with their smaller rolling diameter towards the centre of the wheel. Figure 3 shows the general arrangement of the mainwheel, brake unit and bearings.

General arrangement of the mainwheel and bearings
