AIRCRAFT ACCIDENT REPORT 3/2005

**Report on the serious incident to
Boeing 757-236, G-CPER
on 7 September 2003**

Air Accidents Investigation Branch

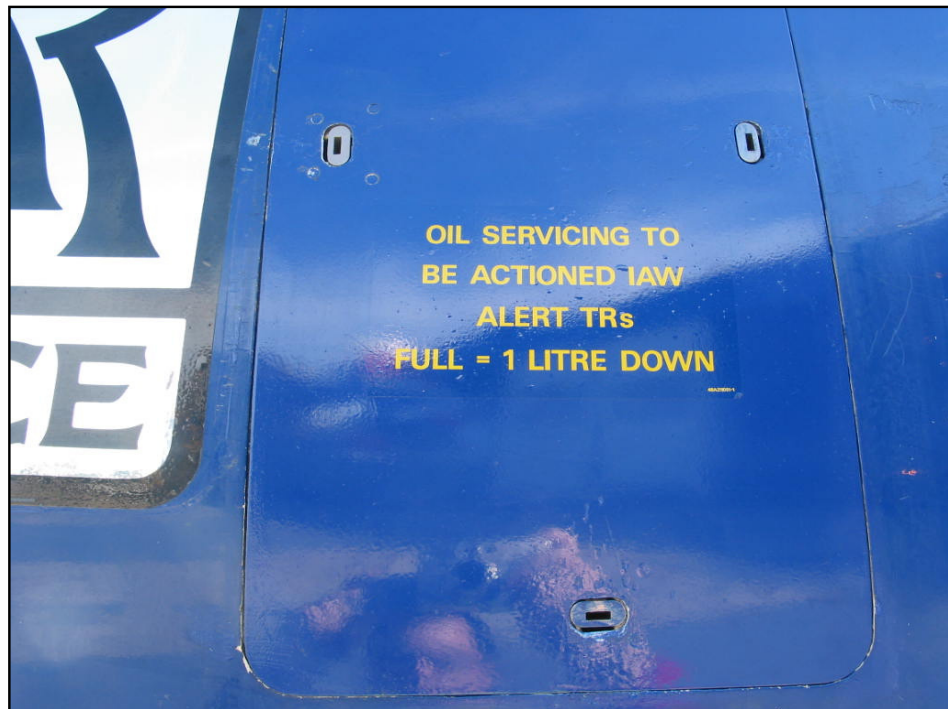
Figure 6

The next day, he went to re-check the engine oil levels, noting that both engines were now showing nearly 20 litres on the sight glass. He recalled from a Technical Newsletter, issued by the Powerplant Technical department, that overfilling the engine oils was known to cause oil smells in the cabin and that the engine oils should be filled to a maximum of one litre below the full graduation mark on the oil tank sight glass. The department had also issued Temporary Revision 12-593 to amend the Aircraft Maintenance Manual instructions for servicing the engine oils and had placarded the engine oil servicing access doors to reflect the new requirement (Figure 6). He decided that the oil quantities were excessive and proceeded to drain one litre of oil from each engine. After this the left and right engine oils were showing 18/19 litres on the EICAS display and 19/19 litres on the sight glass respectively. Satisfied that the quantities were now acceptable, he stamped the 'Daily Check' sheet tasks for the engine oils but did not record the draining of the oil in the Aircraft Technical Log, believing that the LAE would do so. In the event, the LAE did not, due to a breakdown in communication. Each had assumed that the other would record the adjustment of the oil levels in the Technical Log.

B757 Engine oil service access door

The revised oil fill level was also visually highlighted by placarding the engine oil servicing access door (Figure 6).

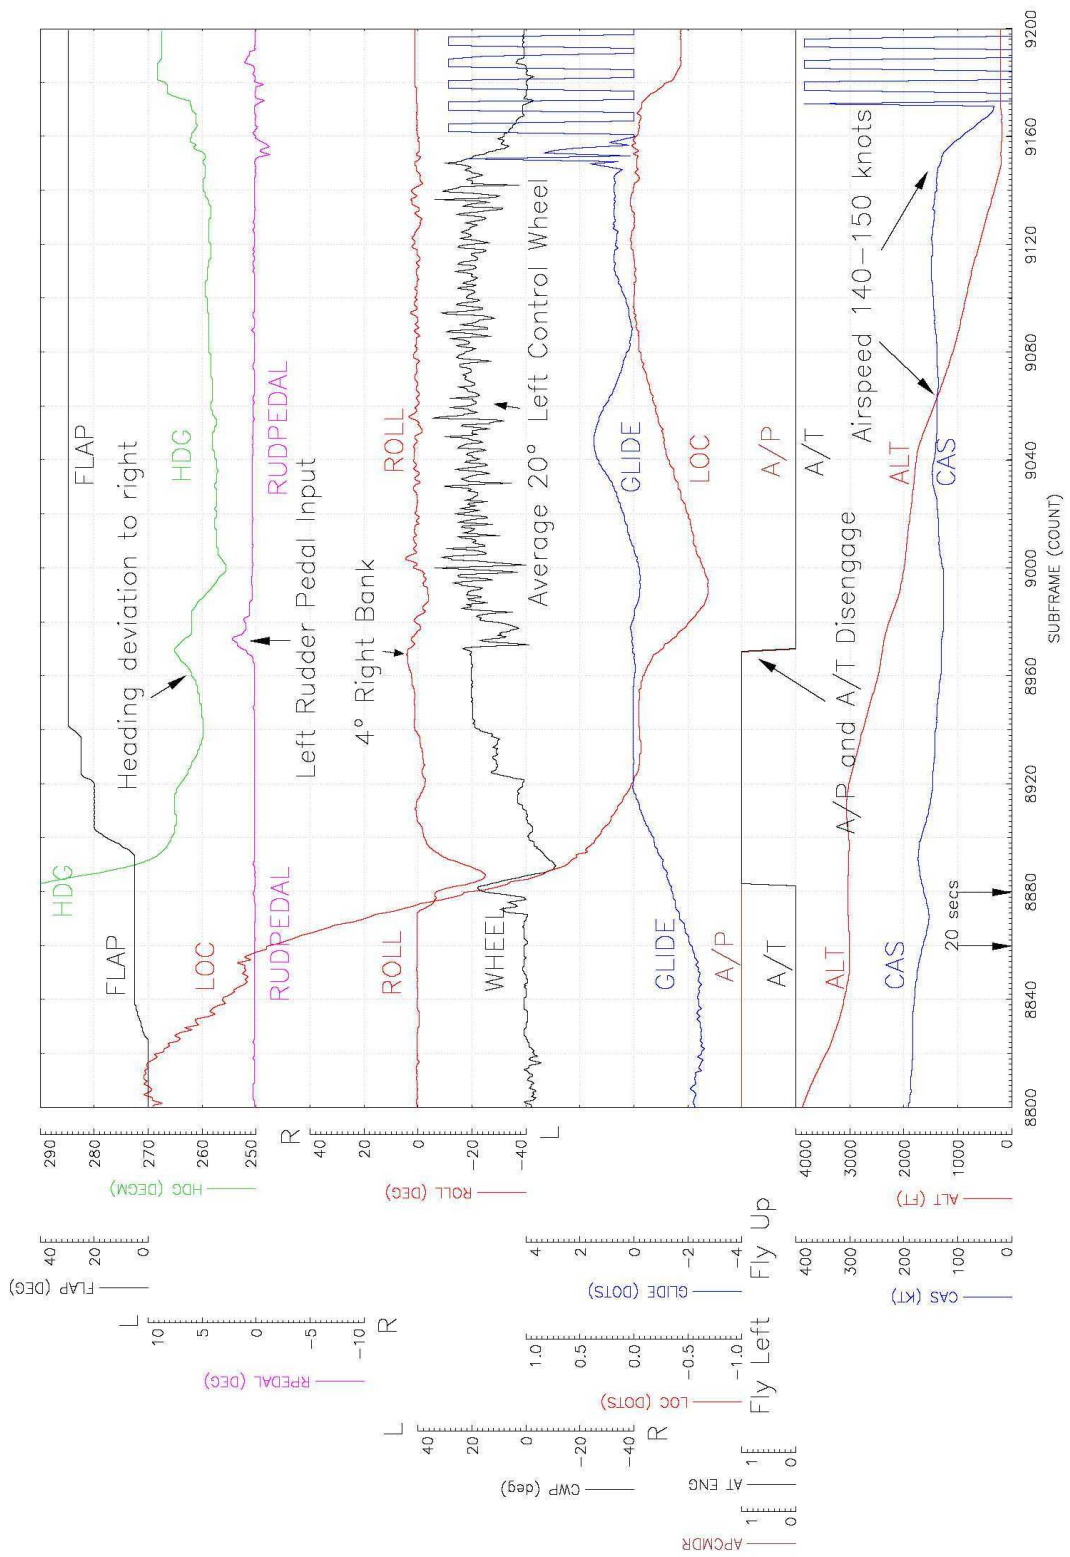
A time history of the relevant flight parameters during the approach to Gatwick is shown in Figure 7. This shows that the approach was normal until the final stages of flap were lowered. When 25° and 30° of flap were selected the autopilot applied about 12° and 20° of left control wheel respectively. The latter control input was insufficient to stop a slight bank angle of approximately 4° to

Figure 7
 Relevant Flight Recorder Parameters for Approach and Landing
 at London Gatwick

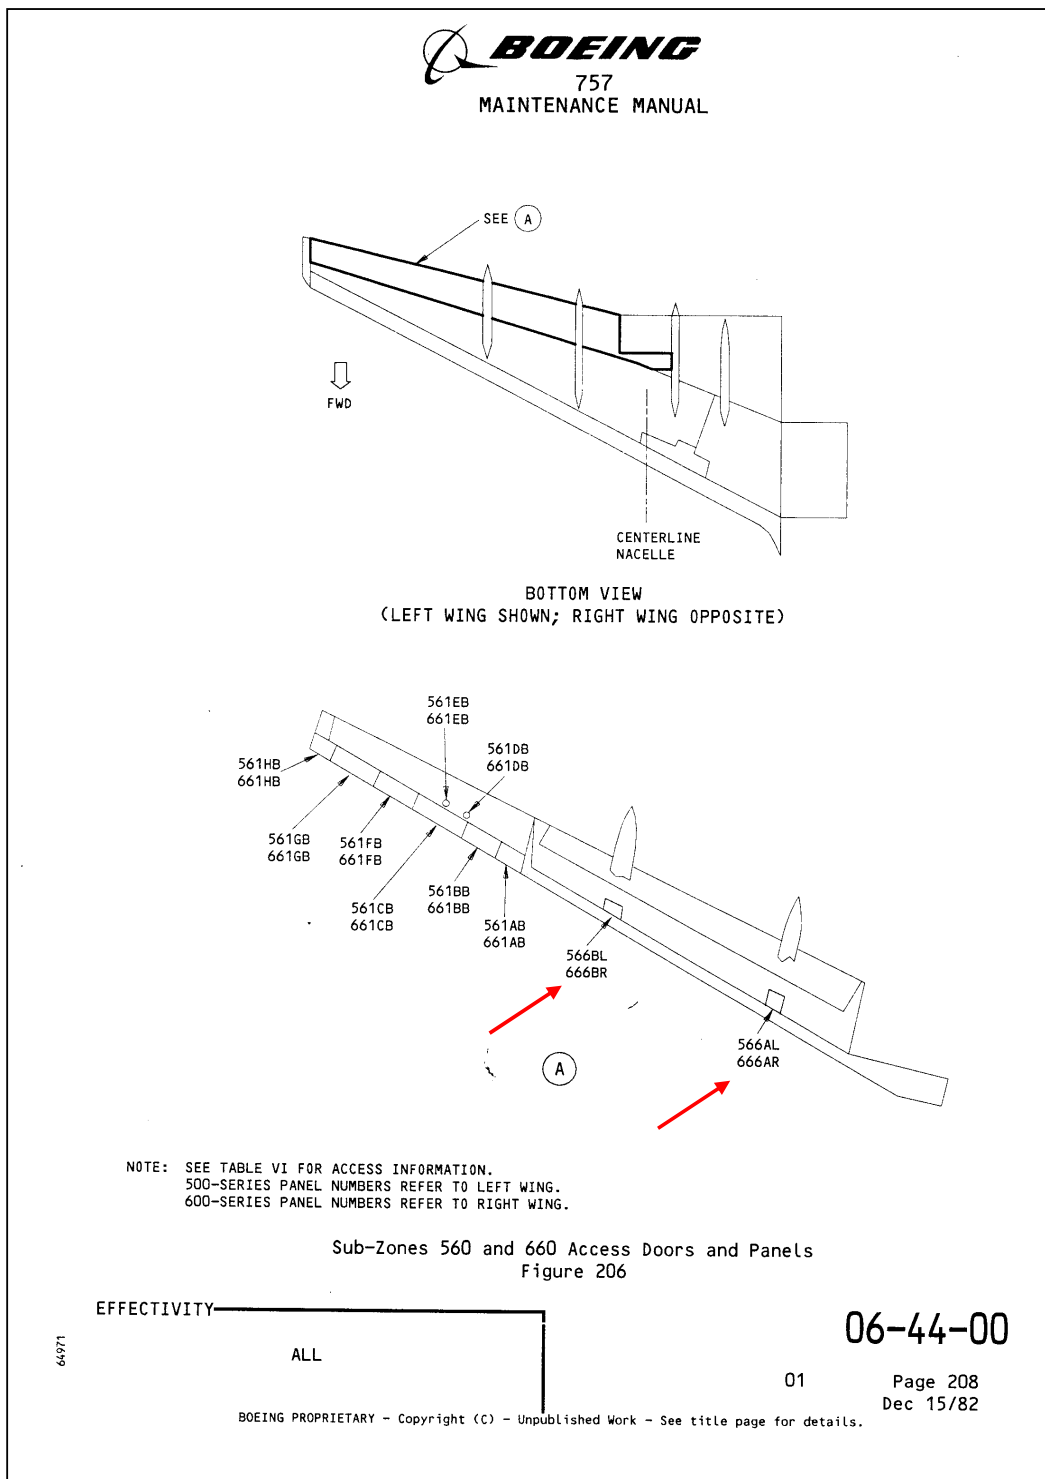
On examining the aircraft with the flaps down, access panels 666AR and 666BR were found to be missing from the outboard flap on the right wing (Figure 1). The panels are approximately 300 mm x 200 mm in size and are installed at the forward attachments for the main flap. Their purpose is to maintain the aerodynamic profile of the flap leading edge.

Boeing 757 AMM Panel Chart showing location of Panels 666AR and 666BR
