ACCIDENT

Aircraft Type and Registration:	Schempp-Hirth Nimbus-3 glider, G-EENN	
No & Type of Engines:	None	
Year of Manufacture:	1981 (Serial no: 9)	
Date & Time (UTC):	4 September 2012 at 1233 hrs	
Location:	Portmoak Airfield, Scotlandwell, Kinross	
Type of Flight:	Private	
Persons on Board:	Crew - 1	Passengers - None
Injuries:	Crew - 1 (Fatal)	Passengers - N/A
Nature of Damage:	Aircraft destroyed	
Commander's Licence:	FAI Gold C Certificate and 2 Diamonds	
Commander's Age:	49 years	
Commander's Flying Experience:	1,325 hours (of which at least 100 were on type) Last 90 days - 1 hour Last 28 days - 1 hour	
Information Source:	AAIB Field Investigation

Synopsis

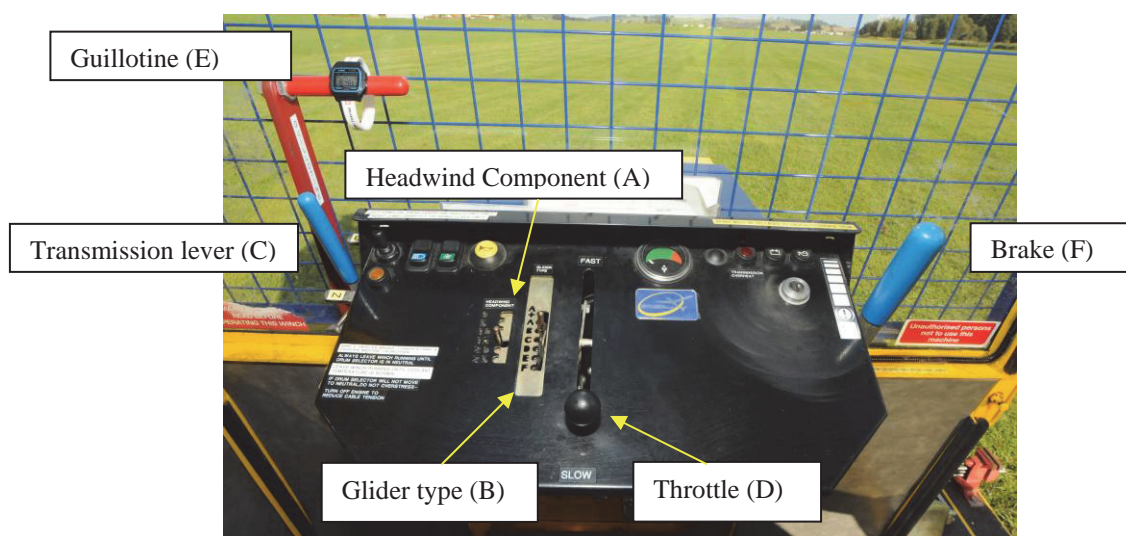
Figure 2

- The headwind is selected on (A).
- The glider type is selected on (B).
- The cable drum is selected.
- Once the operator receives the signal to 'take-up slack' he moves the transmission selector lever (C) from neutral to drive and the cable starts to wind in slowly.
- Once the operator receives the signal 'all out' he moves the throttle (D) to the gate, the winch engine accelerates and the glider is launched.
- The winch is equipped with a guillotine (E) that, in an emergency, can be used to release the cable at the winch. The winch cable brake (F) is not used during the launch.

Following the accident, the preset for the headwind component was found to be set at 15 kt and the 'glider type' was set at 'B'. The weak link fitted to the launch

Winch controls

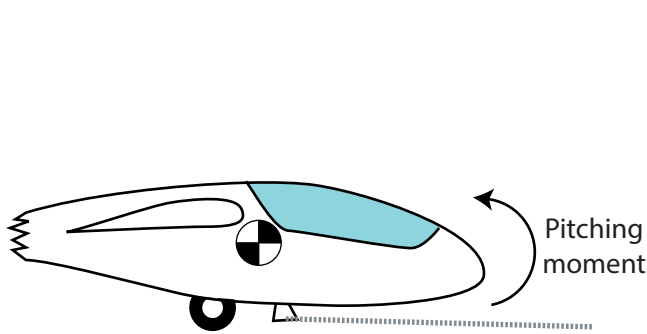
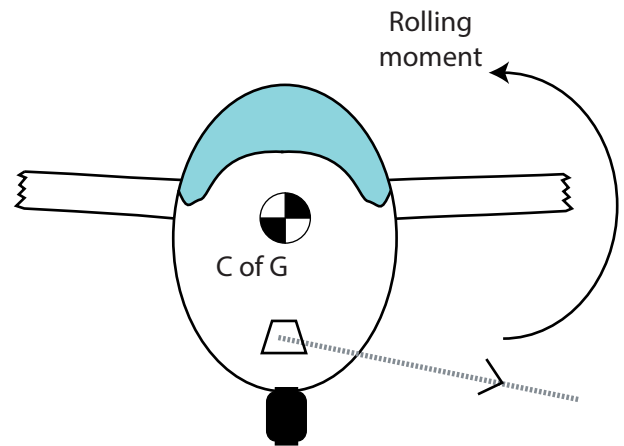
Figure 8a and 8b

The hook used for winch launching is normally located below and forward of the glider Centre of Gravity (C of G) (Figure 8a). If the hook is located along the centre of the lower fuselage, then during the launch the force on the cable will initially attempt to rotate the glider nose upwards about the C of G. If the hook is off-set from the centre line, or the winch cable is set at an angle to the glider's heading, then there will be an additional rolling moment during the launch once airborne (Figure 8b). In general, the greater the misalignment between the glider and the winch cable the greater the rolling moment.
