AIRCRAFT ACCIDENT REPORT 2/2014

Report on the accidents to Eurocopter EC225 LP Super Puma

G-REDW
34 nm east of Aberdeen, Scotland
on 10 May 2012

G-CHCN
32 nm southwest of Sumburgh, Shetland Islands
on 22 October 2012

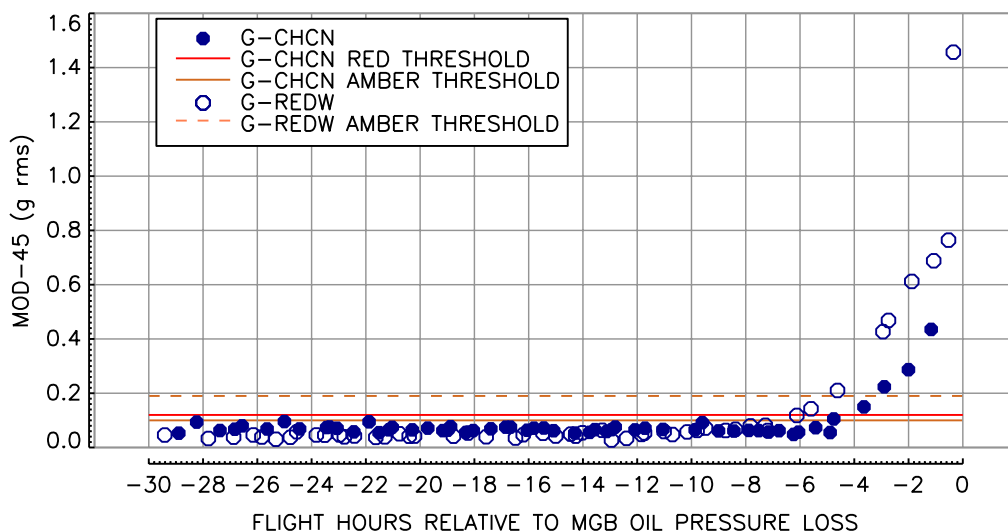
Figure 22

Comparison MOD-45 condition indicator between G-CHCN and G-REDW

For G-REDW the MOD-45 indicator exceeded its learned amber threshold (0.19) 4.62 flying hours before the loss of the MGB oil pressure. No red threshold existed at the time of the accident involving G-REDW. The MOD-45 indicator for G-CHCN exceeded its learned amber threshold (0.10) 4.75 flying hours and its learned red threshold (0.12) 3.63 flying hours prior to the loss of oil pressure (Figure 22).

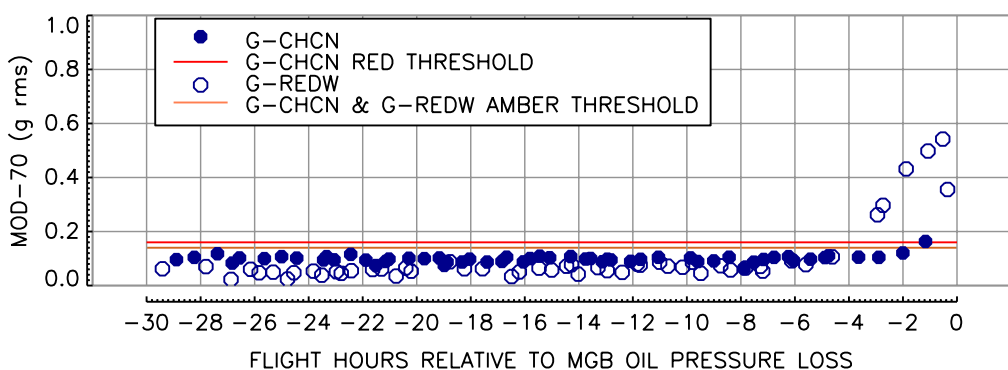
Figure 23

Comparison MOD-70 condition indicator between G-CHCN and G-REDW

For the MOD-70 indicator, the first instance that it exceeded the learned amber threshold (0.14) for G-REDW was 2.95 flying hours before the loss of MGB oil pressure (Figure 23). However, for G-CHCN only the last recorded value of this indicator, which was captured 1.17 flying hours before the loss of the MGB oil pressure, exceeded both its amber (0.14) and red (0.16) learned thresholds.

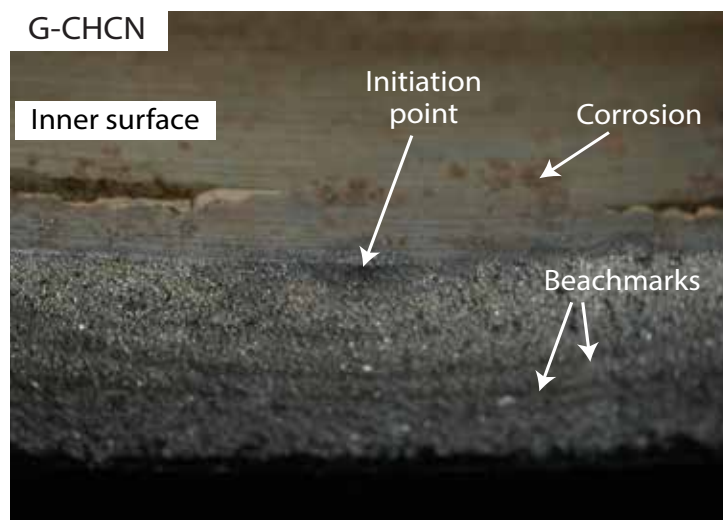
Figure 35

On G-CHCN, the principle crack initiated at a corrosion pit 60µm deep located on the inner radius in the parent material (Figure 34). The initiation point was approximately 45° around the circumference of the shaft from the 4.2 mm hole. The crack then propagated in both directions in the parent material in the lower³⁰ part of the shaft, into the 4.2 mm hole, before it re-initiated on the other side of the hole. As the crack extended around the circumference of the shaft it changed planes a number of times, but always remained in the parent material. In addition, multiple crack initiation sites were identified on the inside of the shaft with small semi-elliptical cracks propagating from the surface. It was assessed that these small cracks initiated and grew as a result of the increase in stress caused by the two major cracks extending around the circumference of the shaft. Both major cracks exhibited evidence of striations and beachmarks, which are associated with fatigue cracking (Figure 35).

Location of crack initiation on G-CHCN

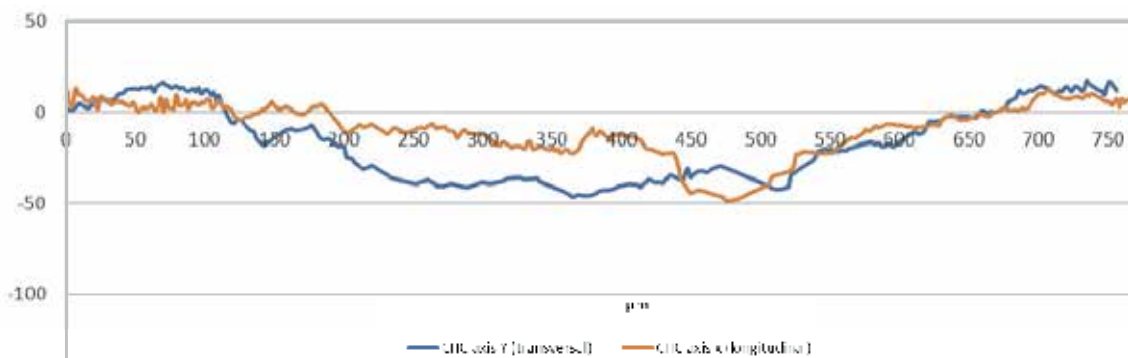
Figure 38 (b)

Profile of corrosion pit on the shaft fitted to G-CHCN
 (using the same scale on the horizontal and vertical axis)

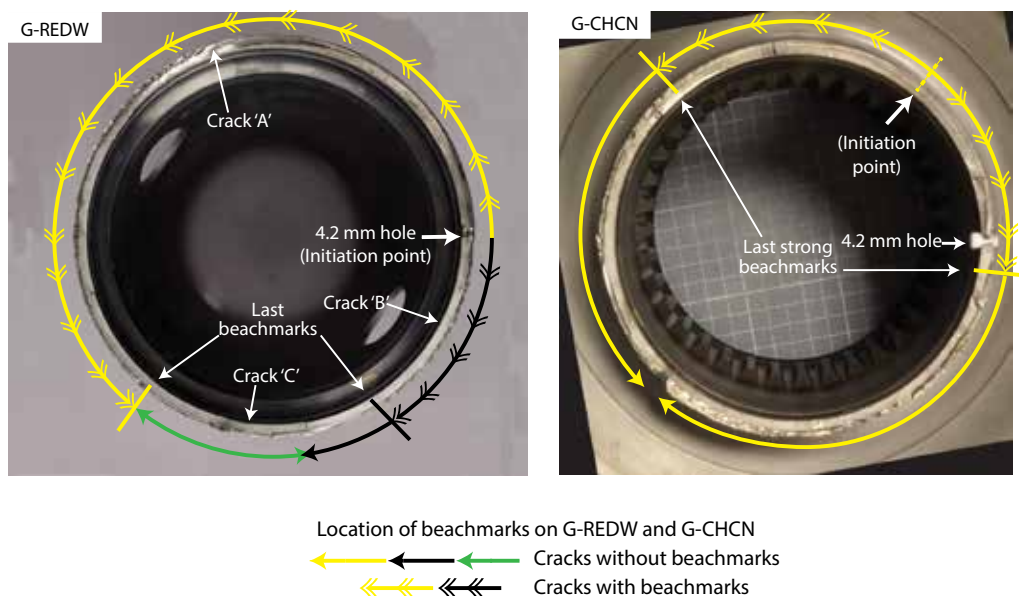
Figure 39

The fracture surfaces of the shafts on G-REDW and G-CHCN both displayed beachmarks, which can be formed when an event such as an engine start or significant change in torque has taken place (Figure 39). Beachmarks may be difficult to identify and can be interpreted in a number of ways.

Fracture surfaces on shafts fitted to G-REDW and G-CHCN

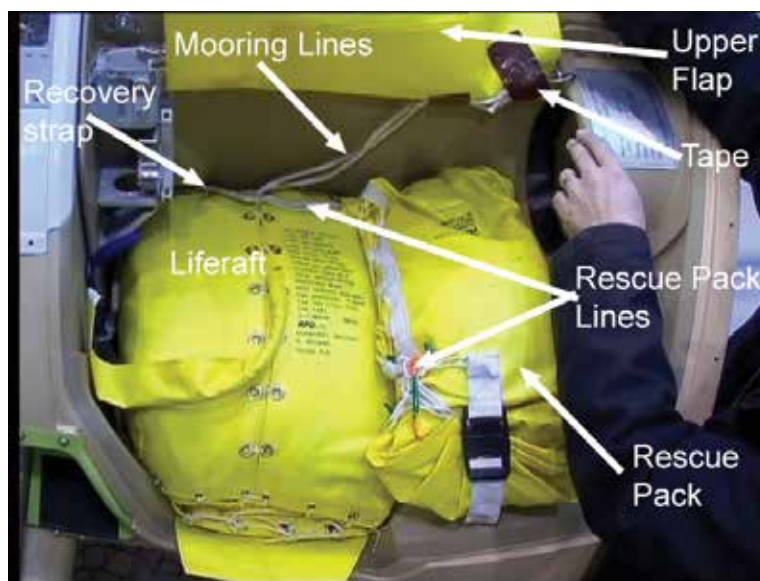
Figure 41

The EC225 LP aircraft maintenance manual (AMM) contains a procedure in workcard 25-66-01-061 (version 2012.06.14) for installing the liferaft, inflation bottle and rescue pack. The procedure calls for the liferaft to be installed first and then it states to '*Attach mooring lines (3) to spring-loaded hook (1) and bind them to upper flap (2) using Commercial Adhesive tape.*' These items are shown in Figure 3 of the procedure, reproduced in Figure 40 of this report. There is a spring-loaded hook secured to the end of the mooring lines and the intention of this instruction is for this hook to be attached to the bracket fixed to the sponson at position (1) in Figure 40. The figure does not show how to tape the mooring lines to the upper flap and the lines are shown to pass in front of the flap, when they should pass behind it as shown in Figure 41. This tape is removed after the inflation bottle is installed. The rescue pack is installed last. Figure 40 also shows the mooring lines (3) routing behind and below the liferaft which is different from the routing of the lines in an installation test carried out by the helicopter manufacturer (Figure 41).

Image from the helicopter manufacturer’s installation test showing
 the routing of the mooring lines and rescue pack lines

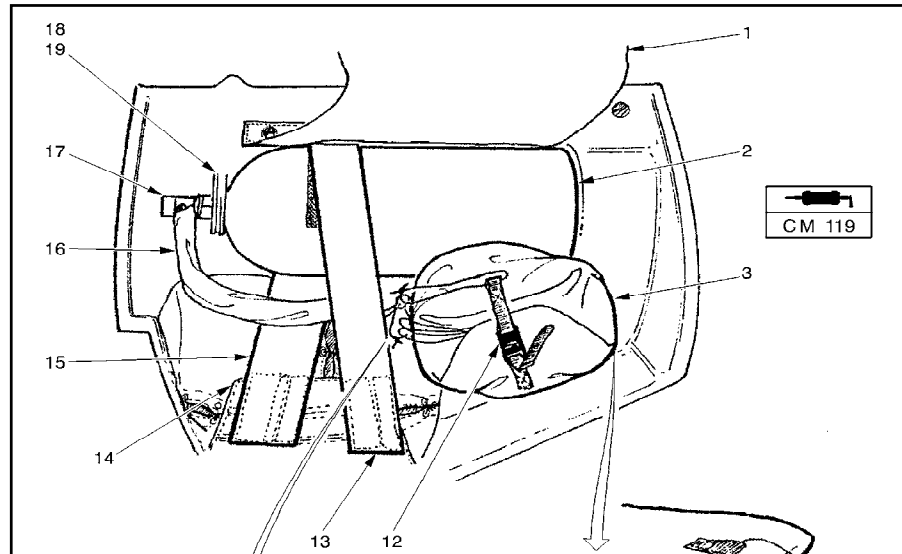
The liferaft installation procedure contains a Caution which states that the mooring lines, recovery strap and rescue pack lines ‘*MUST NOT CROSS EACH OTHER*’, but the actual routing of these lines is not shown. An additional installation diagram, Figure 42 (Figure 2 in the workcard), shows the inflation bottle, rescue pack and liferaft installed, although the liferaft is not easily visible in the lower left part of the image, and the mooring lines are not shown.

Extract from Figure 2 of
workcard 25-66-01-061- liferaft installation procedure

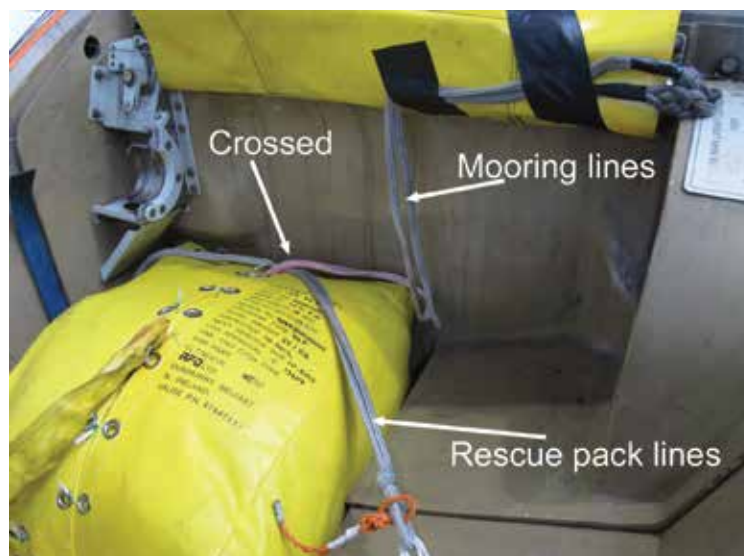
Although the instructions state clearly that the mooring lines and rescue pack lines must not cross, whether this is achievable or not depends upon how the lines exit the liferaft pack. In the liferaft installation shown in Figure 43 it was not possible to route the lines without crossing them because the mooring lines exited the liferaft pack forward of the rescue pack lines. The liferaft packing instructions do not specify if one set of lines needs to be forward of the other – for more detail on packing see section 1.15.6.3.

Liferaft installation showing crossed mooring and rescue pack lines

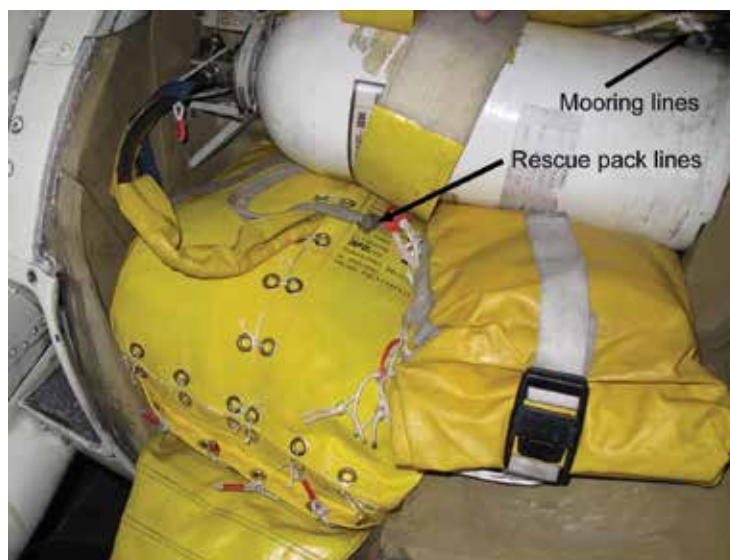
Figure 44

On four of the installations the mooring lines and rescue pack lines were routed correctly, that is they were not crossed and the mooring lines were routed behind the inflation bottle as shown in Figure 44. However, since the exact routing of the rescue pack lines is not specified in the manual, it is not possible to be certain that they were routed as intended by the helicopter manufacturer.

Mooring lines shown correctly routed behind the inflation bottle

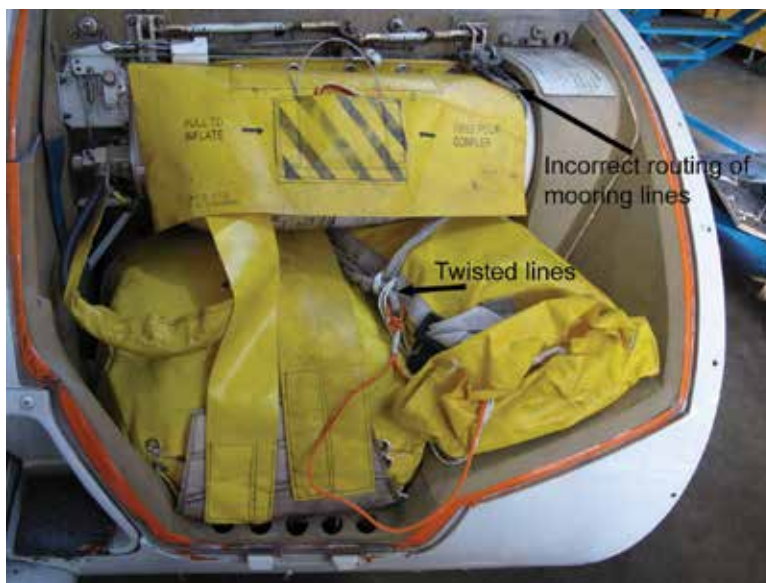
Figure 45

In the left compartment of G-WNSO the mooring lines were routed in front of the inflation bottle instead of behind it and the rescue pack lines were twisted around the mooring lines (Figure 45). The engineer who installed this liferaft was interviewed several months later and could not recall fitting the liferaft. He was aware that the mooring lines should be routed behind the bottle. He stated that sometimes it was difficult to install the bottle with the mooring lines behind it, which may have been the reason why he routed the mooring lines in front of the bottle. He could not explain why the mooring and rescue pack lines were left in a twisted state.

G-WNSO left compartment - incorrect routing of mooring lines in front of the bottle and rescue pack lines twisted around mooring lines

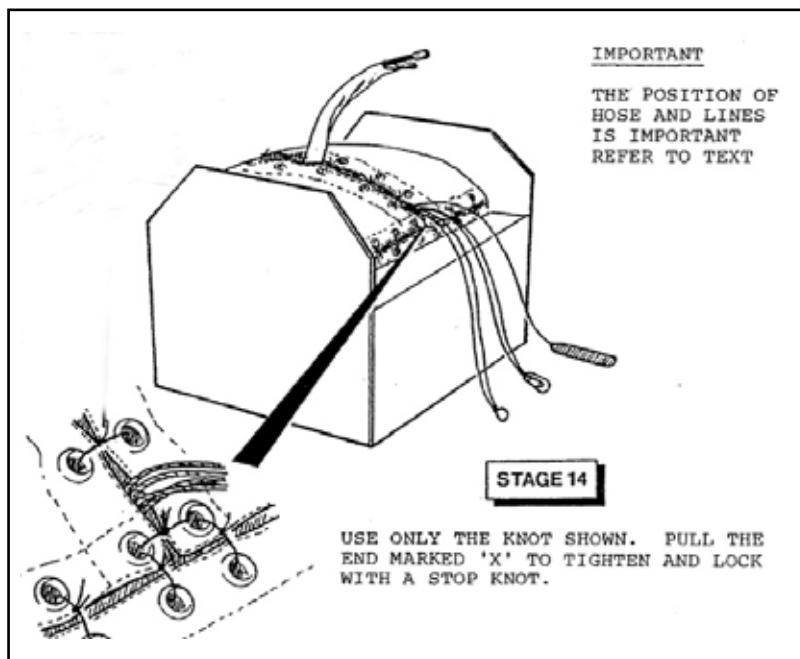
Figure 47

Figure 714 from liferaft CMM – lines shown in different order from Figure 712

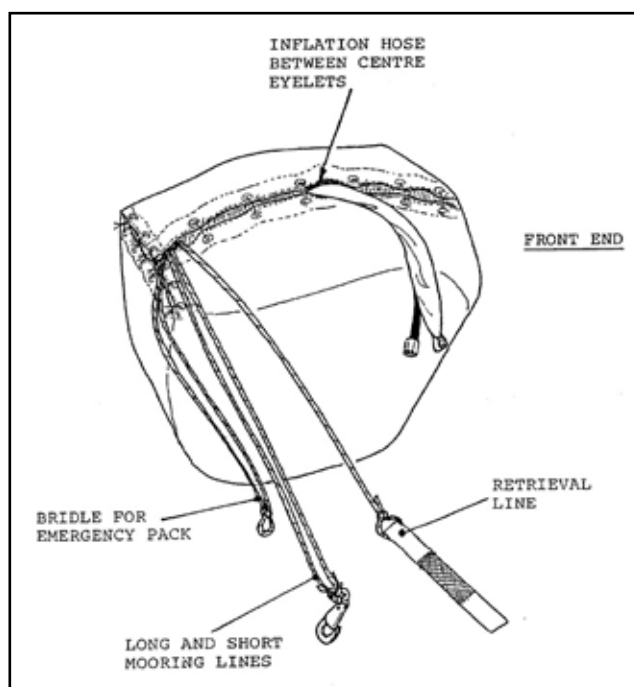
The final diagram in the packing instructions, Figure 48 (CMM Figure 715), shows the rescue pack line⁴⁰ emerging at the back of the valise and the mooring lines forward of these. This orientation will result in these lines crossing when the liferaft is installed in the sponson because the rescue pack line is routed forwards while the mooring lines are routed rearwards. The instructions in the text relating to the lines state (note: the 'bridle' is the rescue pack line):

There are no further instructions detailing how to pack the lines and there are no notes of caution about not crossing the lines.

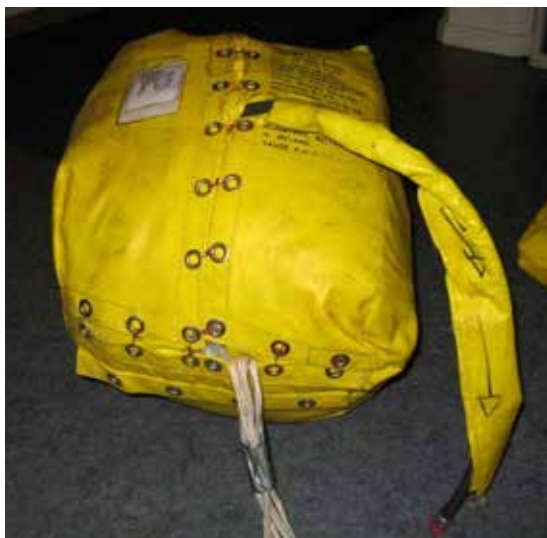
Figure 49

The Part 145 AMO that serviced the left liferaft on G-CHCN was asked if they were aware of any packing issues. A search of their database revealed four reports of incorrectly packed liferafts between May 2008 and September 2013. These were discovered when the liferafts were sent to them for their annual service. In all four cases the mooring, rescue pack and retrieval lines exited the valise at its forward end rather than its aft end (Figure 49). This would have resulted in incorrect inflation of the liferaft, causing the lines to twist, and would also have posed a risk of puncture. In two of the cases the liferafts had been packed by organisations in Brazil and Australia that were not registered with the liferaft manufacturer and therefore would not have had access to official copies of the CMM or updates.

Incorrectly packed liferaft with the lines exiting at the front instead of the rear – discovered during servicing

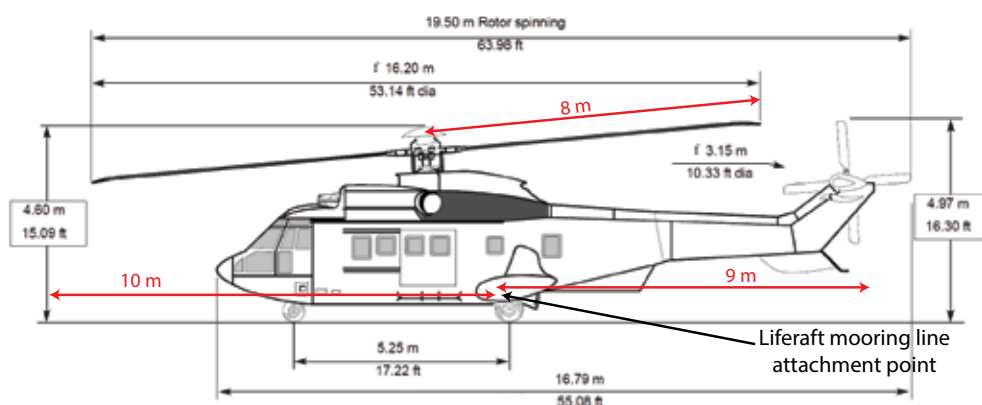
Figure 50

Following the ditching of G-CHCN, the occupants of the right liferaft were concerned about their proximity to the tail rotor and decided to cut the long mooring line. The long mooring line is intended to keep the liferaft attached to the helicopter at a safe distance in order to aid location, and it automatically releases if the helicopter sinks. In the case of the Type 18R MK3 liferaft the long mooring line is 12 m long. The distance from the liferaft attachment point in the sponson to the forward most position where a main rotor blade tip could reach is about 10 m (Figure 50). However, any slack in the line due to wave motion could result in part of the liferaft being beneath the main rotor blade tip.

Neither the helicopter nor the liferaft manufacturer could explain why 12 m had been chosen for the length of the long mooring line. At the time of the liferaft's approval the CAA Specification No. 2 only required that it be longer than 6 m. Currently, ETSO 2C505 requires that it be between 6 and 20 m and the AMC to JAR-Ops 3.830 states it should be 20 m long.

Dimensions of EC225 LP highlighting liferaft mooring line attachment point

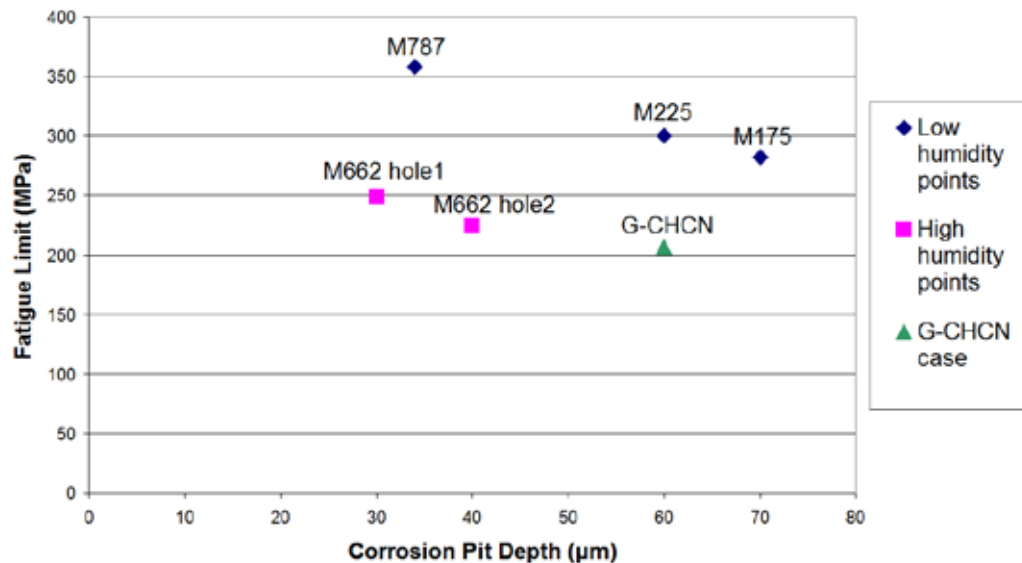
Data points from the bending fatigue tests carried out on shafts M787, M225, M175 and M662 are plotted in Figure 52 as a function of the calculated fatigue limit versus the corrosion pit depth. These data points are all for cracks that initiated from corrosion pits in the inner radius. Points M787, M225 and M175 were considered to be low humidity points and the data points from shaft M662 were considered to be high humidity points caused by water being dropped onto the surface at a temperature of 85°C. The G-CHCN failure is plotted for comparison using the stress level produced at Takeoff Power (TOP).

Effect of corrosion pit depth and humidity on the manufacturer's calculated fatigue limit for the inner radius

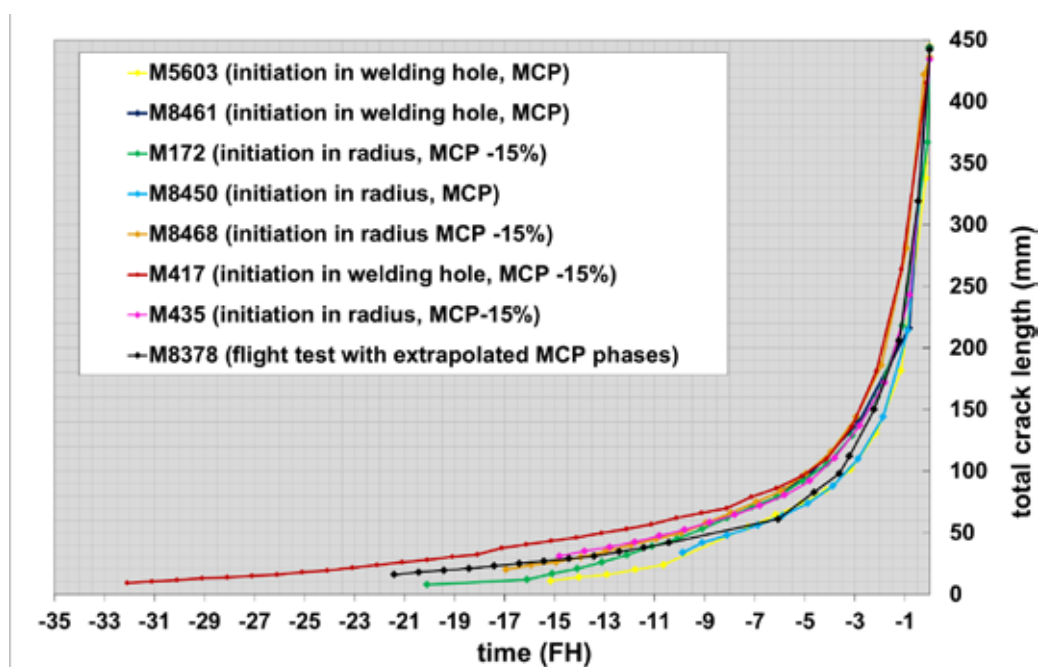
Figure 56

The manufacturer carried out dynamic testing of seven shafts to determine the rate that a circumferential crack would propagate at a power setting of MCP and MCP-15%. Decreasing the engine power by 15% should decrease the rate the crack grows by 33%. (Appendix G). Cracks were initiated at the 4 mm hole, weld and inner radius and the shafts were then subjected to the engine power spectrum similar to that experienced on G-REDW and G-CHCN. At the end of the tests the manufacturer carried out beachmark counting to determine the rate of crack propagation. A similar test was carried out, in flight, on a shaft fitted to an EC225 LP. As the tests were carried out on shafts and not coupons, the results included the effect of residual stress⁵³ and the position of the 29 mm lubrication hole, on the local stress at the 4.2 mm hole and inner radius. The results of the test are at Figure 56.

Results of manufacturer's crack propagation tests

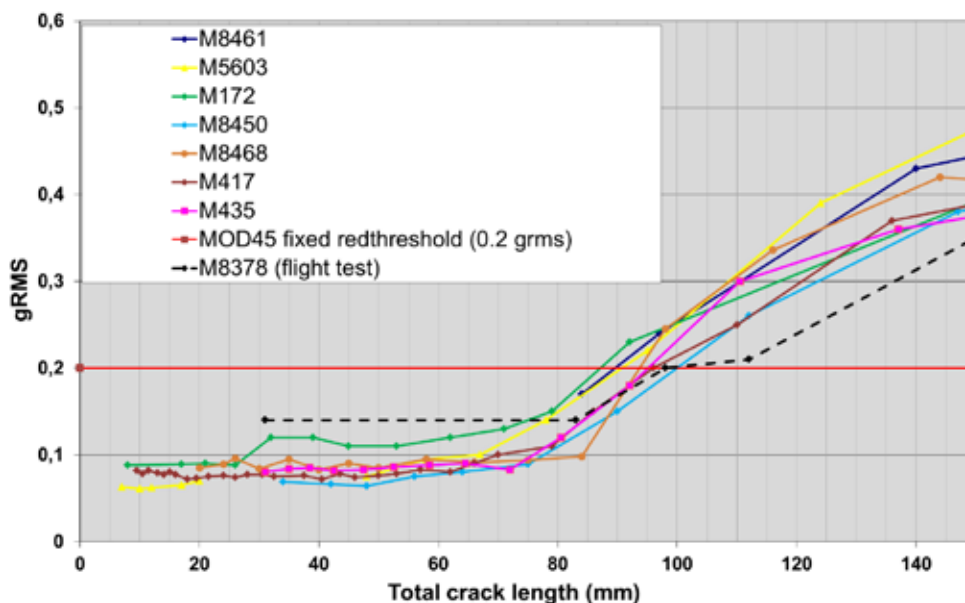
These tests also explored the response of the HUMS MOD-45 indicator as the crack grew in length. The results of these tests are at Figure 57 and show that HUMS indicator MOD-45 exceeded the red threshold of 0.2 g rms when the crack length was between 87 mm and 100 mm.

Results of manufacturer's crack propagation tests

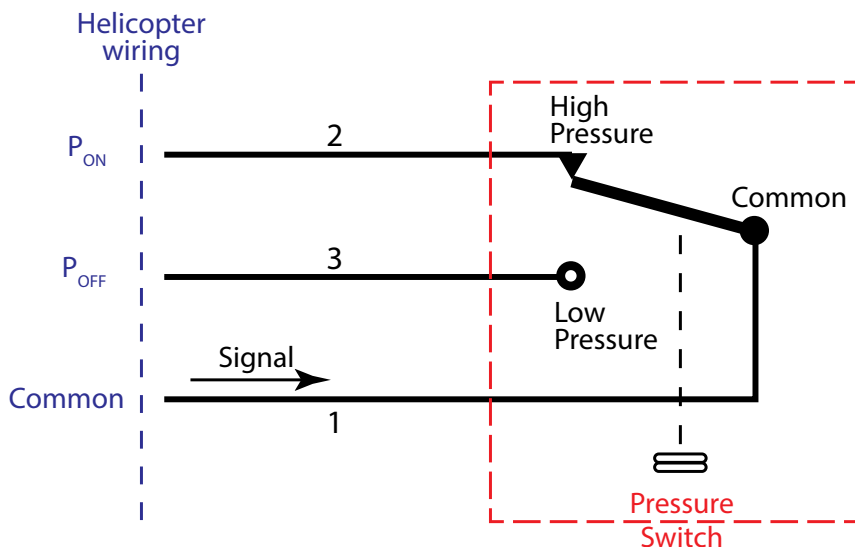
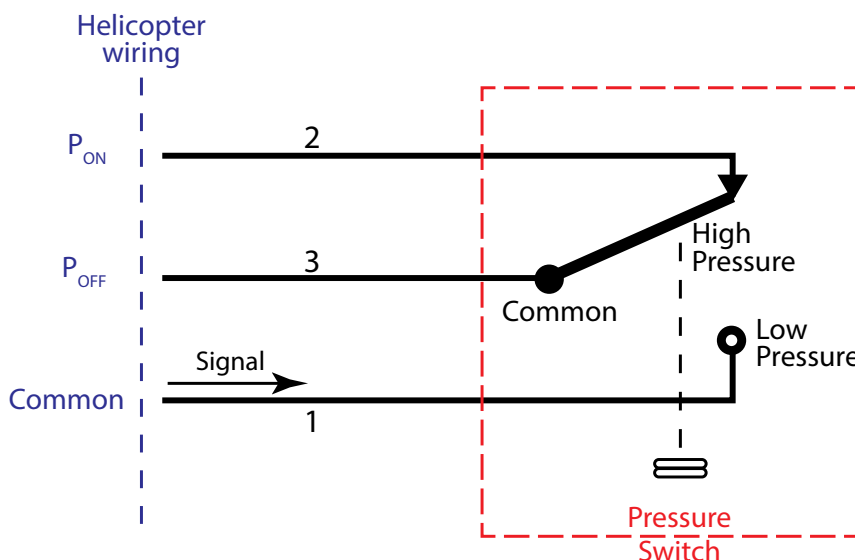
Owing to obsolescence, the helicopter manufacturer issued a specification for new pressure switches, requiring them to be interchangeable with the original switches. It included the original specification for the internal wiring of the pins. Therefore, the replacement pressure switches were developed with Pin 3 as the common pin. The helicopter wiring, however, remained configured for a common Pin 1. The new pressure switches, manufactured by a different supplier, were fitted to helicopters as part of a modification in 2010 (MOD 0752520). The wiring and internal schematic for the switches before and after MOD 0752520 is shown in Figure 63. The schematic is valid for both the Hydrosafe 620 and bleed-air switches.

The terms 'p_{on}', 'p_{off}' and 'Common' in Figure 63 reflect the helicopter wiring identification. The figure illustrates that changing the internal architecture to Pin 3 as 'common' on the replacement switch meant it now fed the p_{off} signal wiring on the helicopter.

In summary, the MGB EMLUB caption will illuminate for any of the three possible states - high pressure, low pressure or an erroneous signal - when the system is activated. These are the only three possible states for the system and hence for all helicopters with MOD 0752520 the MGB EMLUB caption will illuminate after the 30-second delay following system activation. Both G-REDW and G-CHCN had MOD 0752520 embodied.

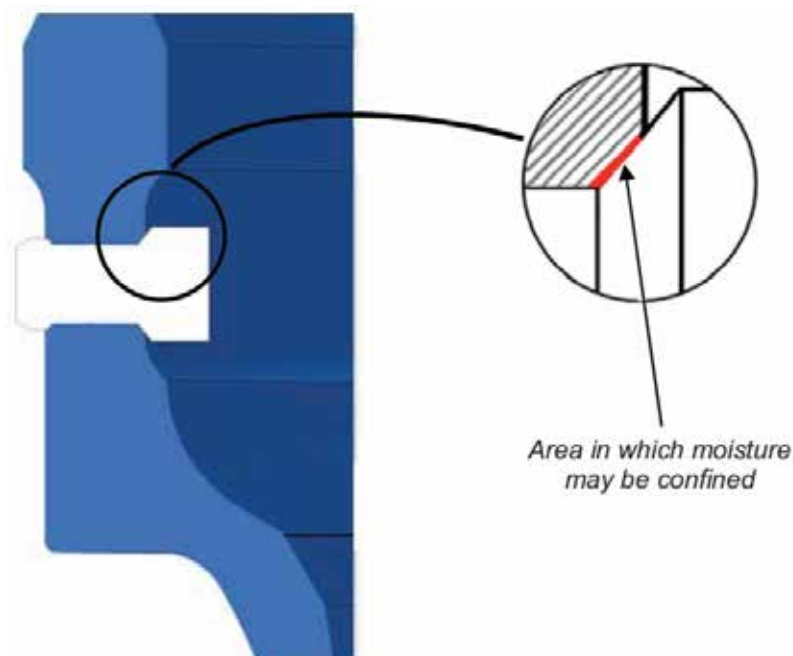
Figure 66

The change of the countersink angle from 100° to 90° meant that there would have been a gap between the PTFE plug and the countersink consistent with the narrow area in which corrosion was found. It is possible that moisture or a corrosive agent might have been trapped in this gap (Figure 66).

However, the geometry of the countersink, which was outside the design specification, should have allowed oil, during the normal operation of the gearbox, to flow into this gap and inhibited the corrosion mechanism. This gap would also have provided a path for other contaminants to enter this area in the countersink during normal operation of the gearbox.

Gap between plug and countersink

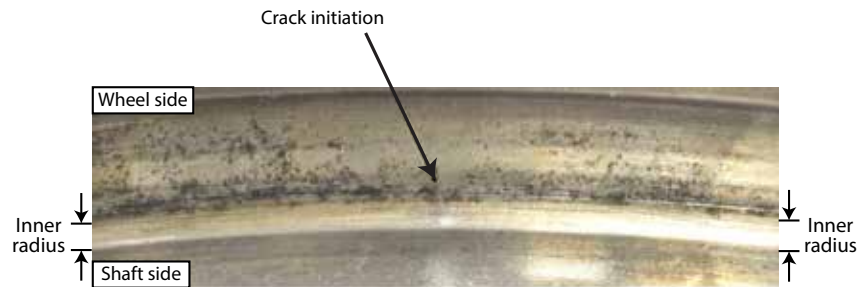
Figure 67

Red deposits were found on the inside of the bevel wheel part of the shaft fitted to G-CHCN (M122). Whilst the deposits covered all of the top part of the inside of the shaft, it was particularly concentrated in three distinct bands where there are features in the shaft. One of these bands was located in the area of the inner radius, a design feature that was not present on the AS332 shaft. On removing the deposit, corrosion pits were found under each of these bands and it was from one of these corrosion pits, located on the inner radius (Figure 67) that the fatigue crack on the shaft fitted to G-CHCN initiated. Apart from these areas, and in the 4.2 mm hole and countersink, corrosion was not

found anywhere else on the shaft or on any other components in the MGBs fitted to G-REDW and G-CHCN.

Corrosion pits at the inner radius on G-CHCN

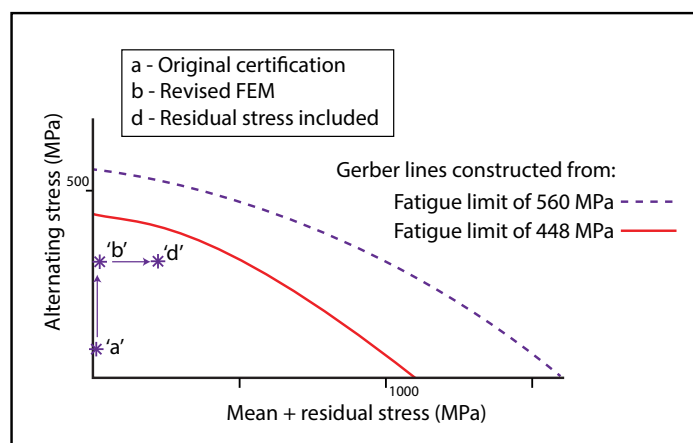
- The first condition is shown at Figure 68 which represents the understanding during the EC225 LP certification process of the stresses at Critical Area 2: the 4.2 mm hole in the weld. The Gerber line (solid line) is constructed from a fatigue limit of ± 448 MPa, based on a surface roughness of $3.2 \mu\text{m}$, and the parent material UTS of 1,200 MPa. Point 'a' is the maximum stress, calculated during the original certification, at the 4.2 mm hole and the safety factor is approximately 5.4. The actual safety factor is more conservative as the design drawing specifies the surface roughness of the 4.2 mm hole as $1.6 \mu\text{m}$. This would give a fatigue limit of ± 560 MPa. This is shown by the dotted Gerber line which uses this fatigue limit and the UTS for the weld material of 1,600 MPa.

Safety factor at Critical Area 2, 4.2 mm hole in the weld

- The second condition represents the stress after the revision of the FEM following the accidents to G-REDW and G-CHCN. As can be seen at Figure 68, the maximum stress at the 4.2 mm hole has moved from point 'a' to 'b'. The maximum stress at the inner radius is plotted as point 'c' on Figure 69, where the Gerber line is constructed from the parent material fatigue limit of ± 480 MPa obtained for a surface roughness of $3.2 \mu\text{m}$. The safety factors are approximately 1.9 for the 4.2 mm hole, using the dashed Gerber Line, and 2.1 for the inner radius.

- The third condition shows the effect of including the residual stress. The Gerber lines are unchanged, but as can be seen at Figure 68, the maximum stress at the 4.2 mm hole has moved from point 'b' to point 'd'. On Figure 69 it can be seen that the maximum stress at the 'inner radius' has moved from point 'c' to point 'e'. The safety factors are now approximately 1.7 for the 4.2 mm hole, using the dashed Gerber Line, and 1.6 for the inner radius.

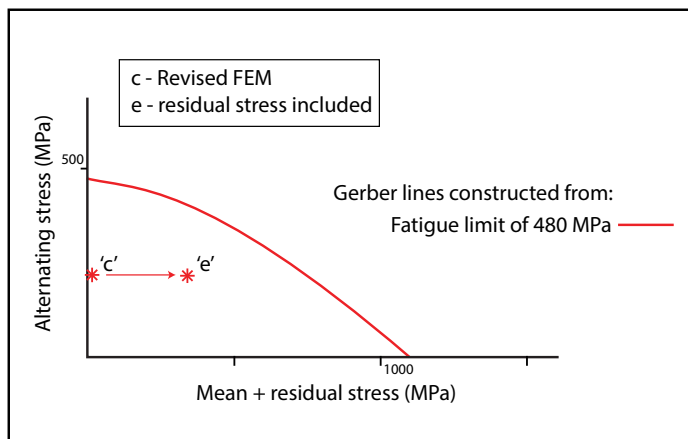
Figure 69

Safety factor at inner radius

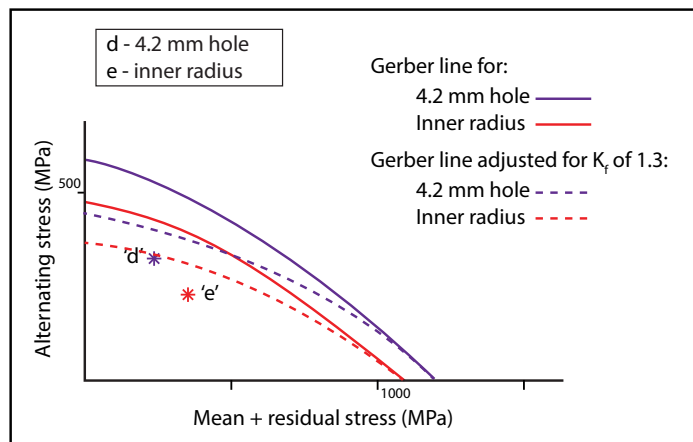
Figure 70

- The results of the first method, using an experimental K_f of 1.3 for a corrosion pit 60 μm deep, are shown at Figure 70. The fatigue limit is decreased by a factor of 1.3 and the Gerber lines for the weld material and parent material move downwards. Consequently, the safety factors are now approximately 1.4 for the 4.2 mm hole and 1.3 for the inner radius.

Effect of a corrosion pit 60 μm deep and K_f of 1.3 on the factor of safety

The above analysis does not take into account the variation in the material properties that will affect the fatigue limit, or the tolerance on the estimated stress concentration factor for the corrosion pit. The K_f of 1.3 was based on an R ratio of -1 and it was not established during this investigation if the residual stress would change the R ratio and hence K_f . Moreover, the fatigue limit on the weld fusion line may be lower than on other areas of the weld; this was demonstrated by QinetiQ's coupon testing. Increasing the stress concentration factor K_f of the corrosion pit from 1.3 to 1.8 for the 4.2 mm hole and to 2 for the inner radius would move points 'd' and 'e' onto their respective Gerber lines. The work undertaken by Cranfield University, in support of this investigation, indicated that stress concentration factors of this level are possible and cites some of the manufacturer's data that indicated that the stress concentration factor, taking into account tensile residual stress, could be around 2.

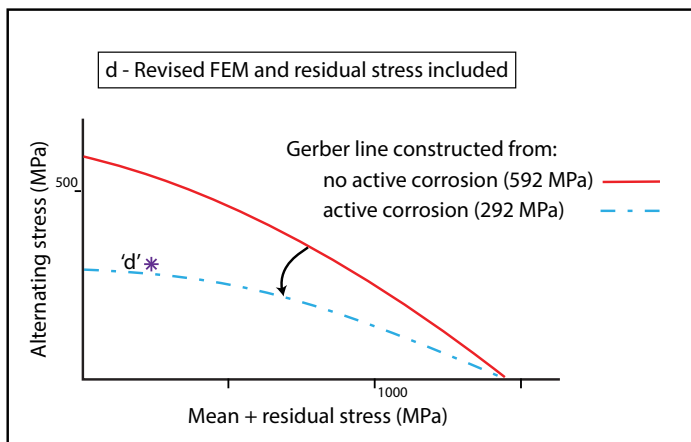
Figure 71 shows the effect of 'active corrosion' on a crack initiating from a 40 μm corrosion pit on the 4.2 mm hole in the weld. An estimated fatigue limit of ± 292 MPa was obtained from the testing of shaft M041. The stress at the 4.2 mm hole is unchanged at point 'd'. The effect of corrosion fatigue is to move the Gerber line downwards such that the safety factor is reduced to 0.9.

Effect of a corrosion pit 40 µm deep and corrosion fatigue on the factor of safety at the 4.2 mm hole

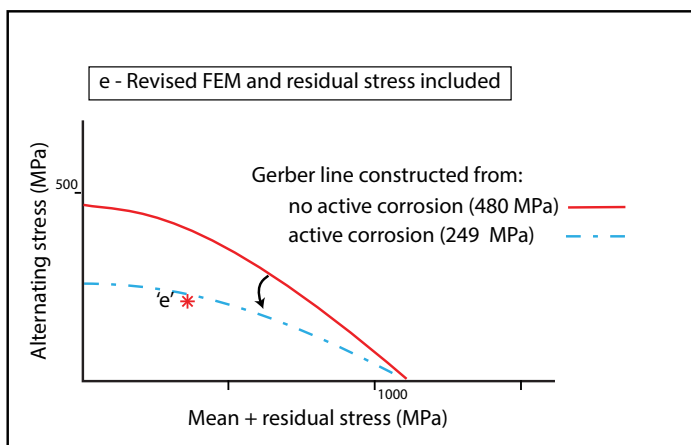
Figure 72 shows the effect of ‘ active corrosion’ on a crack initiating from a 40µm corrosion pit on the inner radius. An estimated fatigue limit of ±249 MPa was obtained from the dynamic testing of shaft M662. The stress at the inner radius remains at point ‘d’; however, the Gerber line has now moved downwards to an extent that the safety factor is now 1.1.

Effect of a corrosion pit 40 µm deep and corrosion fatigue on the factor of safety at the inner radius

While the use of safety factors and the Gerber line is an analytical approach, it demonstrates that the stress levels, residual stress and corrosion pits and/or ‘active corrosion’ could explain the fatigue failures of both shafts.

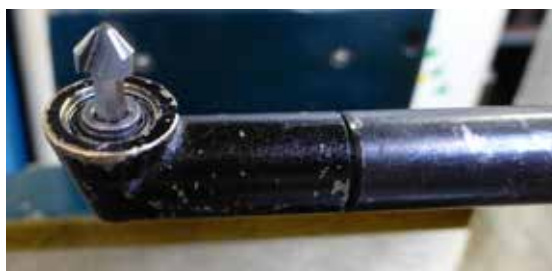
**Figure C-4**

The hand-operated tool was replaced in April 2012 with a countersink tool fitted to a 90° handheld electrically operated drill (Figure C-4). After the countersinks have been formed, the hole is reamed to a diameter of $4\text{ mm} + 0.7 / -0\text{ mm}$.
