CONTENTS

Summary of:	Air Accident Report No: 4/2010	136
	Report on the serious incident to Boeing 777-236, G-VIIR at Robert L Bradshaw International Airport, St Kitts, West Indies on 26 September 2009

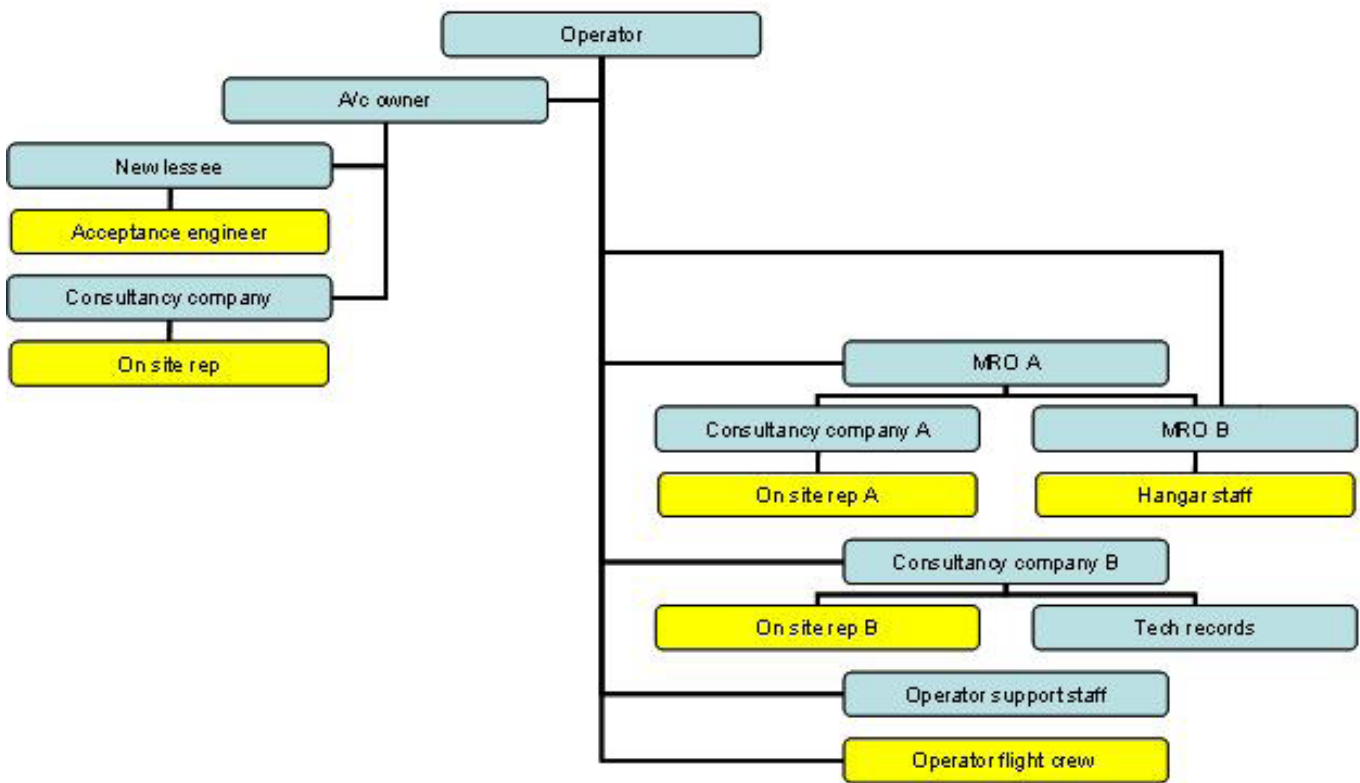
Figure 9

Chart of parties involved in aircraft hand-back (direct involvement in the incident is highlighted in yellow.)

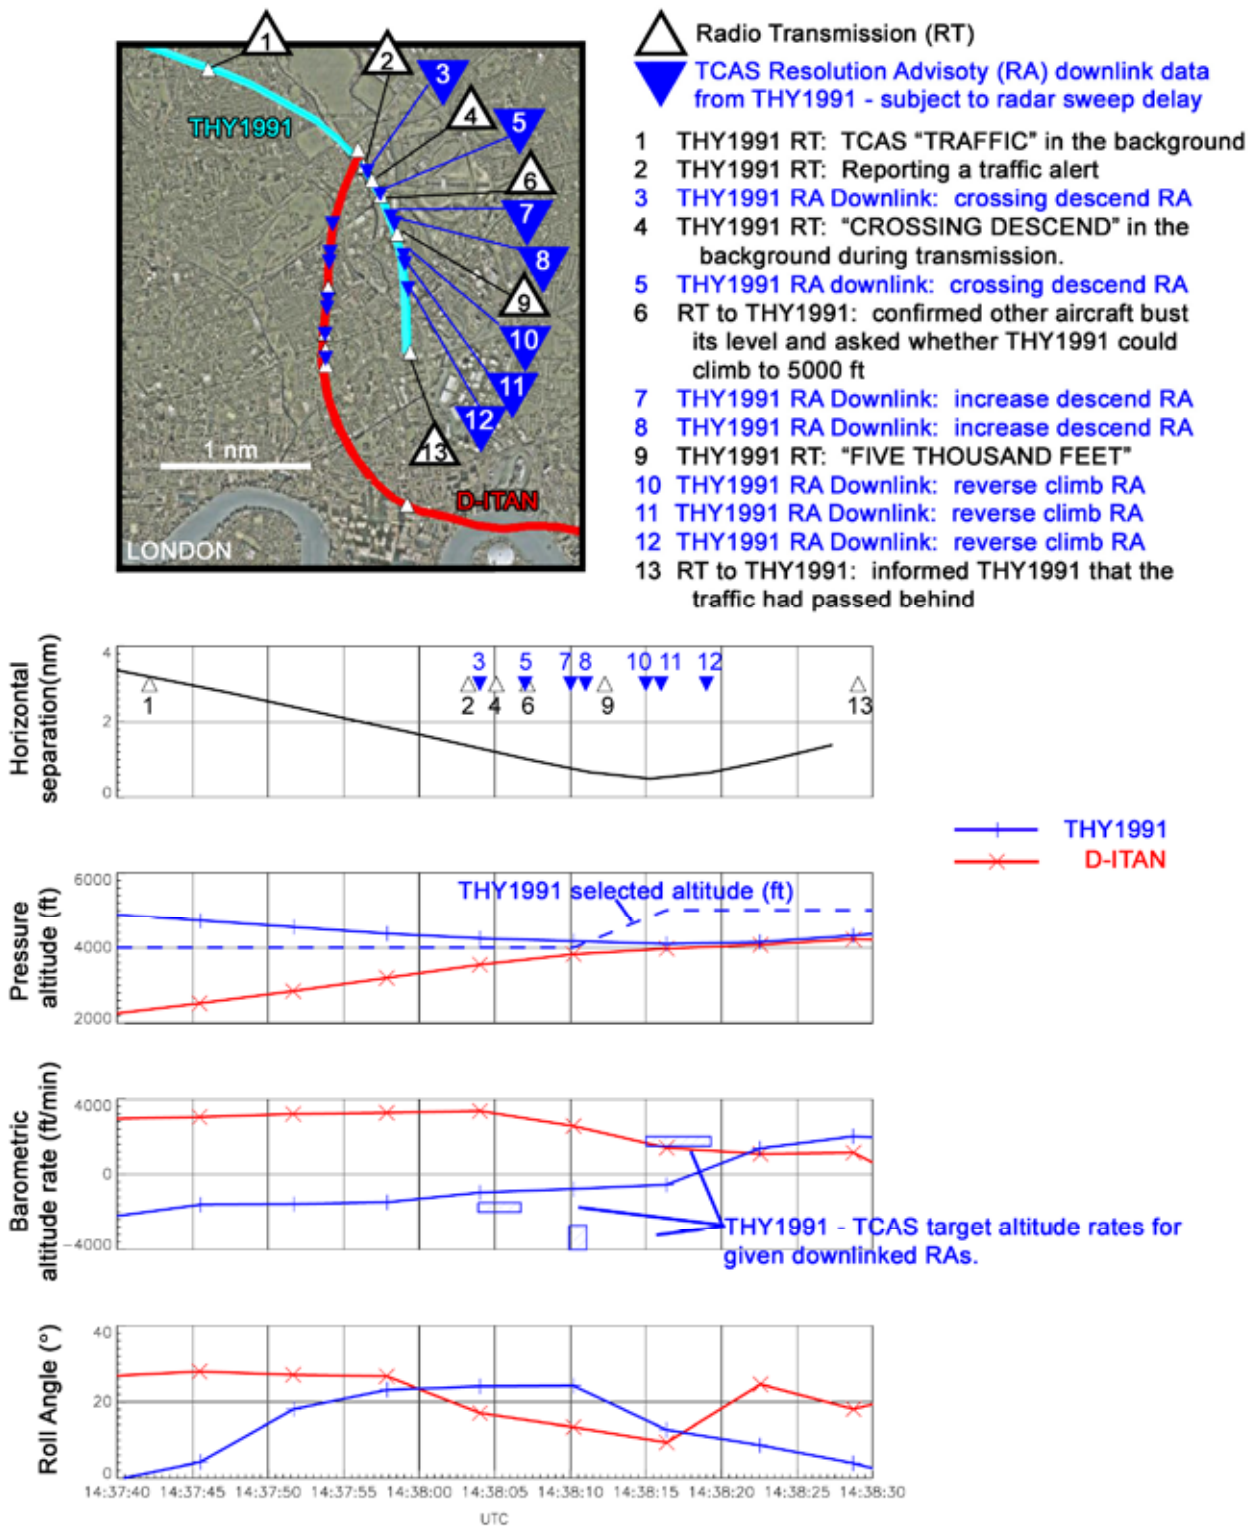
Figure 2
 Salient radar data, downlinked data and RT extracts

Figure 2 is an amalgamation of these data sources. The recordings showed that TCAS was fully operational on THY1991. A traffic alert was issued to the crew whilst descending to a selected altitude of 4,000 ft and the crew passed this information to the controller. Shortly after this, TCAS issued a “CROSSING DESCEND” RA. This was evident in the background of a transmission by THY1991, though may not have been noticeable to the controller, and was also downlinked via Mode S but this was not available to the controller. The RA required an increased descent rate; the descent rate was reduced. The controller asked whether THY1991 could climb to 5,000 ft. This was followed by a downlink of an ‘increase descent RA’, requiring a descent rate of greater than 2,500 ft/min. The crew read back “FIVE THOUSAND FEET”. The next RA downlinks indicated a reversal to a climb RA. This was followed by an increase in the selected altitude of the aircraft. The aircraft then passed abeam each other with a lateral separation of 0.5 nm and a vertical separation of 164 ft.

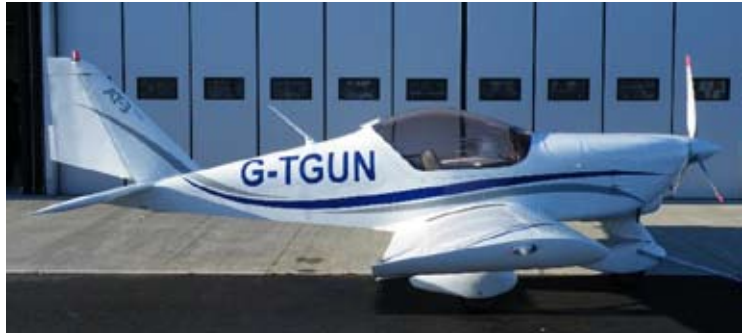
Figure 1

160° the propeller struck the fuel bowser, followed by the right wing. The engine stopped as a result of the propeller strike and the aircraft came to rest. The passenger vacated the aircraft first, followed by the pilot after he had turned off the switches. It was later determined that the parking brake lever had been upright, in the ON position.

Photograph of the incident aircraft, G-TGUN
(photograph courtesy Simon Palmer)

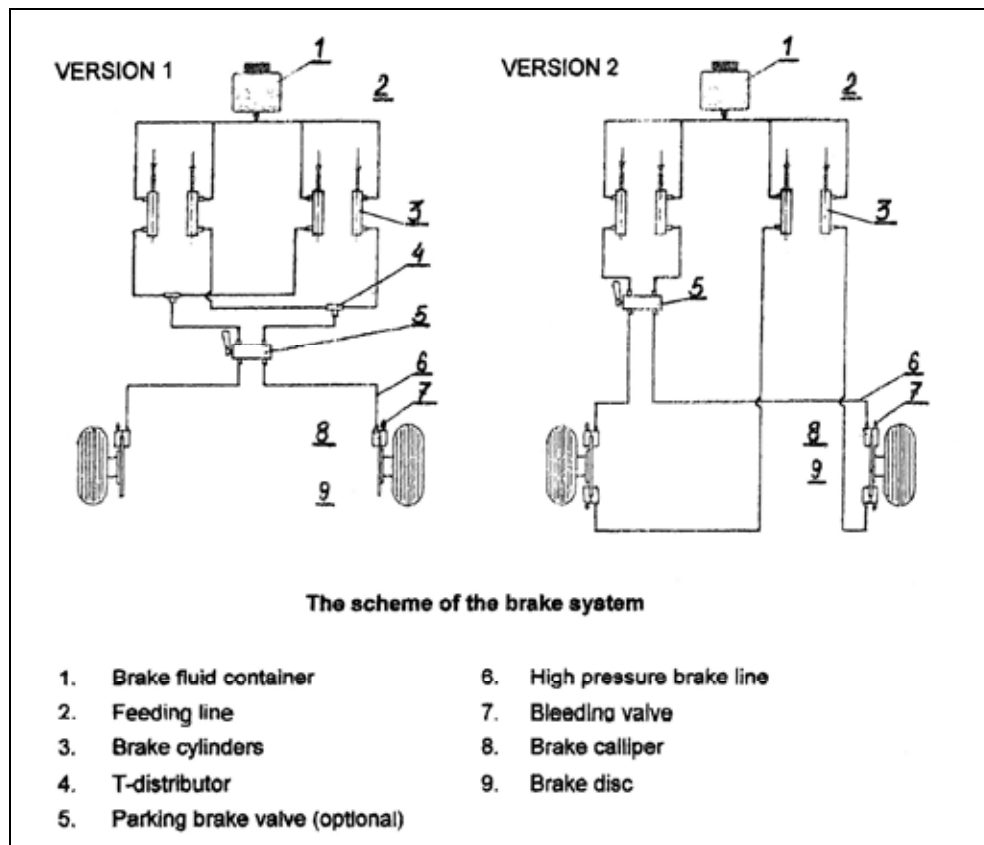
Figure 3

hydraulic pressure in the brake lines. The aircraft maintenance manual depicts two different versions of the braking system: Versions 1 and 2 as shown in Figure 3. Version 1 was fitted to early models of AT-3, while Version 2 was fitted to G-TGUN. In Version 1 there is one set of callipers per brake disk, and the left-seat and right-seat pedals operate the same pair of callipers. The brake pedals from both seats are routed

Brake system diagram extracted from Aero AT-3 Maintenance Manual (G-TGUN brake system was as 'Version 2' above with optional parking brake valve)

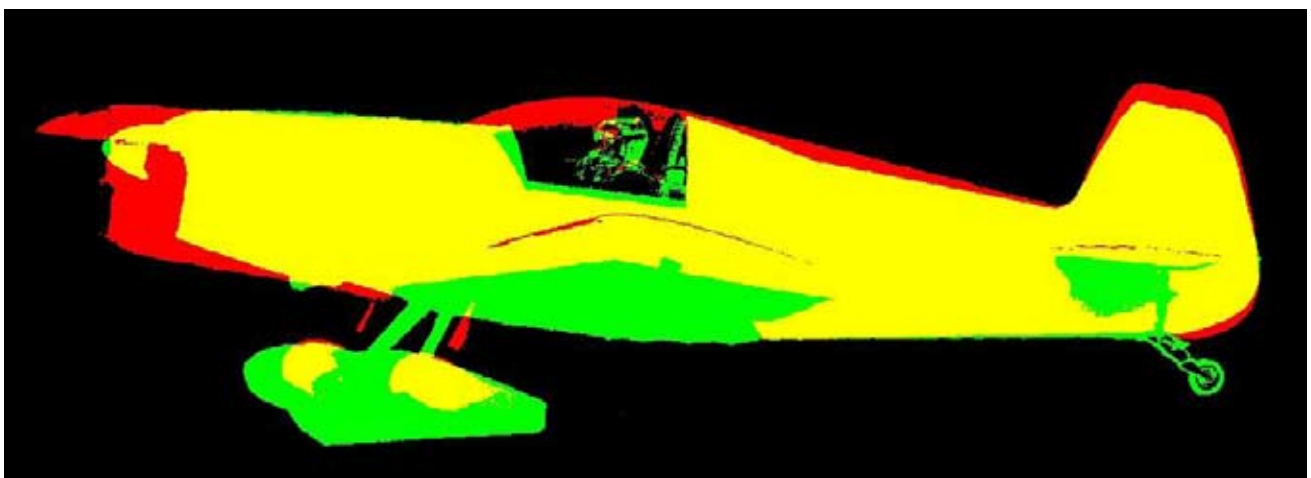
Figure 1

The AAIB investigation also commissioned a report by an aerodynamicist to identify how the spin characteristics of G-MISS differed from those of the standard Taylor Titch. The aerodynamicist used the method stipulated in the Defence Standard 00-970 Leaflet 18, *Spinning and spin criteria for spin resistance and recovery*, published by the UK Ministry of Defence in 1999. His report concluded that G-MISS would have been no more prone to enter a spin than a standard Taylor Titch. He also concluded that G-MISS would probably have recovered from a fully developed spin following the application of the normal spin recovery control

Comparison of the profile of a 'standard' Taylor Titch aircraft (green) with G-MISS (red), overlap region in yellow

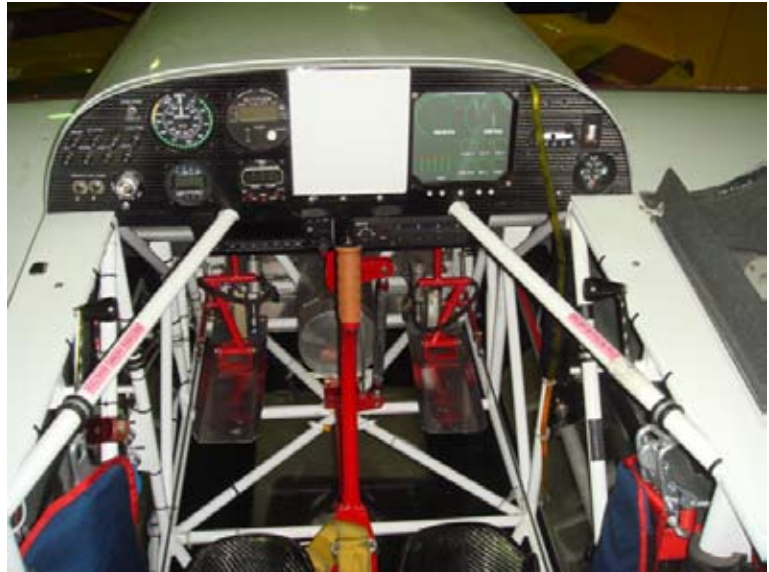
Figure 3 is a photograph of the cockpit layout. The control column was connected to the ailerons and elevators by a series of conventional pushrods and bell cranks. The rudder pedals were mounted on light alloy footplates which were attached to horizontal tubular steel fuselage cross-members. On the outer side of each pedal was a connection to a cable that ran rearwards to the respective rudder control horn. Also connected to the side of each pedal was a light spring that ran forwards and was attached to the fuselage structure. These springs prevented the rudder pedals from falling rearwards when no foot pressure was applied. The rudder pedals were operated with the pilot's heels on the foot plates and the balls of their feet pushing against horizontal tubes on each pedal. The aircraft was fitted with adjustable foot straps which passed through these horizontal tubes. When used, they ensure that the pilot's feet remain in contact with the rudder pedals; they also allow the opposing foot to pull at the same time as the other foot pushes. The range of movement of the rudder cables was ± 45 mm, producing rudder deflections of $\pm 30^\circ$.

Cockpit layout

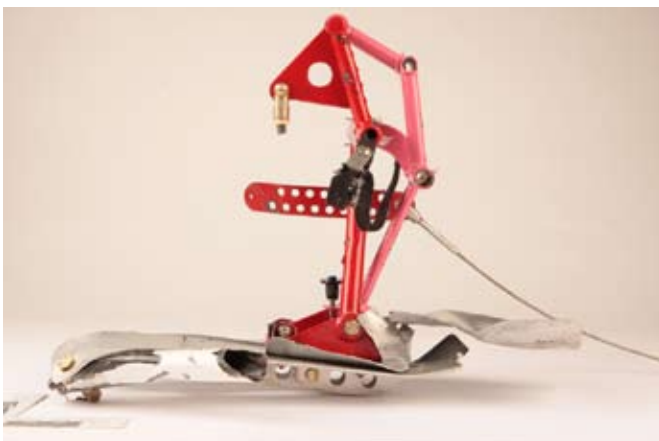
Figure 5
Right rudder pedal with extension

- a) The lower attachment of the rudder pedal extensions could be moved in a spanwise direction along the rudder pedal pivot tubes (see Figure 7).
- b) In the case of the non-extended rudder pedals, the force applied by a foot acts directly above the point at which the vertical element of

- c) There was wear damage on both the left and right pivot tubes consistent with the lower attachment of the rudder extensions moving laterally.
- d) There were witness marks on both pivot tubes. The evidence indicated that these were made by the pip-pins, which were positioned approximately 10 mm from the outboard vertical flange on the pedal base plate (Figure 7). These witness marks were probably made when the aircraft struck the ground, and might be indicative of the position of the lower attachments in the later stages of the flight.

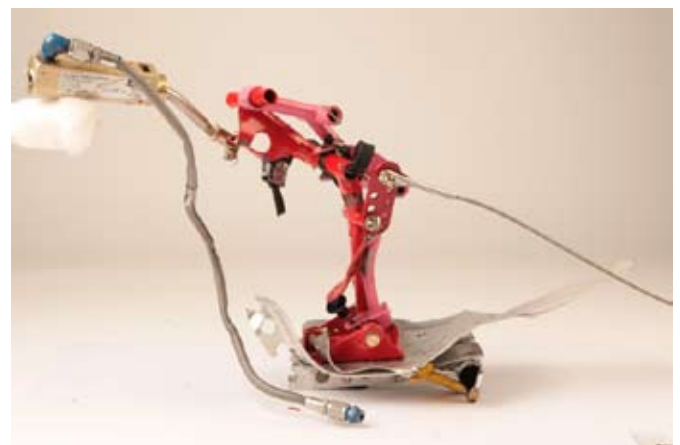
Figure 6
Left rudder pedal with extension

the pedal meets the pivot tube. This is due to the Z shape of the pedal. However, with the pedal extensions, the force applied by a foot acts inboard of the point where the vertical extension element meets the lower attachment, potentially creating a moment that can push the lower attachment outwards along the pivot tubes.

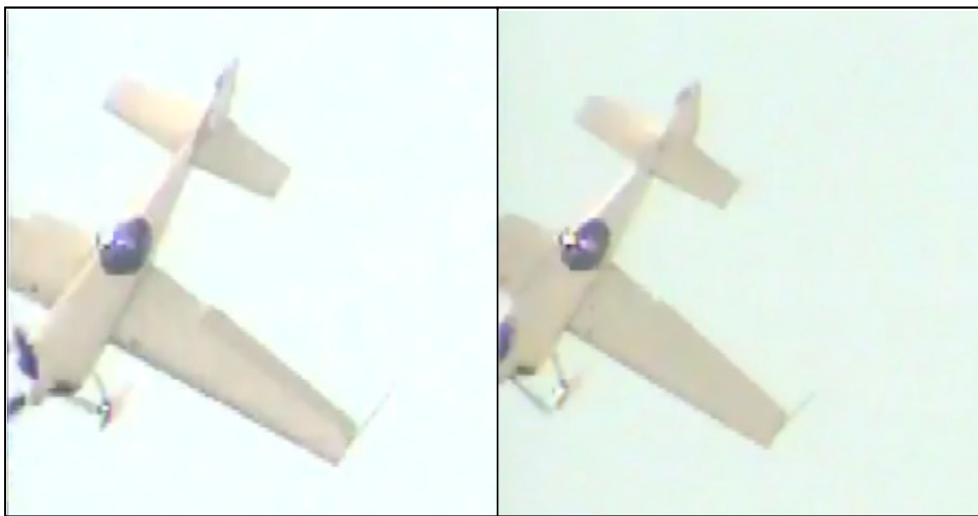
Figure 10 shows comparative video images from the practice and accident manoeuvres, from a point just after

initiation of the snap roll; the aircraft has rolled through about 120° at this point.

Shortly after initiation of the snap roll – the practice manoeuvre is on the left

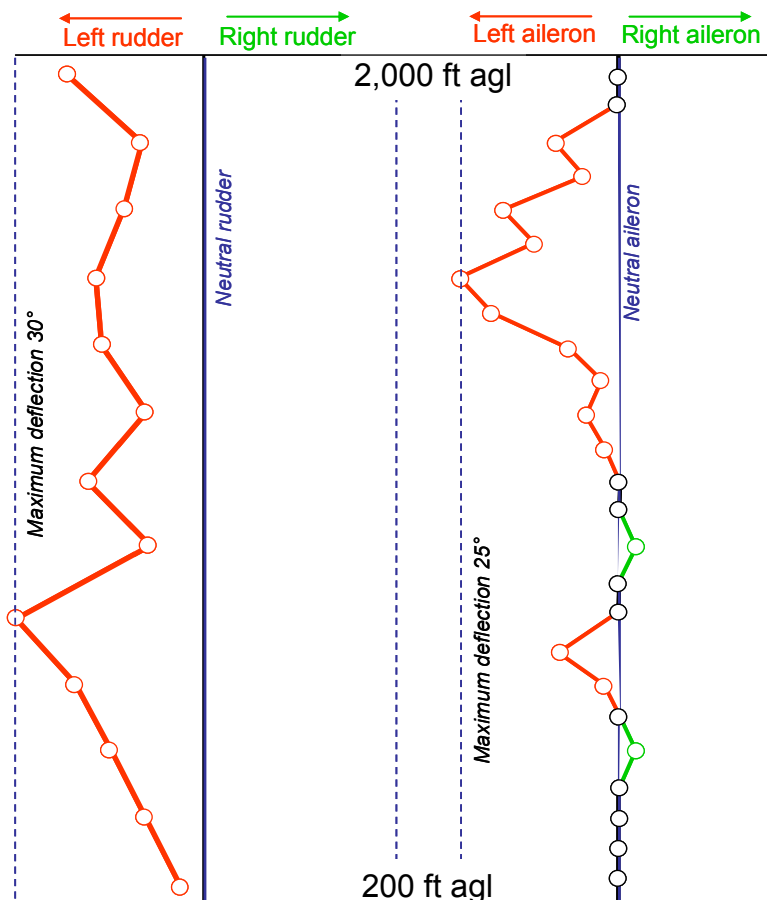
The radar-slaved video allowed a limited assessment of control surface positions. Figure 12 shows a graphical representation of rudder and aileron positions as the aircraft descended. The data begins at the point of intended recovery (1¼ turns after initiation of the snap roll) and ends when the aircraft descended out of view behind trees. Rudder position could only be accurately assessed when the aircraft presented a plan form to the camera, so the data points are plotted for every half turn. Increased data points are presented for aileron deflections; one per quarter turn. This was possible due to movement of the aileron spades under the wing, which allowed an assessment of their position when viewing the aircraft underside. Also, generally better views of aileron deflection allowed a degree of

Rudder and aileron deflections
