No: 8/90

Ref: EW/C1161

- (1) De Havilland DH82A Tiger Moth, G-AOZB
- (2) Piper PA-28-181, G-BNNP

Near Redhill aerodrome, Surrey

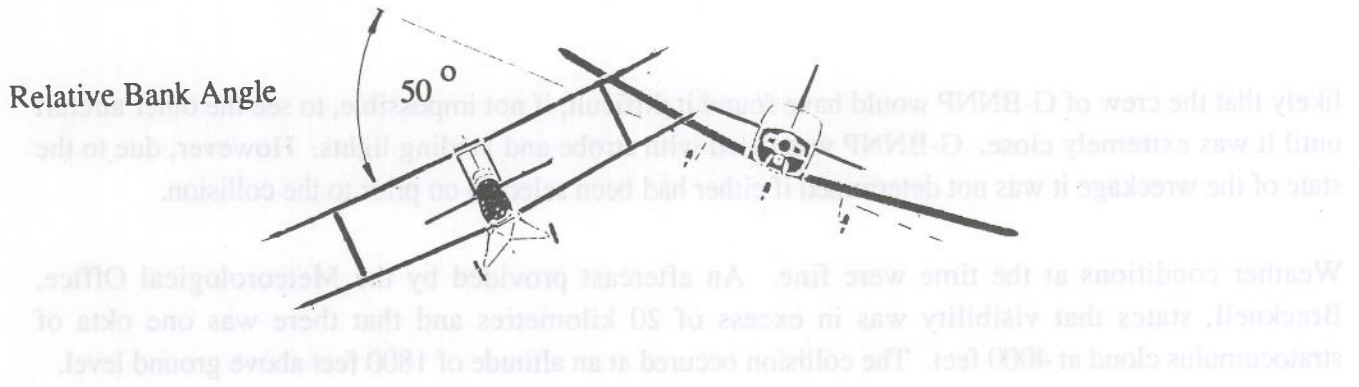
From eye-witness evidence and examination of recordings from both Pease Pottage and London Heathrow radars it is apparent that prior to the collision both aircraft had been flying directly towards each other for a period of at least two minutes, and at a closing speed of approximately 180 knots. During this time G-BNNP was descending and G-AOZB was climbing. Flying on a northwesterly heading, the pilot of G-AOZB would have been heading almost directly into sun. The predominant colours of G-BNNP were light grey and blue. At the same time G-BNNP was descending on a southeasterly heading towards a background of undulating rural countryside. The predominant colours of G-AOZB were green and white. There is some evidence that the pilots may have seen each other's aircraft at the last second, but too late for either or both to complete avoidance action. Figure 2 indicates the likely 'dead ahead' field of view from the cockpits of these two aircraft. From this it would seem

likely that the crew of G-BNNP would have found it difficult, if not impossible, to see the other aircraft until it was extremely close. G-BNNP was fitted with strobe and landing lights. However, due to the state of the wreckage it was not determined if either had been selected on prior to the collision.
