SERIOUS INCIDENT

Aircraft Type and Registration:	Boeing 747-4H6, 9M-MPL	
No & Type of Engines:	4 Pratt & Whitney PW4056-3	
Year of Manufacture:	1998	
Date & Time (UTC):	17 August 2012 at 2320 hrs	
Location:	On approach to Runway 09R at London Heathrow Airport	
Type of Flight:	Commercial Air Transport (Passenger)	
Persons on Board:	Crew - 22	Passengers - 340
Injuries:	Crew - None	Passengers - None
Nature of Damage:	Electrical failures, hard landing and component failure to No 2 engine	
Commander's Licence:	ATPL	
Commander's Age:	40 years	
Commander's Flying Experience:	10,753 hours (of which 393 were on type) Last 90 days - 80 hours Last 28 days - 11 hours	
Information Source:	AAIB Field Investigation

Synopsis

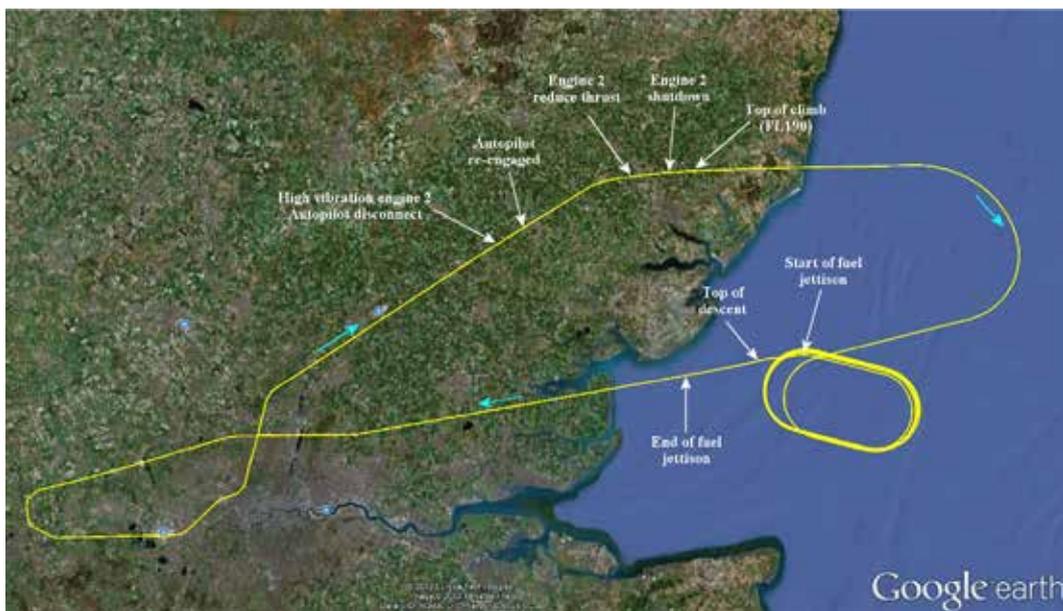
Figure 1
9M-MPL Ground radar track

The DFDR data showed that the departure from London Heathrow at 2129 hrs was uneventful and all engine parameters appeared normal. The recordings showed that takeoff gross weight was 377,000 kg and the aircraft was carrying 149,000 kg of fuel. A ground track of the entire flight derived from the DFDR recording is shown in Figure 1.

At 2140 hrs, as the aircraft was climbing through FL130, the No 2 engine oil temperature started to increase markedly. At the same time there was a step increase recorded in the level of broadband vibration and the vibration levels associated with the N₂ stage of the same engine; no change in engine thrust was evident with all engines indicating an engine pressure ratio (EPR) of about 1.4. The status of the left autopilot, which had been the only one engaged, changed to disengaged but was re-engaged 26 seconds later.

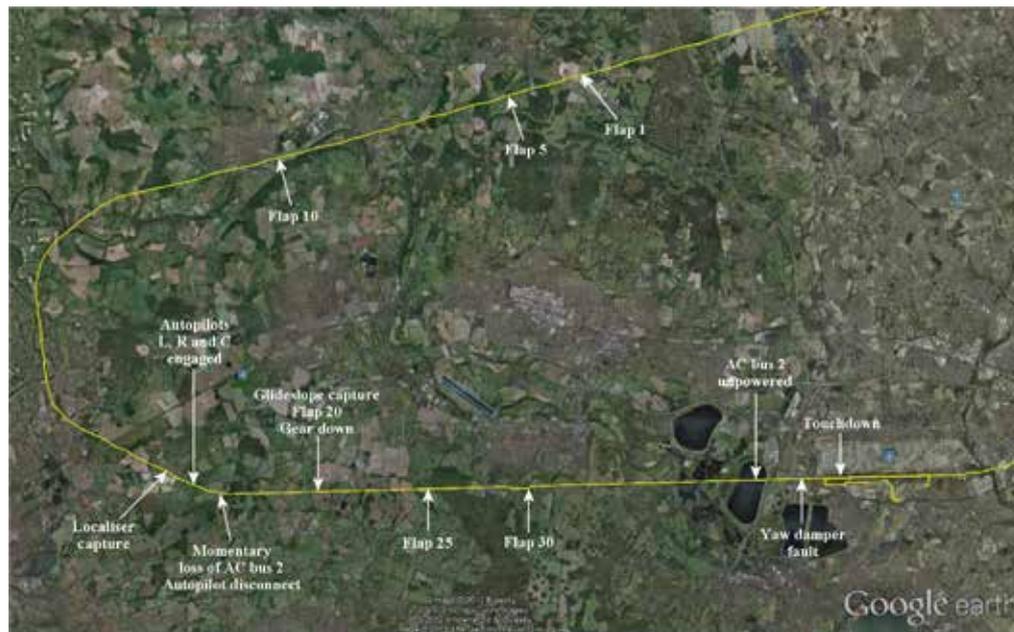
Figure 2

At 426 ft agl, 35 seconds before touchdown, AC Bus 2 lost power and remained in that state until after the landing. Following the loss of AC Bus 2, some other parameters showed anomalies: hydraulic system 2 indicated low pressure and the recorded positions of the left inner and left outer trailing edge flaps changed instantaneously to zero. Seventeen seconds later the lower yaw damper also reported a fault. The approach ground track is shown in Figure 2.

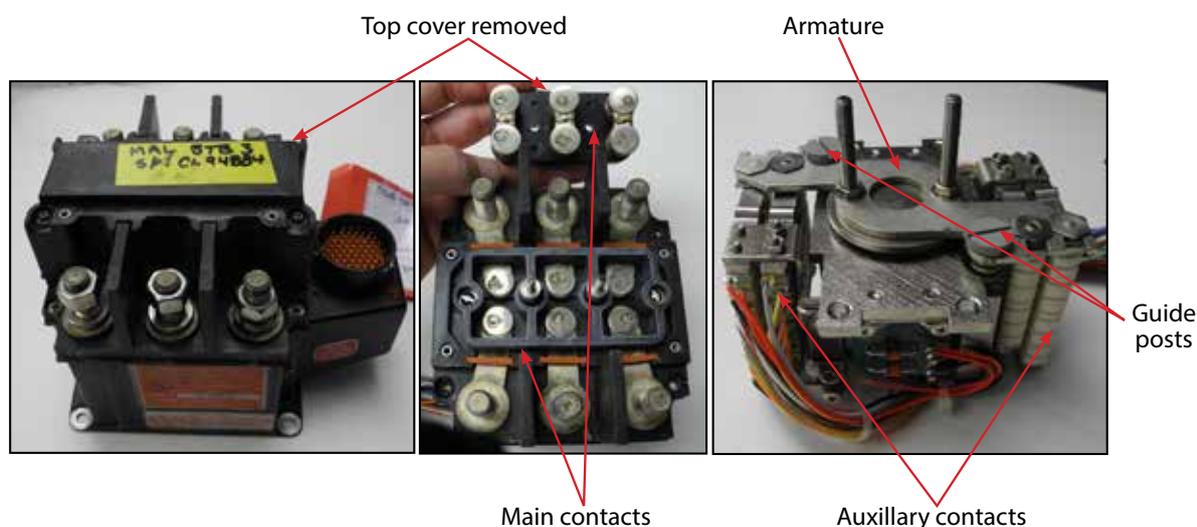
Figure 6
B430Z Contactor

Circuit breakers, or contactors, are used extensively throughout the B747-400 electrical system and include the BTBs, GCBs and SSB. These identical components, Part Number B-430Z, are also used on the B747-8 aircraft. The contactors have three main contacts: T1 L1 for Phase A current; T2/L2 for Phase B; and T3/L3 for Phase C. There are also 26 pairs of auxiliary contacts (1/2, 3/451/52) which fulfil a variety of functions within the electrical system (Figure 6).

Auxiliary contacts 51/52 on the BTBs, GCBs and SSB are used for the Difference Current Protection circuit. They are 'normally open'; that is, when the main contacts are closed, this set of auxiliary contacts will be open, and vice versa. BTB auxiliary contacts 15 /16 provide status information to BCU 1 and auxiliary contacts 31/32 provide status to BCU 2.

The DCP design allows for a maximum of 1 ohm contact resistance in the auxiliary contacts of the BTBs and GCBs. A resistance of more than 1 ohm will give the GCU false current measurements on the GCU sensing circuit, and may cause the BTB on that channel to trip.
