SERIOUS INCIDENT

Aircraft Type and Registration:	Britten-Norman BN2A-26, Islander, VP-MON	
No & Type of Engines:	2 Lycoming O540 piston engines	
Year of Manufacture:	1969	
Date & Time (UTC):	22 May 2011 at 2154 ¹ hrs	
Location:	John A Osborne Airport, Montserrat	
Type of Flight:	Commercial Air Transport (Passenger)	
Persons on Board:	Crew - 1	Passengers - 7
Injuries:	Crew - None	Passengers - None
Nature of Damage:	None	
Commander's Licence:	Commercial Pilot's Licence	
Commander's Age:	34 years	
Commander's Flying Experience:	3,600 hours (of which 2,000 were on type) Last 90 days - 13 hours Last 28 days - 13 hours	
Information Source:	AAIB Field Investigation

Synopsis

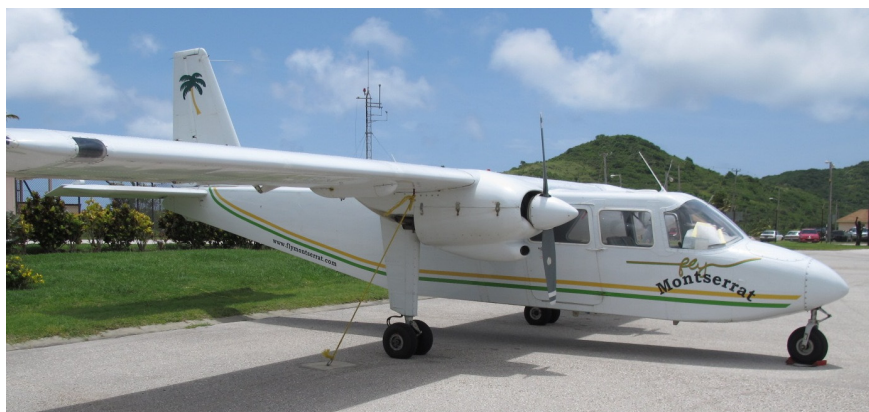
Figure 1

The incident aircraft VP-MON

The locally based Accident Investigation Manager (AIM) carried out an external examination of the aircraft on the evening of the incident while it was parked on the aerodrome apron. He did not notice any damage to the aircraft and he took photographs of the tyres which did not reveal any flat spots to the visible areas. The pilot carried out his normal pre-flight checks with emphasis on checking the brakes and then flew the aircraft to the operator's maintenance facility in Anguilla where a scheduled 50-hr inspection was carried out. During this inspection the aircraft's brake system was examined and tested with no faults found. The brake liners on both left main wheels and the right inboard main wheel were found to be worn and consequently replaced. However, the maintenance engineer reported that the liners were not worn beyond limits and would not have affected normal brake operation. Both right main wheel tyres were found to be worn to near the tread limit and replaced. The aircraft was examined for damage but none was found.

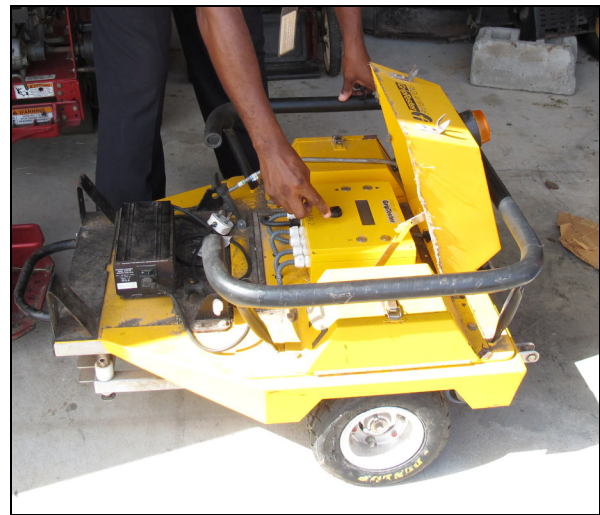
Figure 4

'GripTester' continuous friction measuring device used by the airport operator

The airport operator subsequently carried out some friction runs in July, August, September and October, but due to equipment problems no reliable data was obtained. It stated that it now has personnel trained to conduct friction measurements, and that technical problems with the equipment would be resolved on delivery of replacement parts.
