*Accident
on 25 July 2000
at La Patte d'Oie
in Gonesse (95)
to the Concorde
registered F-BTSC
operated by Air France*

REPORT translation
f-sc000725a

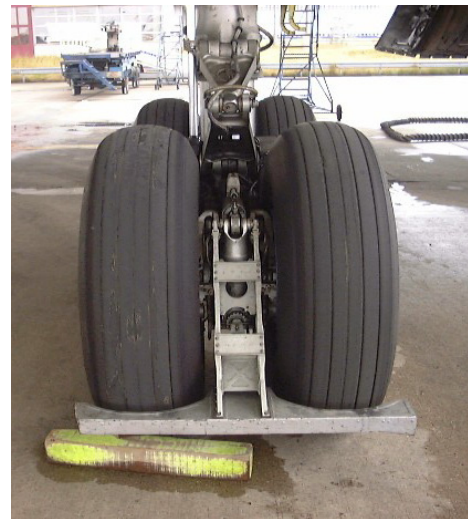
Figure 4: Water deflector

The deflectors are situated forward of each main landing gear. Their function is to deflect projected water so that it does not enter the engine air intakes. Weighing around four kilos, they are made of composite materials and fibre glass (to make them frangible) except for the bogie fasteners.

In 1995, these deflectors were the subject of an optional Service Bulletin (SST 32-103 of 12/01/95 modified on 28/02/95) which proposed the insertion of two cables in the leading edge in order to retain pieces of the deflectors in case of failure. Air France did not apply the aforementioned Service Bulletin.

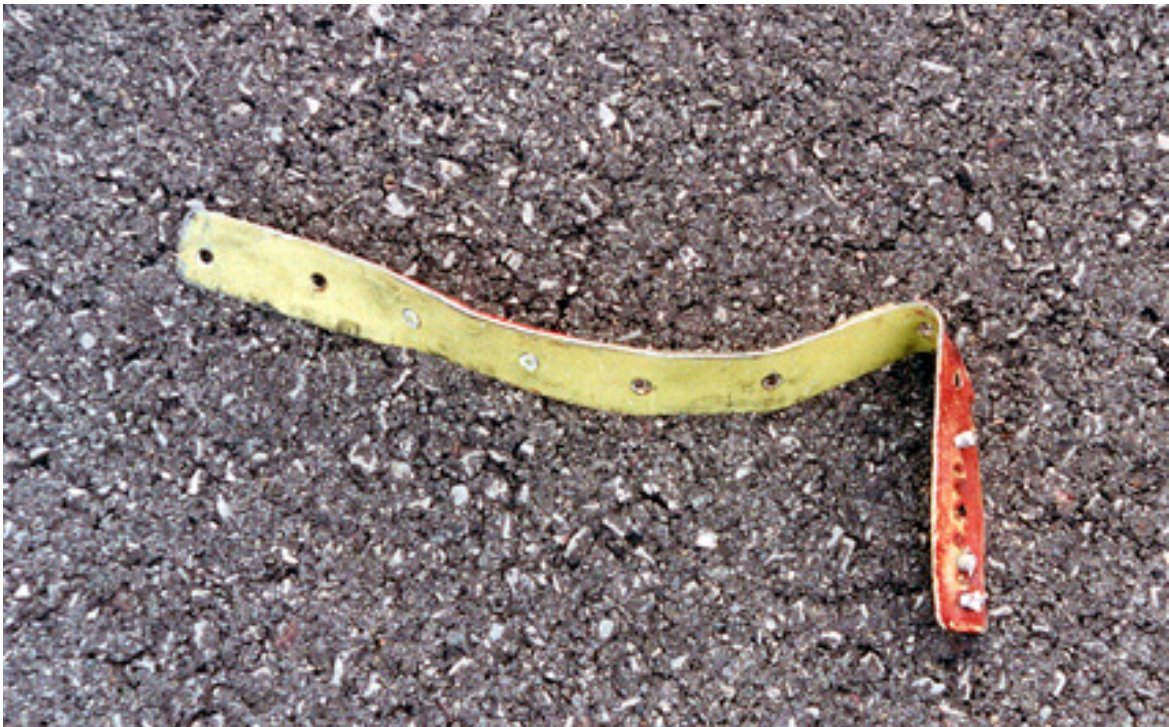
Figure 21: Piece found at line 152

On visual inspection, the piece appeared to be made of light alloy, coated on one side with epoxy primer (greenish) and on the other side with what appeared to be red aircraft mastic for hot sections (RTV 106). It did not appear to have been exposed to high temperature.

This piece was not identified as part of the Concorde.

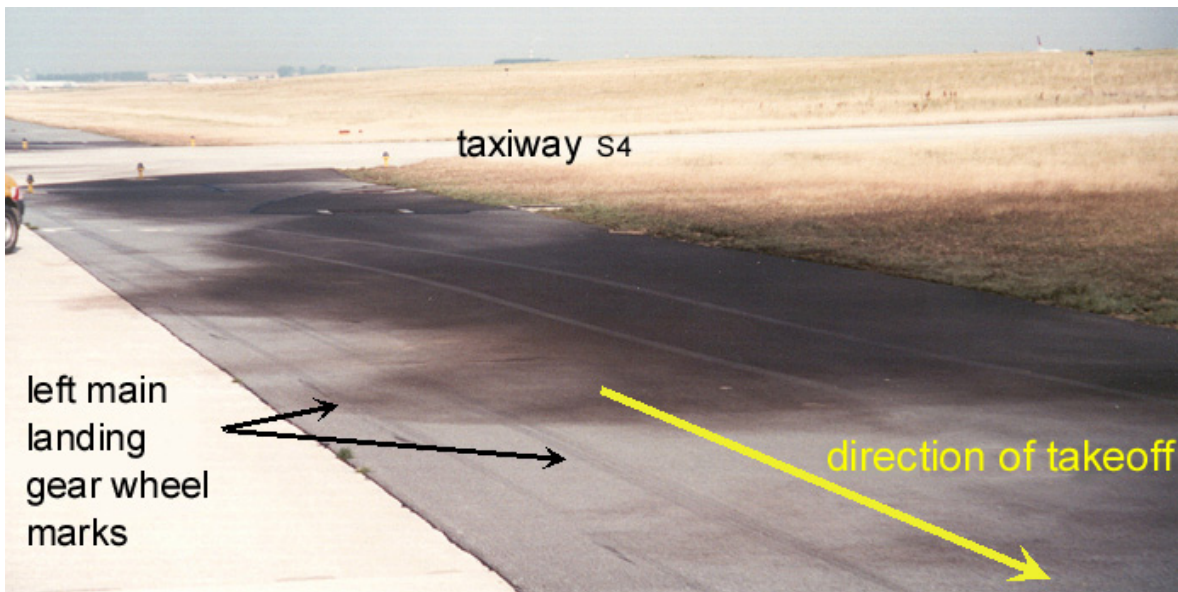
Figure 27: Left main gear wheel marks

The grass was burnt adjacent to the runway edge, between 2,902 and 3,165 metres. This area, also featuring soot deposits, indicated that there was an extensive flame after the aircraft became airborne.

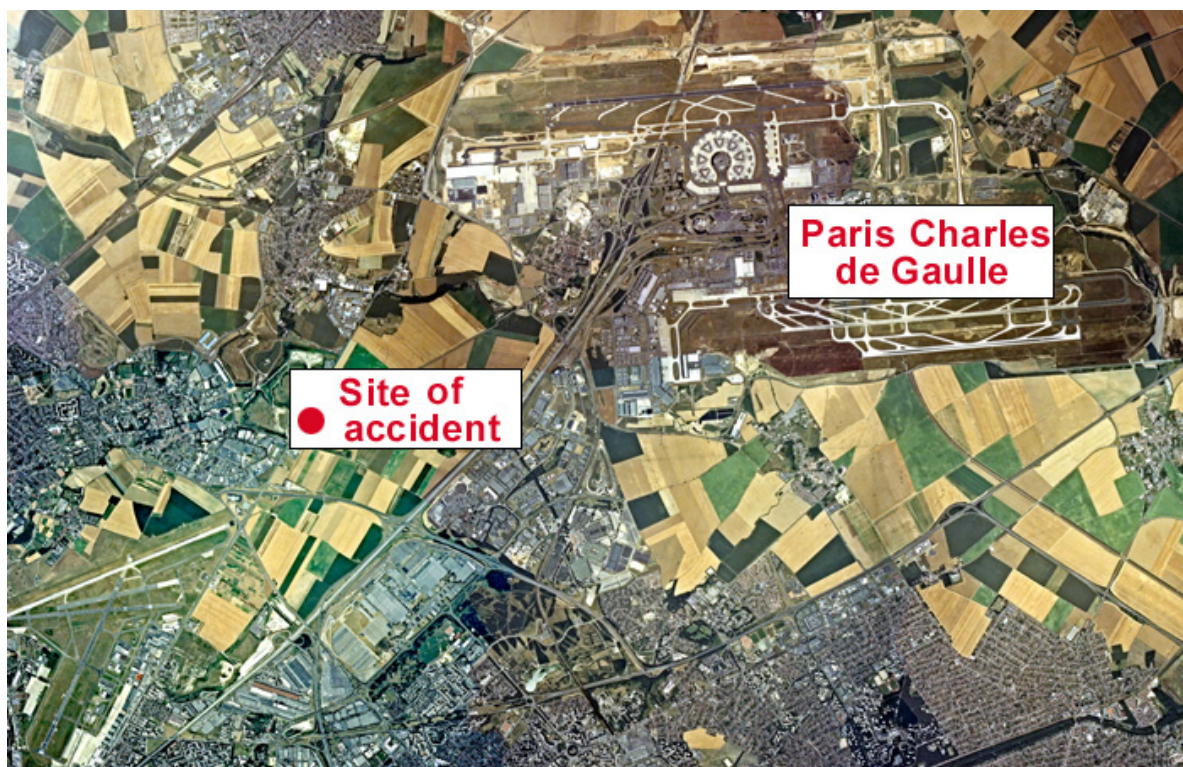
Figure 29: BEA/IGN/FLEXIMAGE image - Aerial photo of the accident site

The crash occurred south-west of Paris Charles de Gaulle airport at about 9,500 m from the threshold of runway 26R in a level area. The altitude of the area is 400 feet. The wreckage was at the intersection of the N17 and the D902 roads.

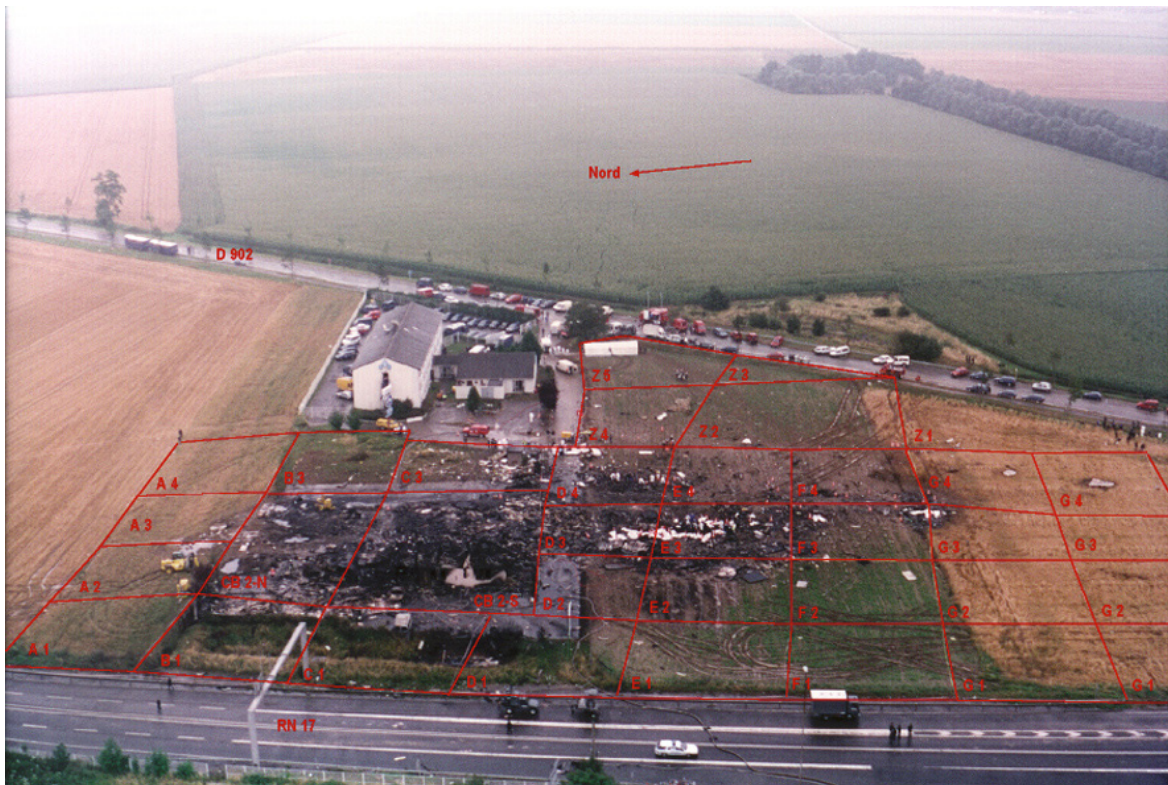
Figure 31: Aerial view with indications of zones

Examination of the site showed that the aircraft had struck the ground on heading 120° left, practically flat with little forward speed. After the impact, it broke and spread generally to the south, with the aircraft upright.

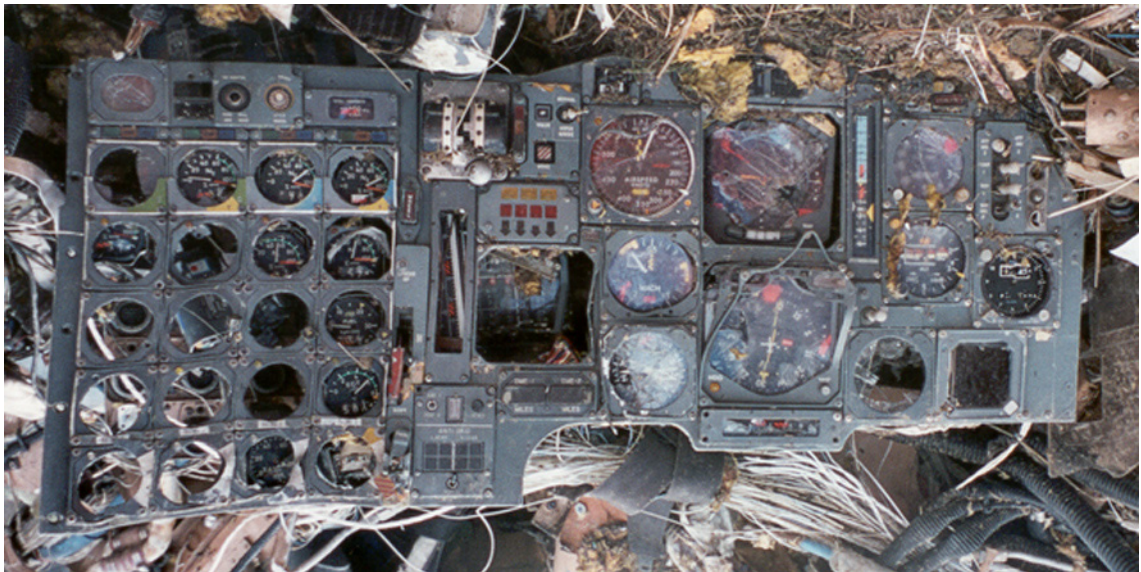
Figure 34: Overall view of instrument panel

- the Nose/Visor lever was in the "Down" position
- the landing gear selector was towards the "Down" position, past the gate
- on the rudder position indicator (damaged on impact), the rudder indicators were at 20° left for the upper control surface and 12° right for the lower control surface on "G" (Green). The indicators for the elevons were on "M" (Mechanical) and provided no information
- the airspeed shown on the airspeed indicator was 99 Kt, "STBY" flag, and V2 bug was on 230 kt
- HSI heading 105°, ADI 30° roll to the left and 32° nose down. Vz - 1,800 ft/min, altimeter - 240 feet "STBY" flag, radio altimeter unreadable, VOR1 028°, VOR2 038°
- FD switch on number 2
- attitude selector on ATT INS3, comparator on COMP2, deviation on DEV2, navigation on NAV INS2
- clock on 14 h 45 UTC

- HSI heading 105°, ADI 15° roll to the left and 75° nose down, standby horizon 90° roll to the left and 18° nose-up, Vz – 1,200 ft/min, altimeter - 250 feet STBY, radio altimeter on 0, angle of attack indicator unreadable, RMI ADF heading 100°
- trim indicator on 54.3%
- the TCAS was broken

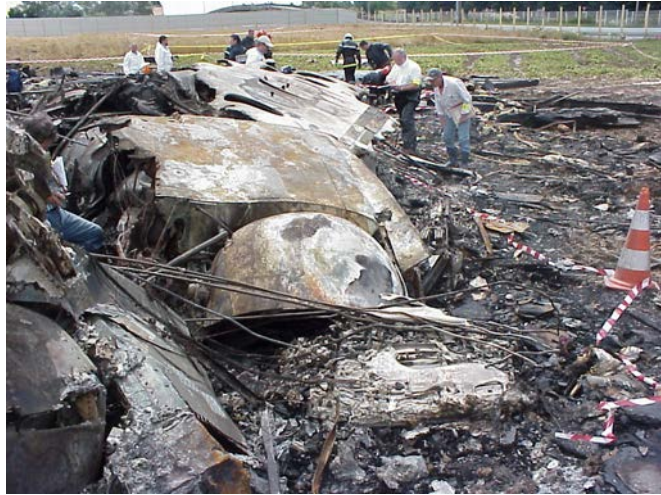
Figure 35: General view of engine 4 upper nozzle

The upper secondary exhaust nozzles were still in place on engines 1, 2, 4 and separated from the nozzle structure on engine 3. The lower secondary exhaust nozzles were separated from the structure and three of them were found intact. The upper actuators from engines 2 and 4 were attached to the structure and to the nozzles. The lower actuators were found at the site with the exception of that of engine 3.

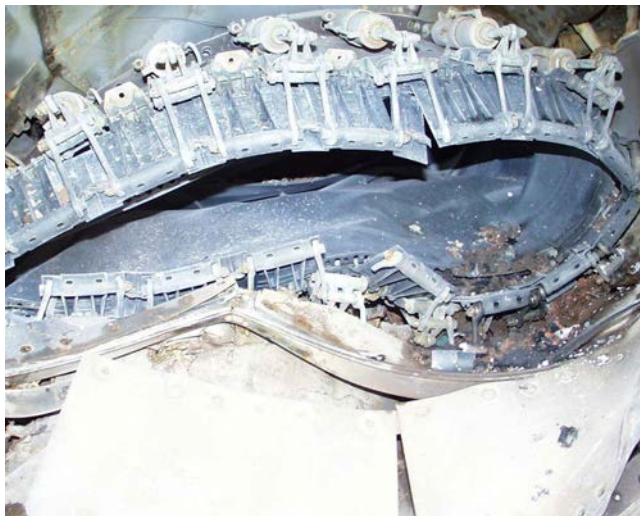
Figure 36: Engine 2 exhaust nozzle

The primary exhaust nozzle from engine 3 was separated from the structure of the secondary nozzle. The latter was torn away from the rest of the engine. The nozzles from engines 1, 2 and 4 were in place but flattened by the impact with the ground.

The primary and secondary nozzles showed no signs of overheating on any of the engines. Black marks were visible on the inner panels of the engine 1 nozzles. Traces of soot were also found on the upper right part of the structure of the engine 2 nozzles. No trace of damage caused by an uncontained engine burst was noted.

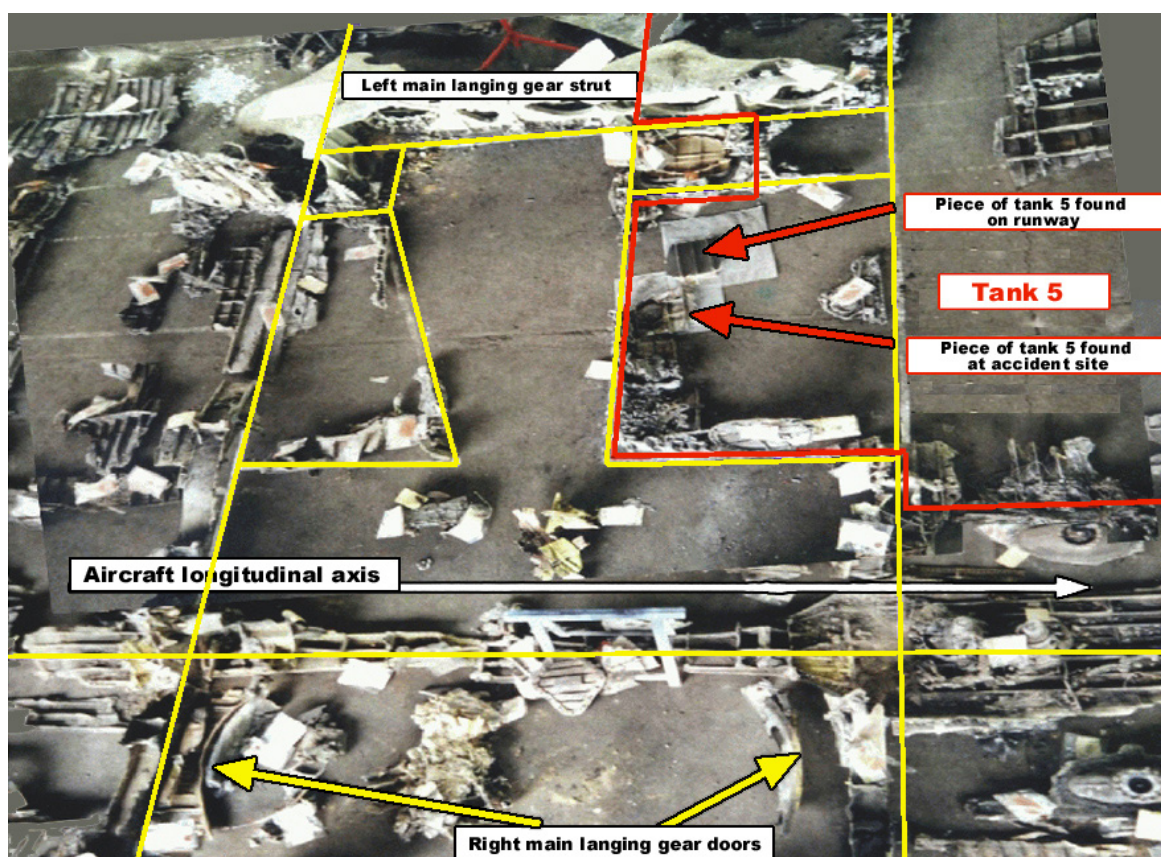
Figure 38: View of wing reconstruction in hangar

The parts found at the accident site were sorted according to geometrical criteria, so as to create groups of pieces before identifying and positioning them. The pieces of the wing were laid flat on two areas representing the upper and lower wing surfaces. The condition of the wreckage did not, however, allow much useful information to be gleaned for the investigation.

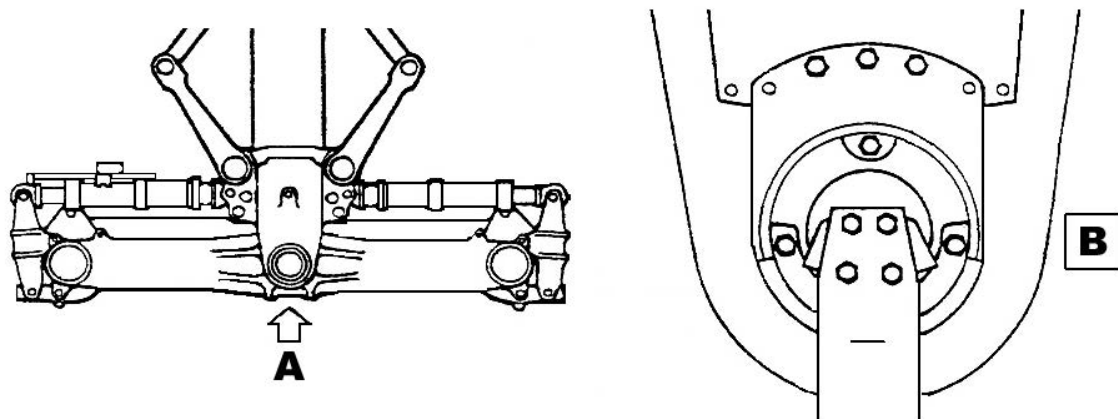
Figure 41: Leg-bogie coupling

- The forward and rear hinges of the right main landing gear inner door were identified.. The forward hinge was blocked in a position consistent with a closed door. The rear hinge was limited to a movement of about 20° around the normal closed position.
- A spacer, which holds two lateral rings in position, was missing from the oleo/bogie coupling on the left main landing gear. This retainer had not been re-installed during the A01 check performed from the 17 to the 21 July 2000.

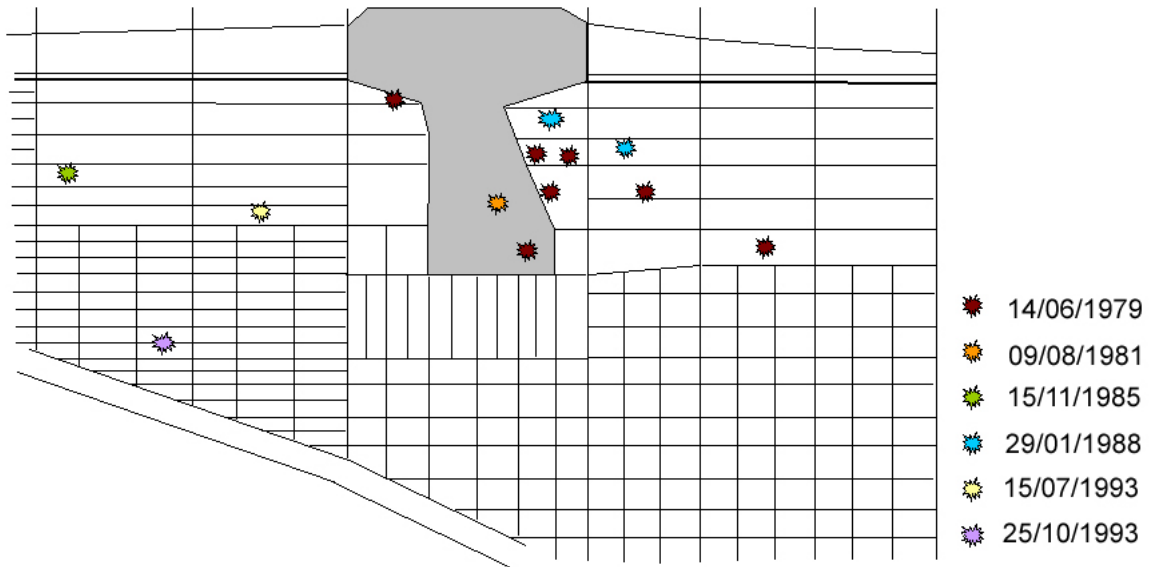
Figure 46: Location of impacts with punctures during various incidents

15 July 1993: G-BOAF on landing at London Heathrow. Burst of tyre No 4 leading to damage to the gear door mechanism. Tank 8 was damaged, probably by a piece of this mechanism.

25 October 1993: G-BOAB during taxiing at London Heathrow. Burst of tyre No 2 leading to damage to the water deflector. Tank 1 suffered minor penetration, probably from a piece of the deflector.

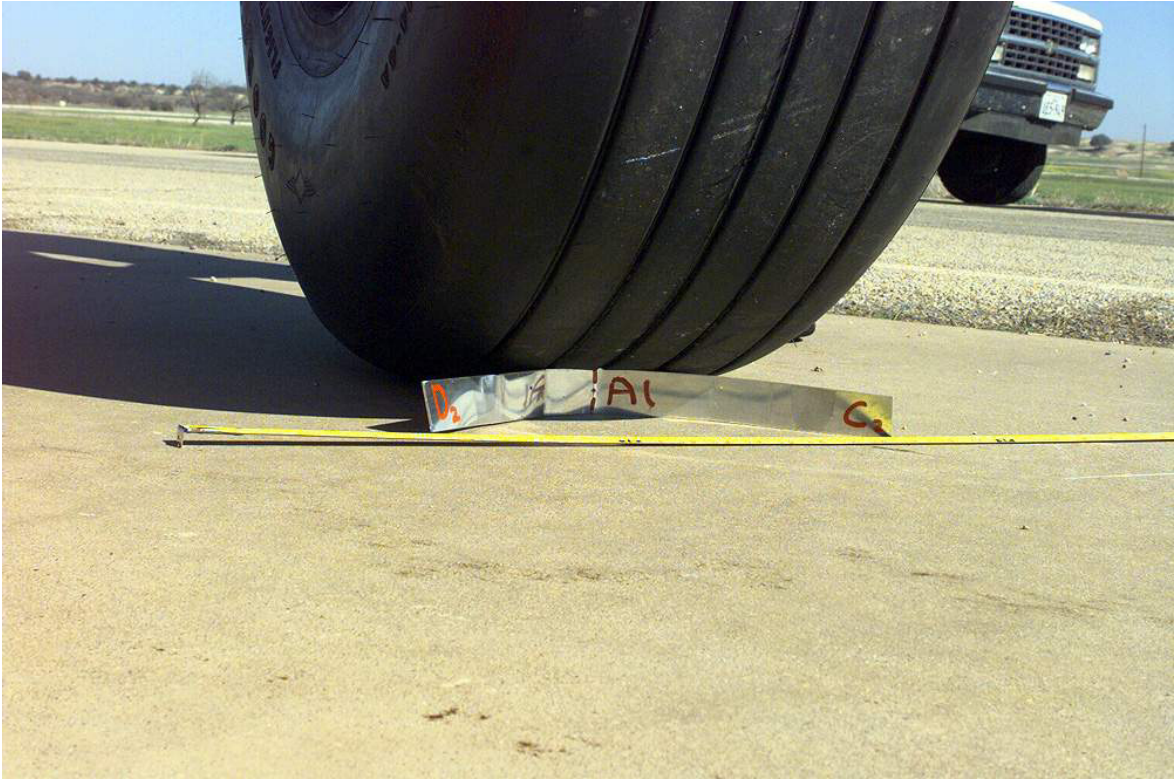
Figure 48: Position of the metallic strip under the tyre

- an initial positioning of the strip, done with the titanium strip, resulted in its being flattened by the tyre,
- in a second position, the strip remained stable on its cutting side and the tyre was cut into,
- the tyre cut went right through its thickness, practically all across the width of the area in contact with the ground and in accordance with the shape of the strip,
- this cut continued as tearing onto the tyre shoulders and sidewalls through a static rupture in the direction of the reinforcing material of the tyre body,
- the static tear spread as far as the tyre beads, in other words slightly more deeply than the tear noted on the remains of tyre No 2 on F-BTSC.

Extension of the lines from the tear demonstrates that the piece that could be released was comparable to the piece of tyre found after the accident near to the strip.

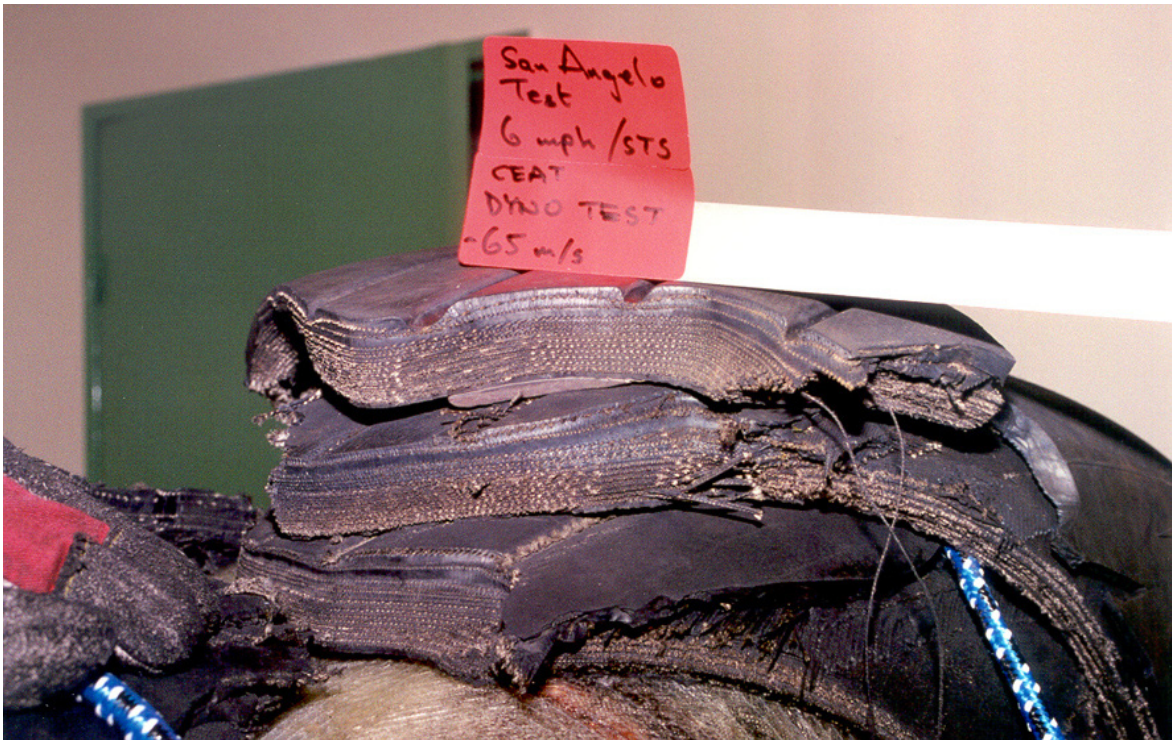
Figure 50: Cuts in various Concorde tyres

Various pieces of the tyre cut during the tests conducted in the USA and at the CEAT were examined at the LRCCP. Observation showed the resemblance of their rupture topography with that of tyre No 2.

The photo below shows the positioning of three pieces coming, from top to bottom, from tyre No 2 (speed of around 85 m/s), from a tyre tested at the CEAT with impact at 65 m/s and a tyre tried in the United States with impact at 2.5 m/s.

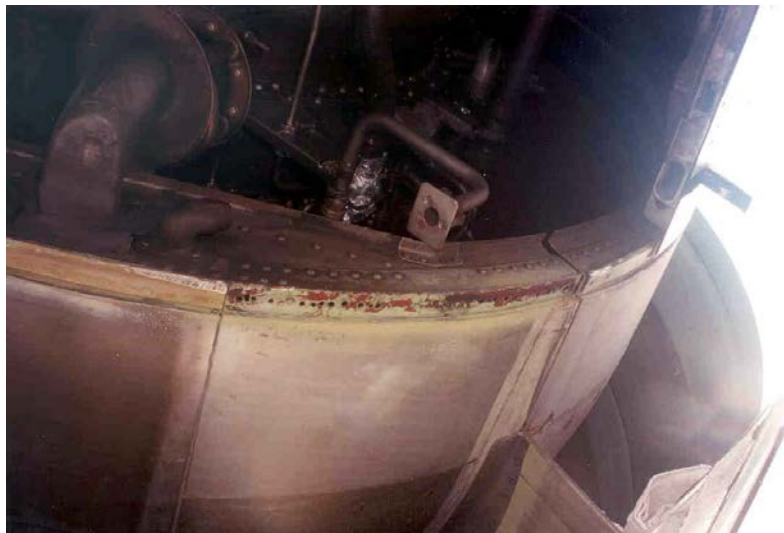
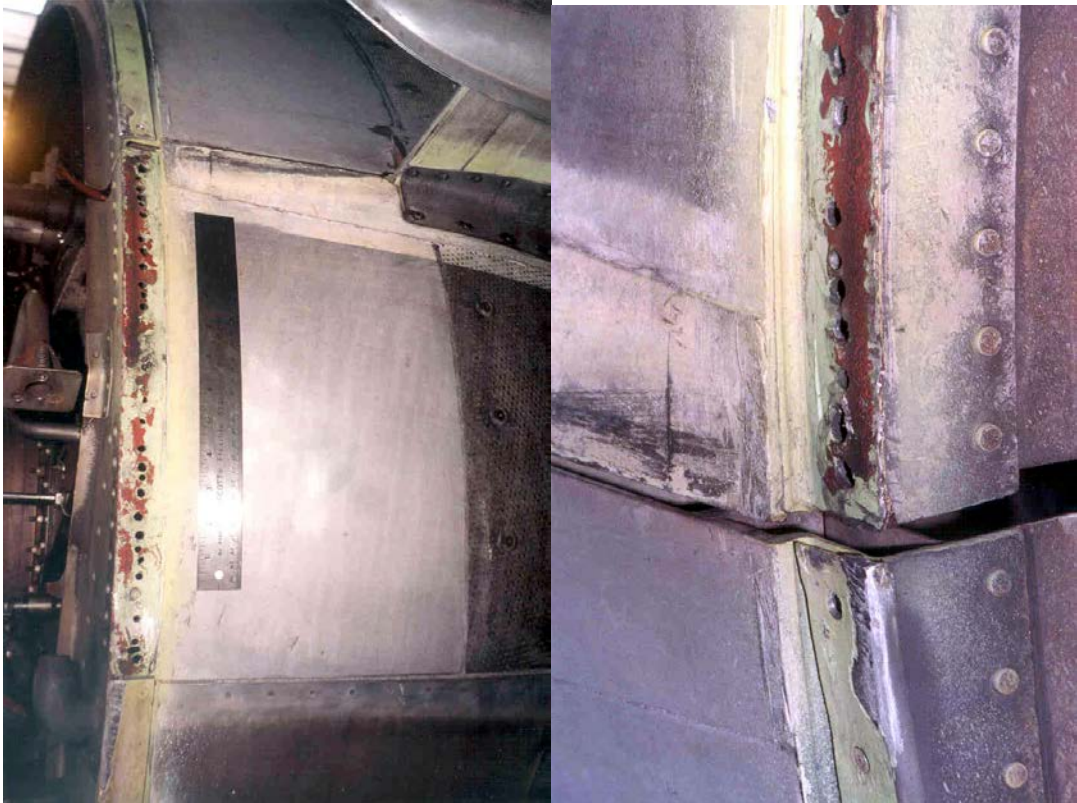
Figure 52: Pictures showing the position of the wear strip

- the lower left wear strip, about forty-four centimetres long, was missing. When closed, the forward part of the core door usually rests on the wear strip,
- the support was painted with green epoxy primer,
- in the position where the missing part would be, the support was covered in red type RTV 106 mastic,
- there was no trace of RTV 106 on the other parts of the support,
- there was no trace of RTV 106 on the wear strips which are in place,
- there were numerous paint runs on the support and on the wear strips and the paint,
- partially overlapped onto the fan reverser cowl,
- in the position of the missing part, the support still possessed several rivets,
- the support was drilled with thirty-seven holes, of which some had gaps between them,
- that were less than twice the diameter of the holes.

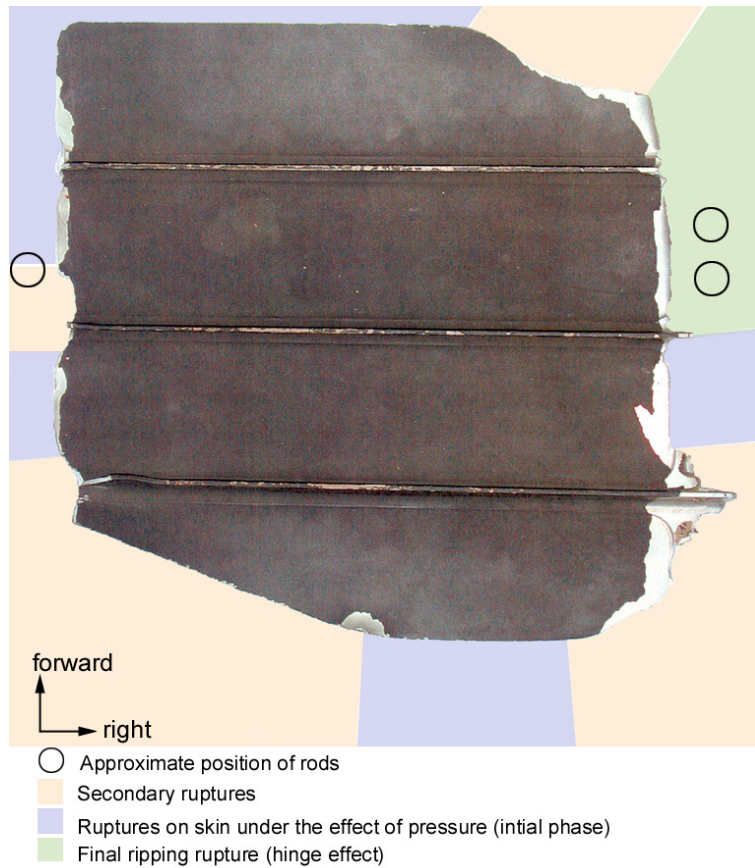
Figure 56: Rupture sequence for piece from tank 5

- some of the damage noted on the rear part was caused by impact with the ground,
- the cells possessed bulge deformations whose main line was perpendicular to the stiffeners. the radius of curvature measured in the areas away from the point of impact with the ground was of the order of 1.2 m,
- the ruptures in the thin skins were matt for the most part; the rupture face was angled at 45°, which indicates that these were static ruptures,
- the ruptures on the stiffeners displayed roughness characteristic of violent static ruptures following an abnormally high load.

The overall findings on this part show that it suffered pressure directed from the inside of the tank towards the outside, causing it to rupture in three phases as shown in the following figure:

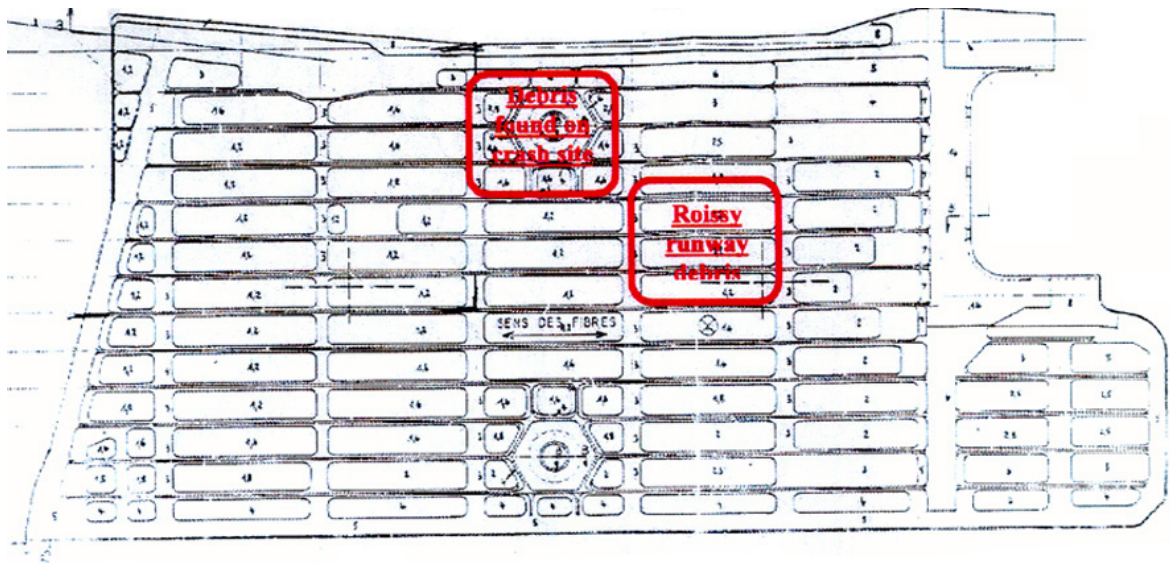
Figure 58: EADS diagram

A melted piece with a generally highly deformed shape, also found at the site, appears to come from the upper part of tank 5, between spars 55 and 56 but its deformed condition made it impossible to perform thickness measurements so as to confirm its location. This part bore three holes that were attributed to gravity acting on melting metal.

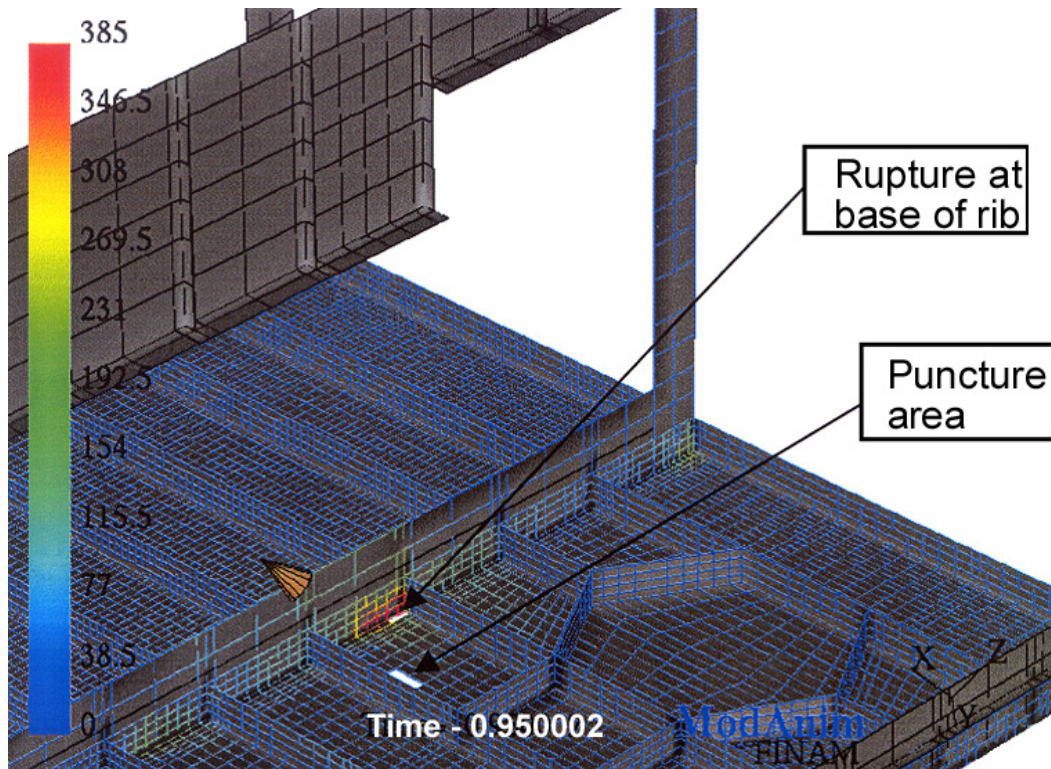
Figure 61: Position of the rupture areas on the lower skin

- the calculations for each simulation took place normally, without any accumulation of energy errors or numerical instability, which shows that the method was reliable;
- a hydrodynamic pressure surge phenomenon was observed following penetration and turning of the projectile in the tank;
- the loads transmitted to the structure did not lead to a rupture in the area affected by the pressure surge. However, they can lead to structural damage in the connection areas : the shock wave created overpressure that loaded the rib laterally and the resulting bending could initiate a local rupture at the base of the rib;
- the crack did not initiate in the puncture area itself.

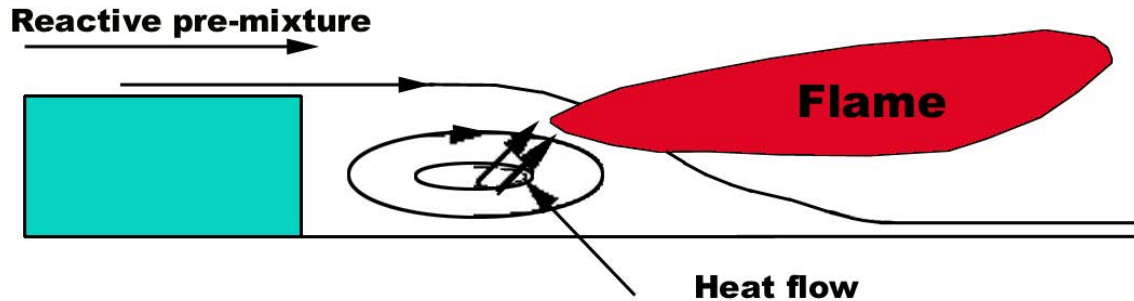
Figure 62: Re-circulation zone

- the re-circulation generates an area of low speeds,
- the re-circulation zone contains burnt gases and acts as a reservoir for hot gases that contribute to the ignition, slightly downstream, of the fuel-air mixture.

These mechanisms may explain the stabilisation of the flame in the left landing gear bay, as can be seen on photos of the aircraft on takeoff. Indications of stabilisation of the flame are not therefore necessarily apparent on the gear leg, partly because the flame is slightly stabilised downstream and in part because the leg is continuously cooled by the flow from upstream.

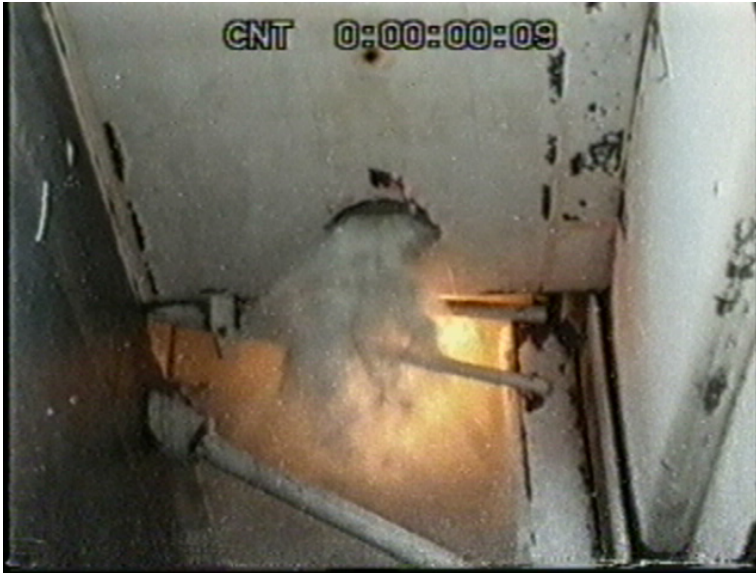
Figure 64: Ignition after spark

The tests simulated a short-circuit in the case of damage by crushing, tearing or cutting through the insulators of the electric line supplying the brake ventilators (3-phase 115 V, 400Hz). During the tests, the circuit breakers never tripped, apparently because the phenomenon was of too short a duration for them to detect it. The successive sparks had an energy estimated at twenty-seven joules, clearly above that required to ignite the vaporised kerosene, including in turbulent air conditions.

Although the electric cables are partially protected by the gear leg, possible damage due to the destruction of tyre No 2 cannot be entirely ruled out. It should, however, be noted

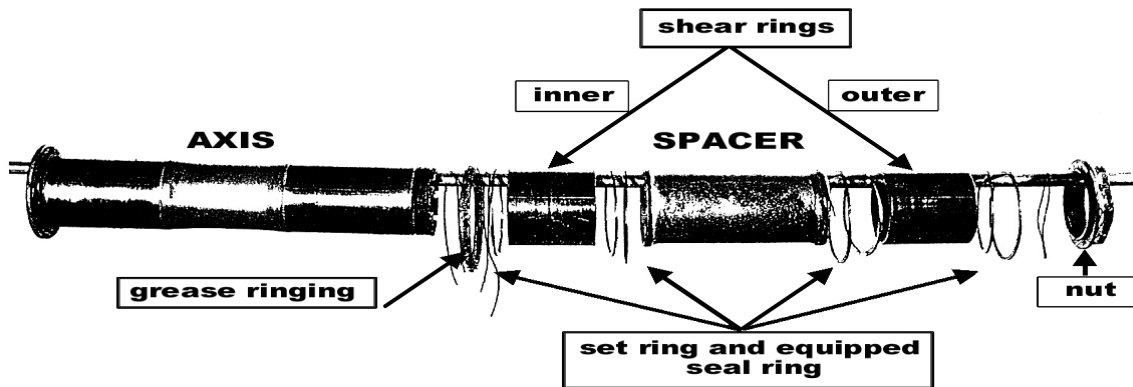
Figure 69: Landing gear, parts of the bogie beam

During removal of the bogie, the extractor tool was not used. Only the bushes were extracted after removal of the axle. The spacer remained on the bogie. Because they were using the tool reference in their working document, the AMM, the personnel did not find the extractor in the store. A check carried out after the discovery of the anomaly on 23 October 2000 confirmed, however, the presence of two extractors.

During reinstallation, the shear rings were positioned directly in their end bogie beam shock strut bores, before the axle was reinstalled. This made it impossible to detect the absence of the spacer on the new bogie.

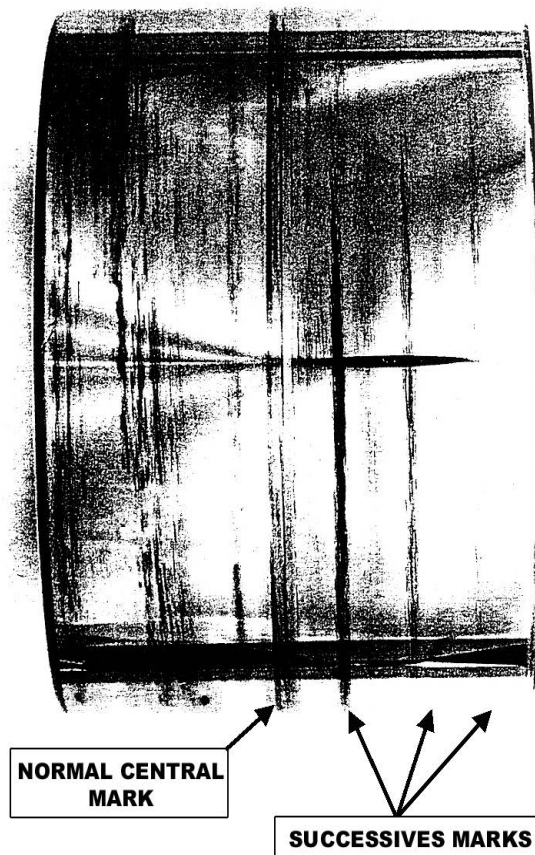
Figure 70: Left landing gear, inner shear ring

The condition of the various pieces (shear rings, bronze bearings, seals) show that the inner shear ring had moved from its position incrementally during the last few flights. The marks indicate that the mechanism was operational although the shear ring was no longer in its position on the bronze bearings of the shock absorber and bogie.

The exact chronology of this displacement is, however, difficult to determine since the ring was not new and certainly bore marks related to its previous usage. The only marks observed on the mechanical parts correspond to movements in the vertical plane alone or to normal oscillations of the bogie.

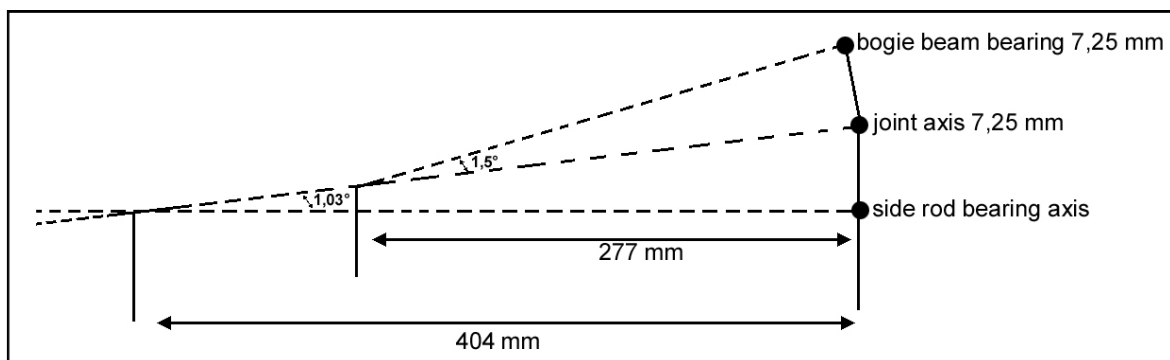
Figure 71: Effect of the lack of ring on the axle geometry

The bogie beam can move by the same amount in relation to the axis of the shaft, disregarding the residual guidance provided by the outer shear ring.

Maximum displacement of the geometrical axis of the bogie beam results from the combination of the two movements described above, which corresponds to 14.5 mm at the radius, thus a cone angle at the apex of 5° , the tip of the cone being located at the centre of the outer bearing.

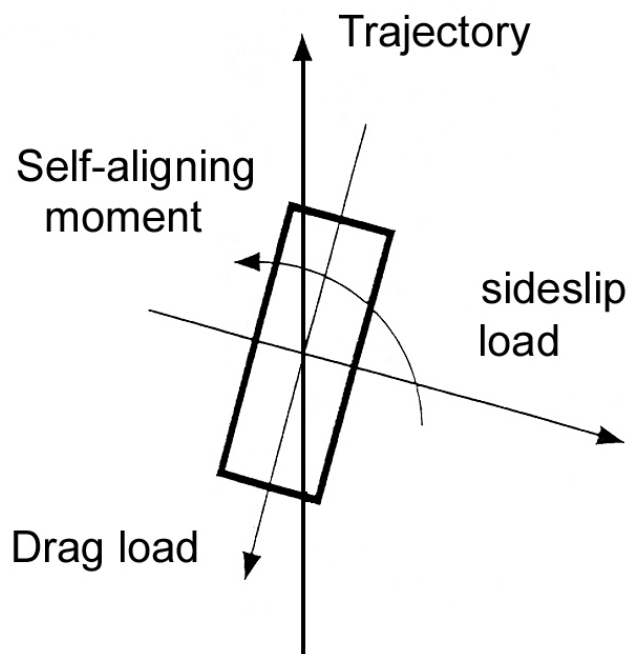
Figure 72: Typical behaviour of tyre under sideslip

It is also necessary to consider the possible effect of sideslip. The complete displacement of the shear ring can in fact engender lateral loads as a result of the appearance of a sideslip angle. Studies show that for sideslip angles of less than 5° , the self-aligning moment that appears tends to pull the wheel back towards the running axis.

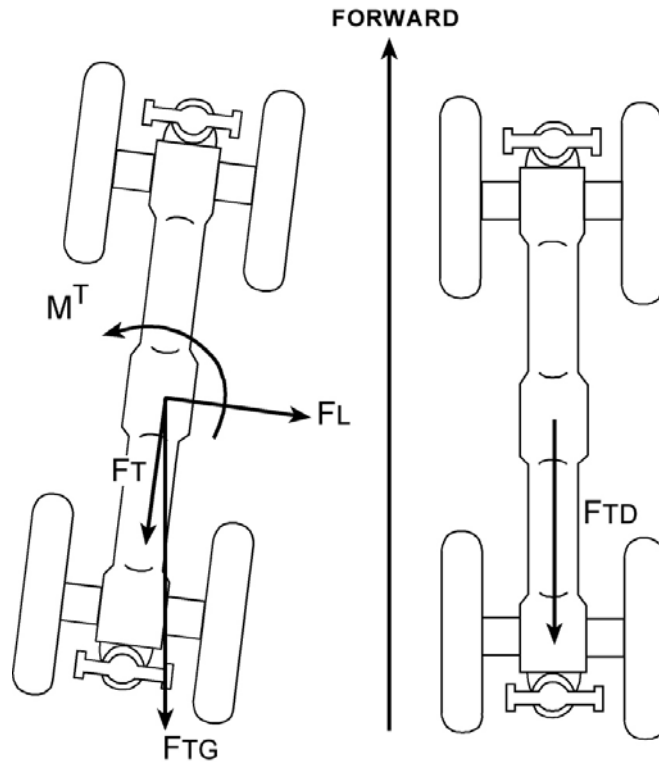
Figure 73: Loads in sideslip situation

Overall, the balance of forces at the centre of the bogie would result in self-aligning moment and two loads whose resultant is increased drag, that is to say a tendency to make the aircraft yaw to the left. The level of this drag would be at most around 1000 daN, very low in relation to the thrust of the engines. The influence of possible sideslip on the trajectory is thus very low or negligible.

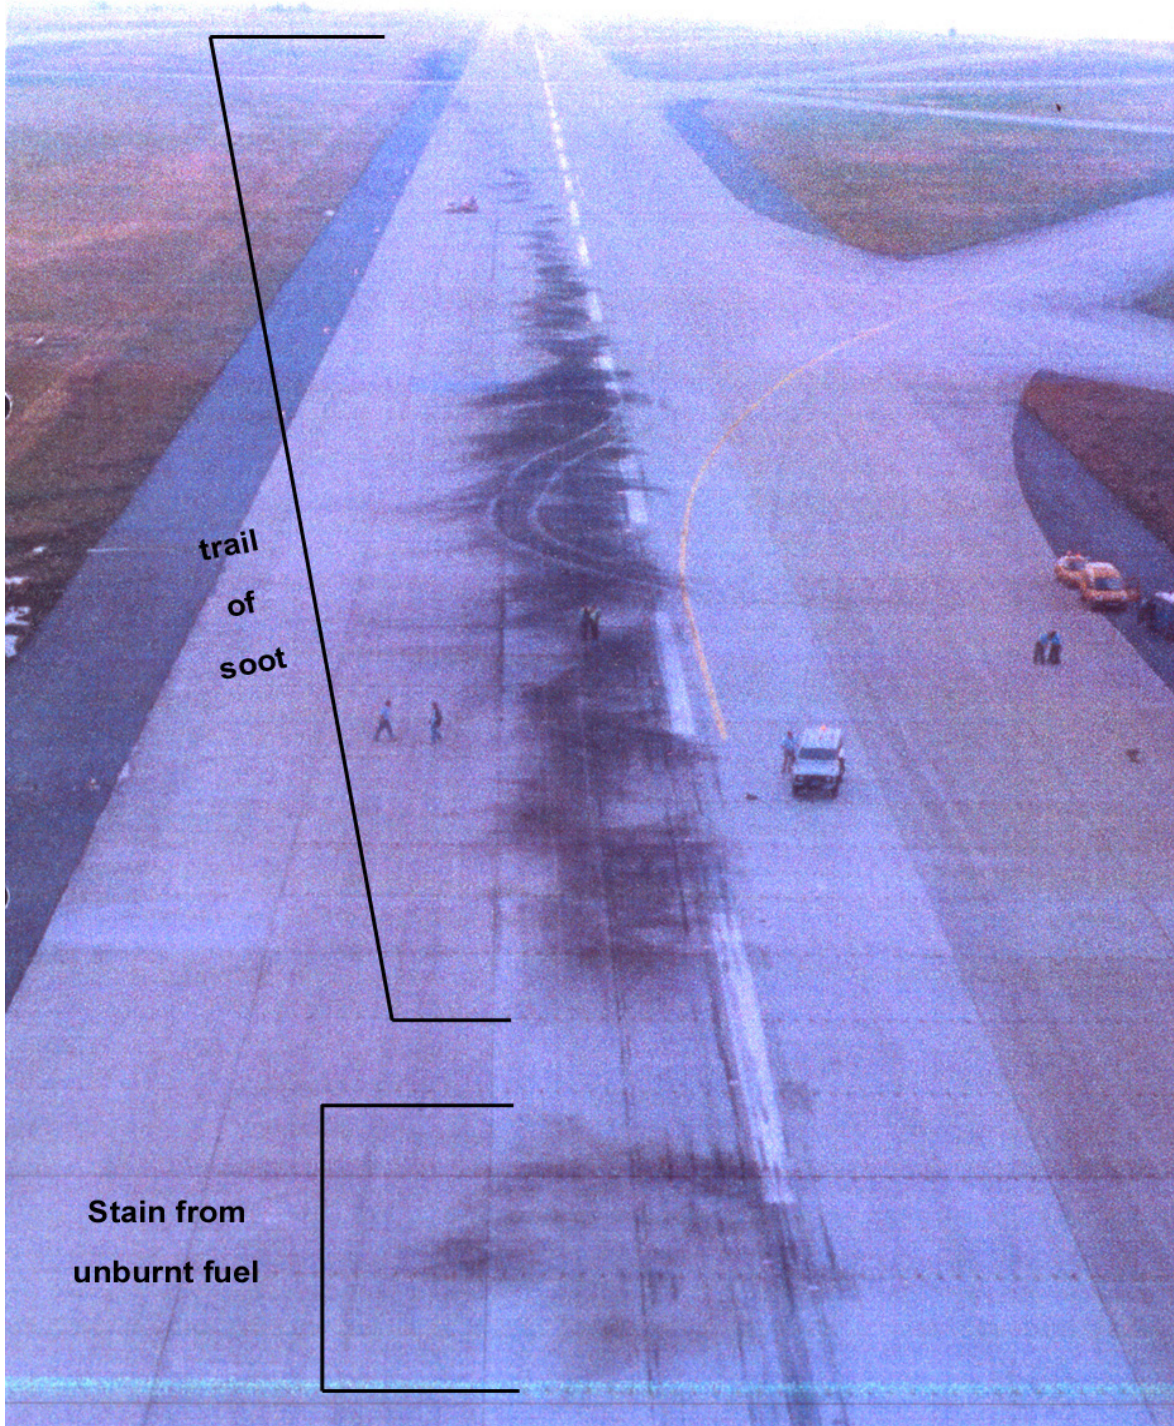
Figure 74: Aircraft track on takeoff

At 14 h 42 min 30.4 s, which is FDR reference time 97560.9, the characteristic clicking of the thrust levers in maximum thrust position is heard. The Captain gave the takeoff “top” one second later. The aircraft’s centre of gravity was around ninety metres from the threshold of the runway.
