AAIB Bulletin S2/2007

ACCIDENT

Aircraft Type and Registration:	Boeing 777-222, N786UA
No & Type of Engines:	2 Pratt & Whitney PW4090 series turbofan engines
Year of Manufacture:	1997
Date & Time (UTC):	26 February 2007 at 1000 hrs
Location:	London (Heathrow) Airport
Type of Flight:	Commercial Air Transport (Passenger)
Persons on Board:	Crew - 20 Passengers - 185
Injuries:	Crew - None Passengers - None
Nature of Damage:	Heat and fire damage to the right main power distribution panel, surrounding structure and components inside the Main Equipment Centre
Commander's Licence:	Airline Transport Pilot's Licence
Commander's Age:	52 years
Commander's Flying Experience: (Hours all approximate)	18,000 hours (of which 2,800 hours were on type) Last 90 days - 215 hours Last 28 days - 65 hours
Information Source:	AAIB Field Investigation

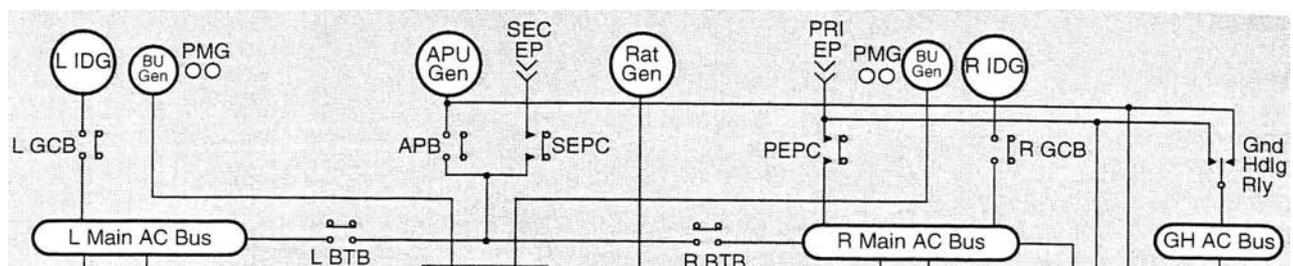
The electrical power system on the Boeing 777 normally operates as two independent 1 power channels. Each channel has a Main AC Bus. During normal flight operations the Left Main AC Bus receives power from the left engine IDG and the Right Main AC Bus receives power from the right engine IDG. On the ground, the APU or external power sources can be used to provide power to both main busses. A top level schematic of the power distribution system is shown in Figure 1. The flow of power is controlled by contactors which open

and close; seven contactors are shown in Figure 1 which include the right generator circuit breaker (RGCB) and right bus tie breaker (RBTB). The RGCB, RBTB and Right Main Bus are components of the P200 Electrical Load Management System (ELMS) power panel located in the right forward section of the MEC.

Boeing 777 electrical power distribution schematic
