INCIDENT

Aircraft Type and Registration:	Slingsby T67M260, G-EFSM
No & Type of Engines:	1 Lycoming AEIO-540-D4A5 piston engine
Year of Manufacture:	1989
Date & Time (UTC):	23 November 2006 at 0945 hrs
Location:	Near Cambridge Airport, Bedfordshire
Type of Flight:	Public Transport (Training)
Persons on Board:	Crew - 2 Passengers - None
Injuries:	Crew - None Passengers - N/A
Nature of Damage:	Possible cracking of the cockpit floor
Commander's Licence:	Commercial Pilot's Licence
Commander's Age:	36 years
Commander's Flying Experience:	2,000 hours (of which 300 were on type) Last 90 days - 38 hours Last 28 days - 20 hours
Information Source:	Aircraft Accident Report Form submitted by the pilot, information from the maintenance organisation and manufacturer and AAIB examination of the aircraft

Synopsis

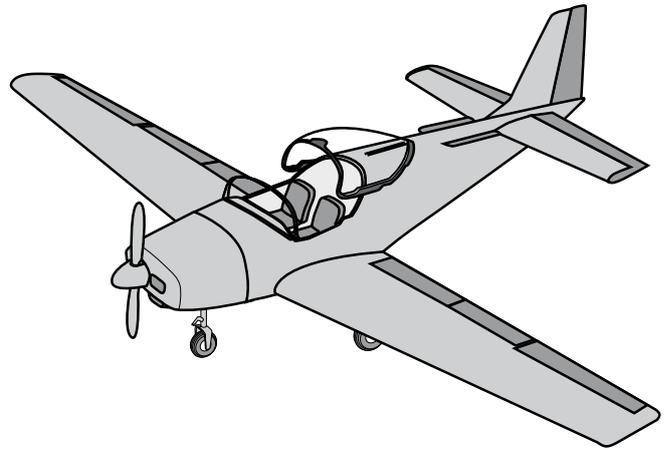
Figure 1

The Slingsby T67 Firefly is a single-engined low-winged monoplane, designed to be fully aerobatic (Figure 1). It is constructed principally of glass reinforced plastic (GRP). Two side-by-side seats are provided. The Firefly was first certificated in 1983, as the T67M, and a number of other versions were subsequently developed, including the 260 shp T67M260. In total, 280 aircraft have been
