Robinson R22 Beta, G-VFSI

AAIB Bulletin No: 12/2003	Ref: EW/C2002/07/01	Category: 2.3
Aircraft Type and Registration:	Robinson R22 Beta, G-VFSI	
No & Type of Engines:	1 Lycoming O-320-B2C piston engine	
Year of Manufacture:	1991	
Date & Time (UTC):	13 July 2002 at 1703 hrs	
Location:	Hampton Magna, Warwickshire	
Type of Flight:	Private	
Persons on Board:	Crew - 1	Passengers - 1
Injuries:	Crew - 1 (Fatal)	Passengers - 1 (Fatal)
Nature of Damage:	Aircraft destroyed	
Commander's Licence:	Private Pilot's Licence	
Commander's Age:	24 years	
Commander's Flying Experience:	269 hours (of which 264 were on type)	
	Last 90 days - 50 minutes	
	Last 28 days - 50 minutes	
Information Source:	AAIB Field Investigation

Synopsis

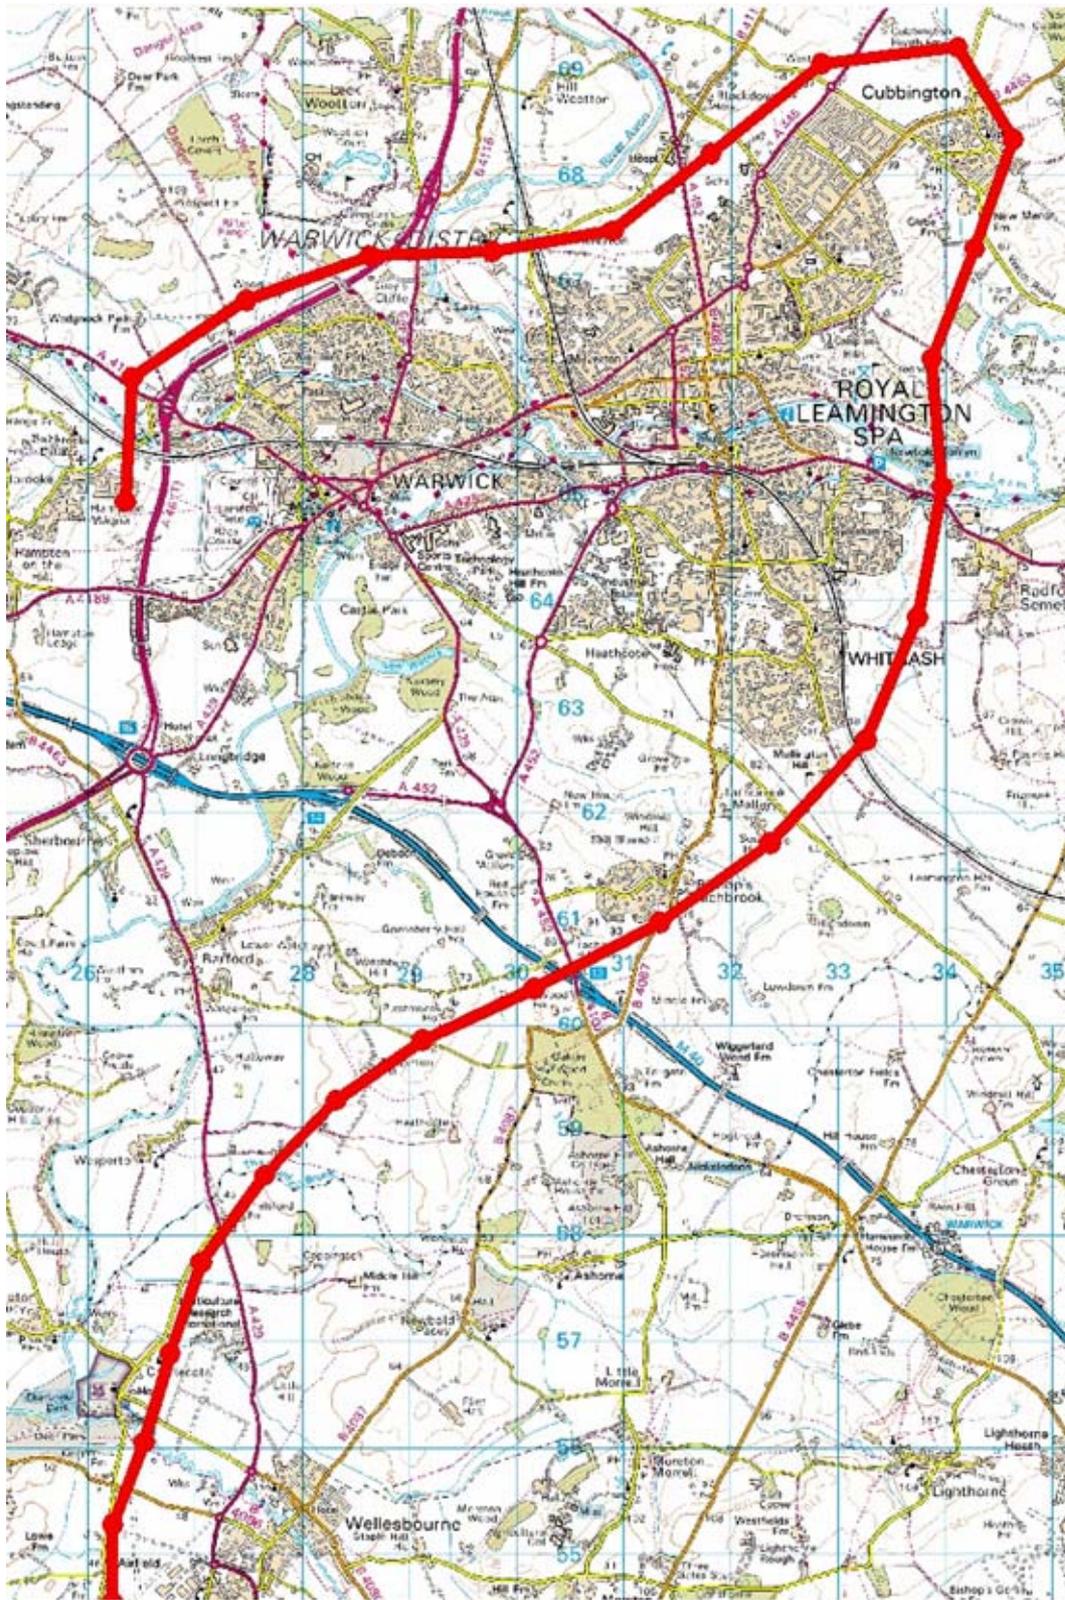
GPS Track of Flight

The helicopter lifted at 1640 hrs and hover taxied for a departure from Runway 36. After takeoff it turned north east to circumnavigate RLS and Warwick in an anticlockwise direction (see Figure 1).

A Skyforce Global Positioning System (GPS) was retrieved from the wreckage. Although the equipment was damaged, it was possible to recover recorded data which made it possible to reconstruct the aircraft's flights on the day of the accident. The data consisted of points defined by date, time, latitude and longitude, aircraft groundspeed, heading and altitude. This data had been recorded every 30 seconds. The last point was recorded at 1702:28 hrs. The data indicated that the aircraft had followed a very similar track on the accident flight to that flown on the previous flight around Warwick and Leamington Spa.
